CENTRAL VALLEY REGIONAL WATER QUALITY CONTROL BOARD

INSPECTION REPORT

DISCHARGER: Walker Mine, Abandoned and Unclaimed Private Property

INSPECTION DATE: 5 November 2013

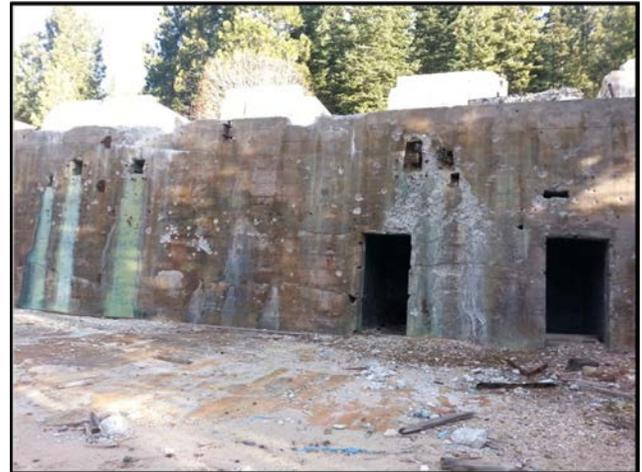
An inspection of the former concentrator plant area was made as shown in photos 2-11 of the attached photo-log. The formation of copper oxides was observed throughout the area on the concrete ruins and in residual mining waste material in and below the concentrator plant foundations. Copper oxides become soluble in water and pose a threat to water quality by means of flushing during winter rains and snowmelt. In general, little vegetation which might help to control erosion of mining waste was observed on the exposed mining waste within and near the concentrator plant ruins.

Photo 4. Upper concentrator plant foundations showing formation of copper oxides on the concrete foundations.

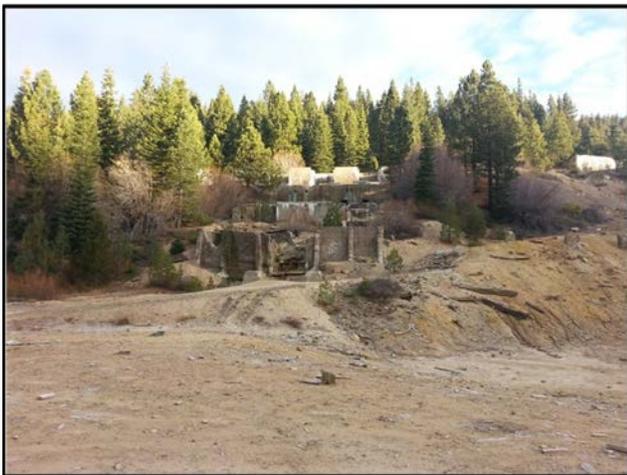
Photo 2. Concentrator plant location. Mining waste is evident in and below the concentrator plant foundations.

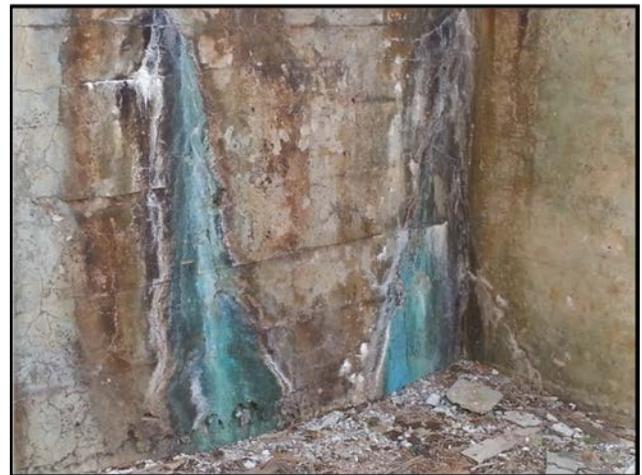
Photo 5. Closeup view of the previous photo.

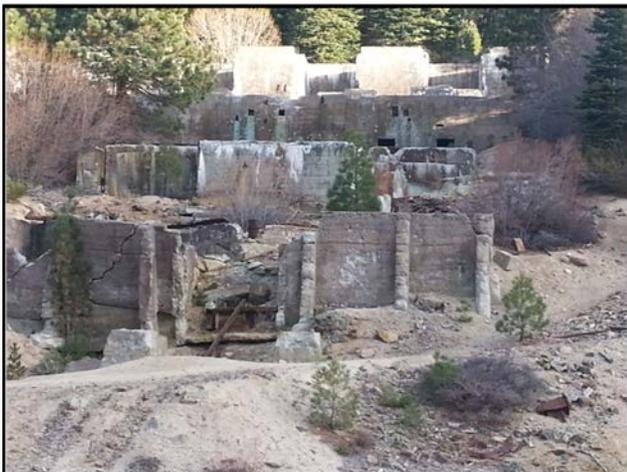
Photo 3. Concentrator plant foundations. Formation of copper oxides can be seen in numerous locations within the concrete foundations.

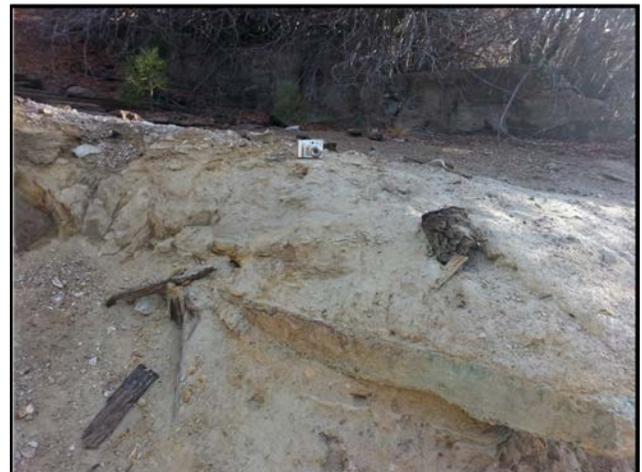
Photo 6. Residual mill tailings containing copper oxides within the mill foundations.

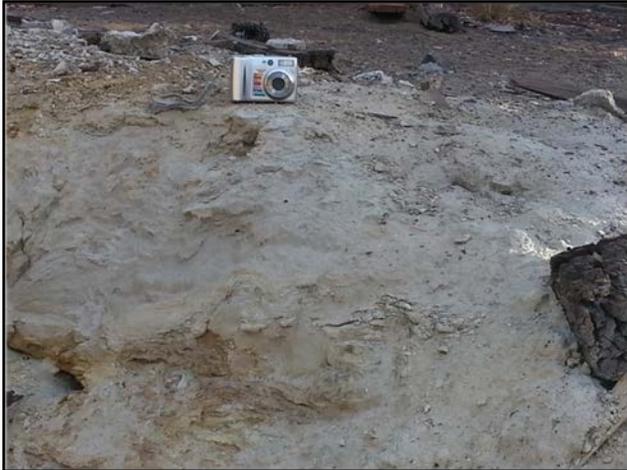
Photo 7. Closeup view of the previous photo showing fine grained mill tailings.

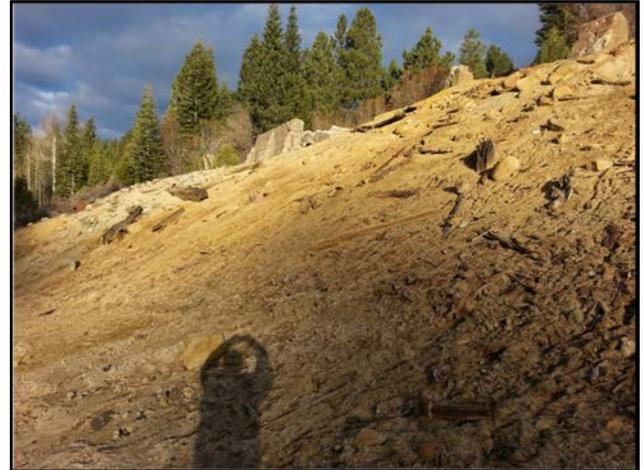
Photo 10. Close-up view of previous photo. Note the absence of vegetative growth in the mining waste.

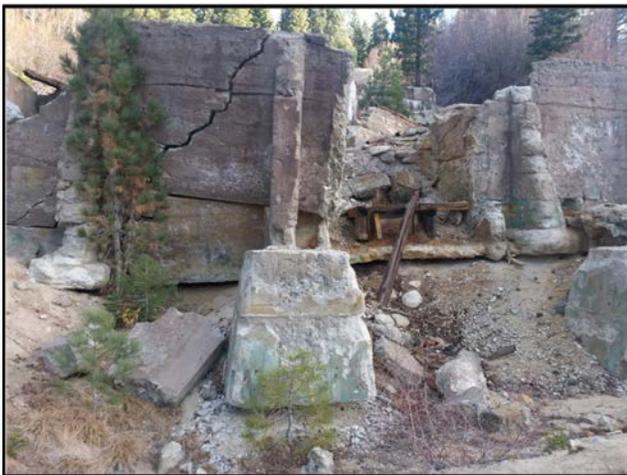
Photo 8. Showing drainage pathway from the concentrator foundations to the tailings area located below the concentrator foundations.

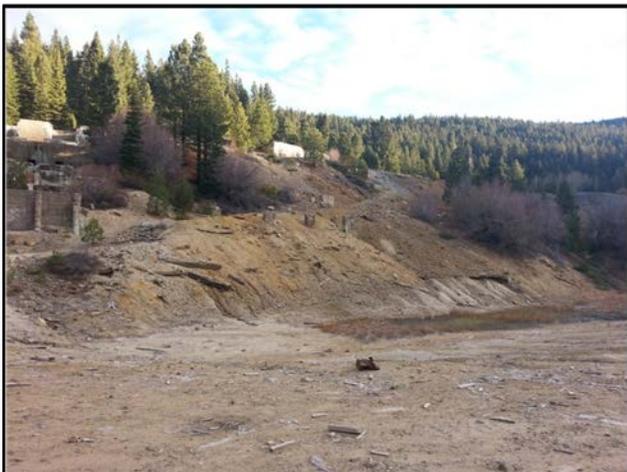
Photo 9. Mining waste located below the Concentrator foundations.

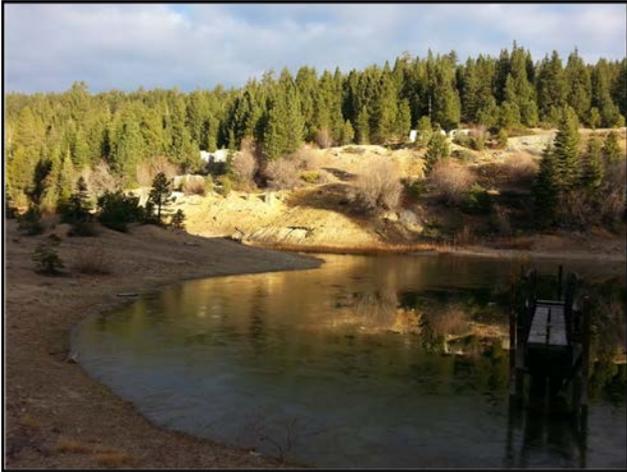
Staff also inspected the former 1920s period tailings area located below the Walker Mine and Mill area (see photos 11-18). A settling pond (photos 13-14) collects runoff from the slope below the former mine and mill area. The pond never completely fills, but it is suspected to indirectly discharge to Dolly Creek via a buried drainage structure or through the fill material. The tailings material shown in photos 15-18 is sparsely vegetated and copper oxides were observed in the drainages shown in photos 15-18.

Photo 13. Settling pond located below the Walker Mine mill location. Settling pond likely discharges to Dolly Creek.

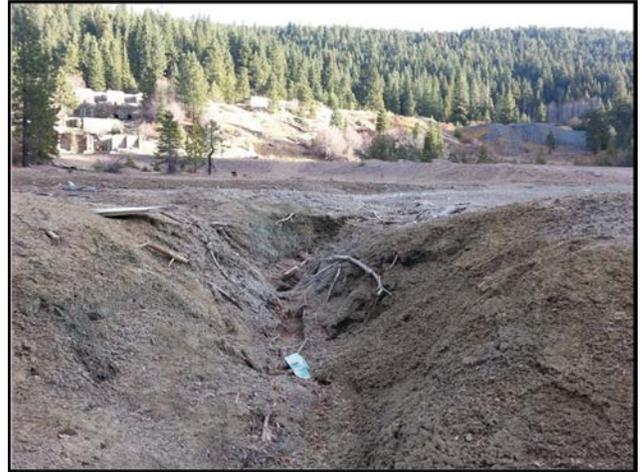
Photo 16. Looking up gradient and east at feeder channel to the drainage channel in previous photo. Drainage channel is cut into fine grained tailings material.

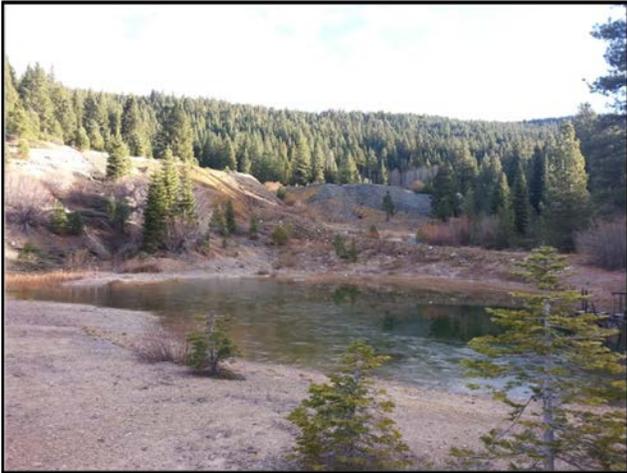
Photo 14. Looking northeast at mining waste piles located below the Walker Mine portal. Runoff from the mining waste piles flows to Dolly Creek.

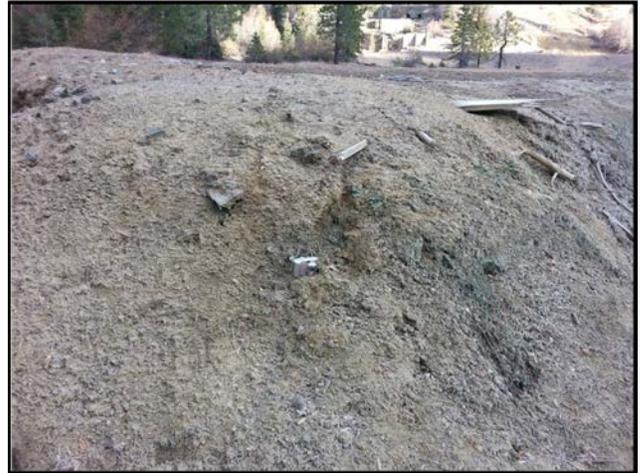
Photo 17. Close-up view of tailings material in feeder channel shown in the previous photo.

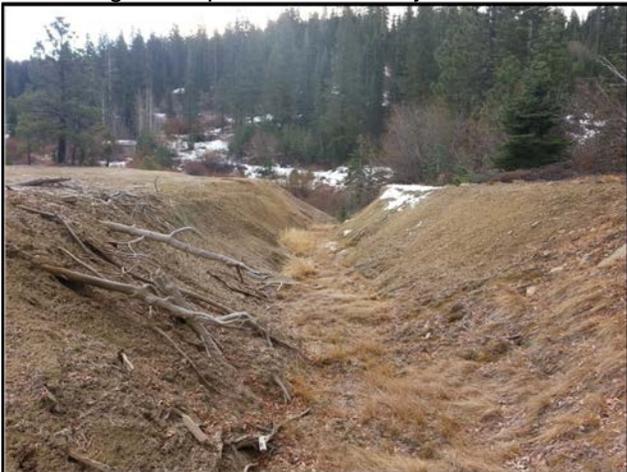
Photo 15. Looking southeast down gradient towards Dolly Creek. Drainage channel has cut into tailings material from the 1921 to 1927 period tailings pond.

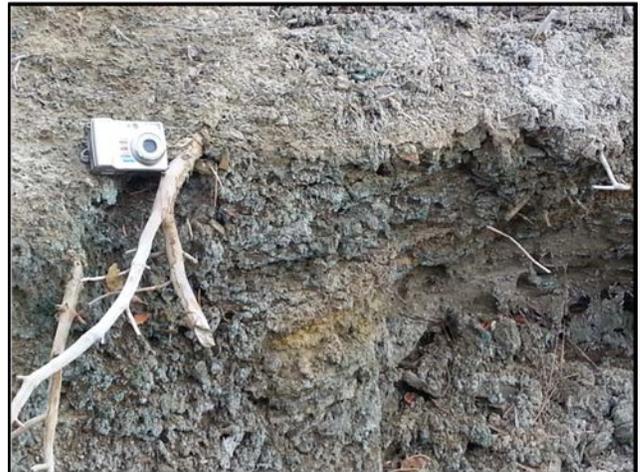
Photo 18. Copper oxides are shown (blue-green material) in the fine grained tailings material.

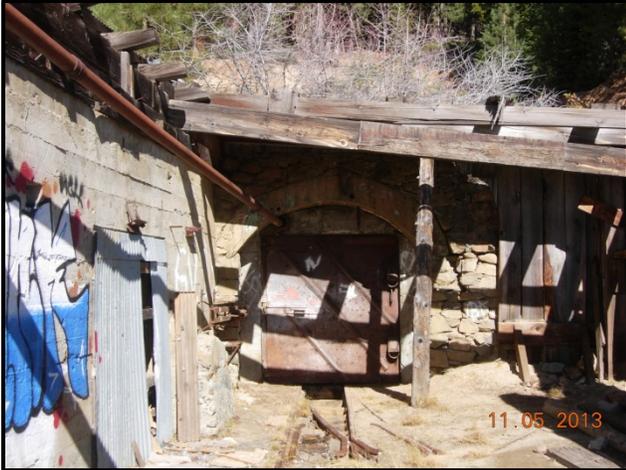
The drainage channel between the mine portal and the waste dump was open and flowing at about 0.5 gallons per minute. The portal door (photo 19) at the 700 level adit had been tampered with by vandals which made the door difficult to open, but it was still securely locked upon our arrival.

Photo 19. Walker Mine 700 level access adit.

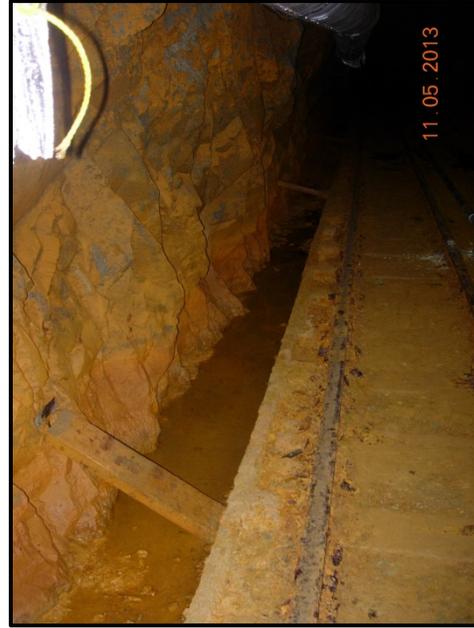
No scaling was necessary in the unsupported section of the 700 level and no signs of recent rockfall were noted. Water seepage observed in the unsupported section of the adit was minimal; however a small pool of water was noted for the first time on the left-hand side of the adit near the 1600 foot station (photo 22).

Photo 22. Small pool of water noted for the first time near the 1600 foot station.

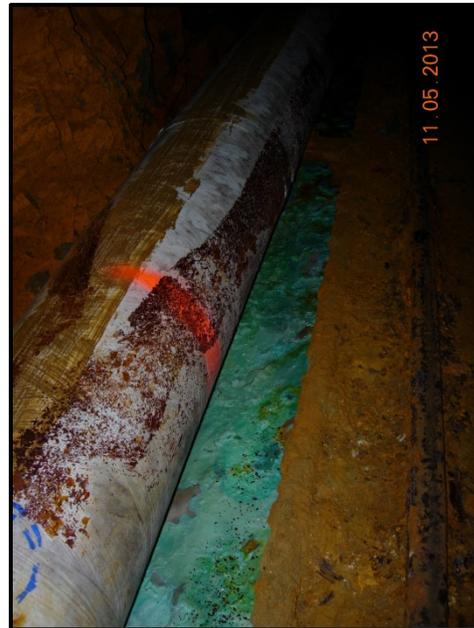
Photo 23. Copper oxide on the floor of the 700 level adit next to the ventilation ducting. Location of the photo is about 2000-feet inside the 700 level adit.

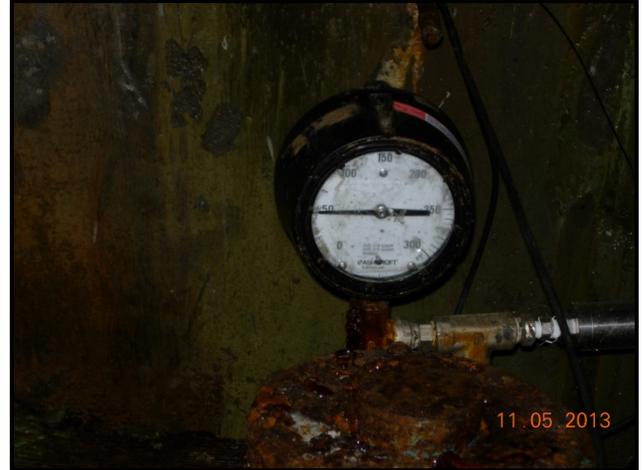
Conditions at the mine seal are shown in photos 24-28. The pressure gauge read nearly 50 psi, which indicates a head of approximately 115 feet over the mine seal. Water seepage from around the mine seal and pooled water conditions at the base of the mine seal appeared to be unchanged since July of 2010. Seepage appears to come from the crown of the seal and along both sides. Iron precipitate is evident on the face of the mine seal (photo 24) but does not appear to be significantly different than that shown in the *Walker Mine Seal Testing and Evaluation Report* (GEI Consultants, 1 March 2002). The piping and valves were uncovered (photo 26) and inspected. No seepage or significant changes in corrosion were noted. The valves were not tested due to concern that they may not close completely if opened. Samples of the water pooled at the base of the seal (monitoring location #30) were collected for laboratory analysis. Staff then exited the 700 level adit and securely locked the portal door.

Photo 27. Pressure gauge showing 50 psi. This equates to 115 feet of head over the mine seal.

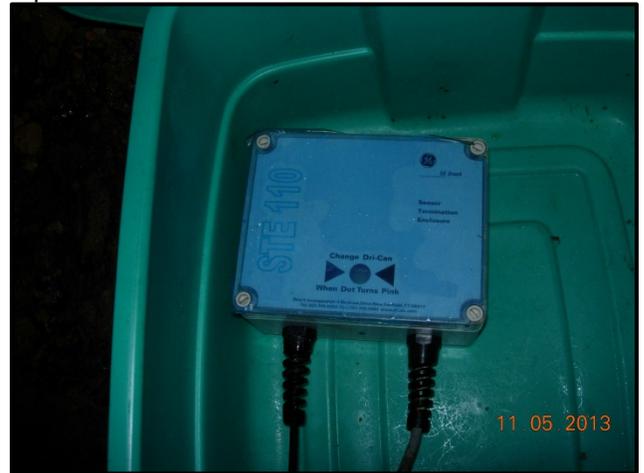
Photo 28. Pressure transmitter sensor termination enclosure located near the mine seal.

A semiannual inspection was made of the Walker Mine site. Surface water sampling was performed and water pressure measurements on the mine seal were obtained. The pressure transmitter for the Walker Mine seal appears to have failed on or about August 19th and a new pressure transmitter needs to be purchased and installed during the spring 2014 inspection.

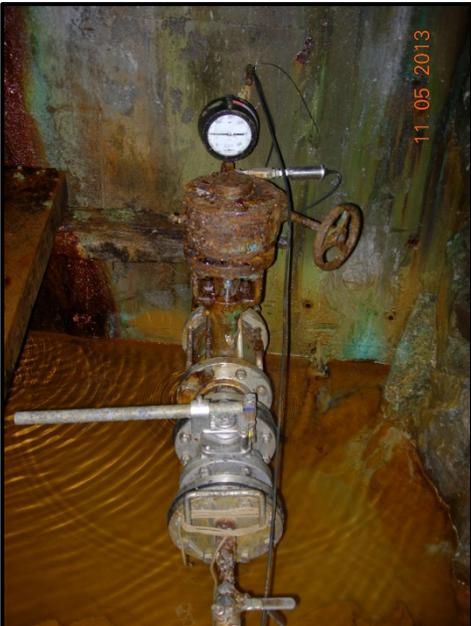
Photo 26. One of the two stainless steel 4-inch valves and pressure gauge at the mine seal.

An experience underground mine contractor should be hired to inspect the timbered section and the unsupported section of the 700 level adit for signs of ground support deterioration. Furthermore, while the stainless steel piping and valves need to be inspected and physically tested to ensure their operability in accordance with the Board's Operations and Maintenance Plan for the Walker Mine, there is some potential risk that the valves cannot be completely closed after being opened.

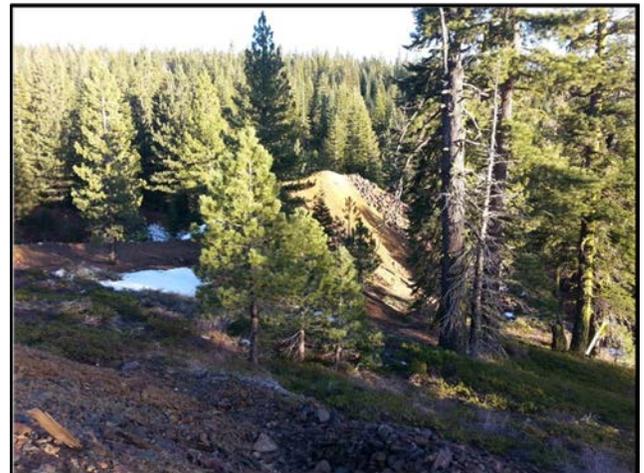
Photo 28. Central ore body location. Mining waste pile shown in the center of the photo. Subsidence area to the left of the waste pile. Runoff from the waste pile drains to the South Branch of Ward Creek.

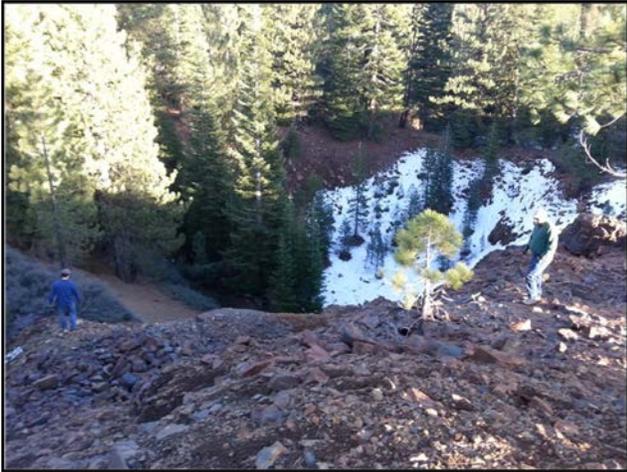
Inspection of the Central ore body area was made later in the afternoon (see photos 28-34). The primary mining related features in this area consist of the subsidence areas caused by sublevel mining below the Central ore body, several small mining waste piles, and a ventilation shaft located near the top of the hill north of the Central ore body. The subsidence areas act as a natural funnel to transmit precipitation to the underground workings, which in turn increases the hydrostatic pressure on the mine seal, which was installed to stop the discharge of acid mine drainage from the Walker Mine. Staff also inspected the concrete lined diversion ditches, constructed on behalf of the Central Valley Water Board in the early 2000's, which are intended to reduce the amount of surface water runoff during snowmelt periods to the subsidence areas. The diversion ditches were relatively clean of debris, but contained no water at the time of our inspection.

Photo 29. One of several subsidence areas in the vicinity of the Central ore body. Subsidence areas resulted from sublevel mining activities (see below).

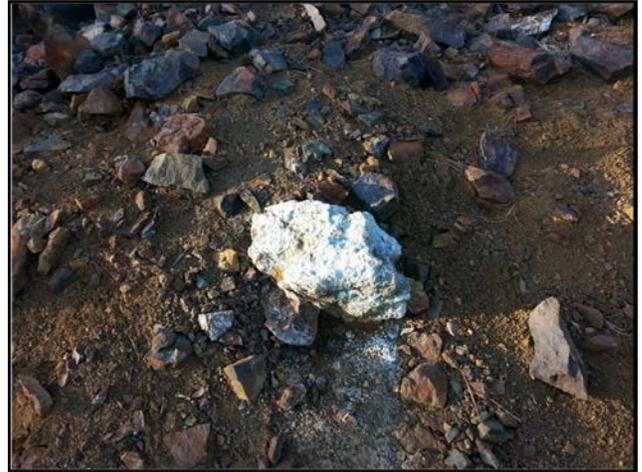
In a brief examination of the mining waste piles located near the Central ore body location, some copper oxide formation was observed as shown in photos 32-33. As noted above, copper oxides become soluble in water and pose a threat to water quality by means of flushing during winter rains and snowmelt. Finally, we located an open ventilation shaft near the top of the hill north of the Central ore body. The ventilation shaft appears to drop approximately 50 vertical feet before dipping at an angle of about 30 degrees to the east to some unknown depth. Coordinates for the shaft were recorded and will be mapped for future reference. The open shaft is an obvious safety hazard and should be closed so that it no longer poses a physical hazard.

Photo 32. Copper oxide formation on the surface of waste rock at the Central ore body location.

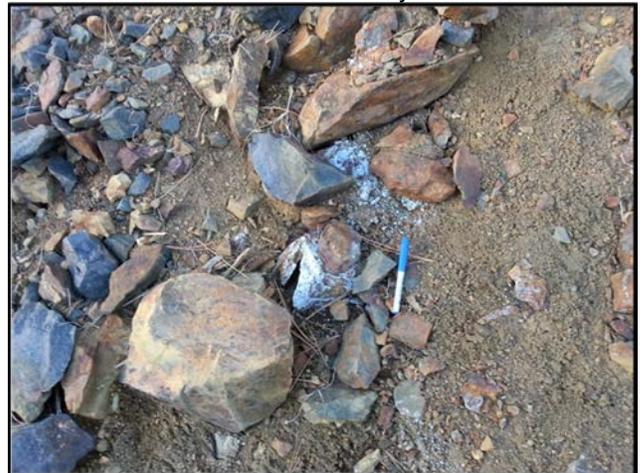
Photo 33. Another example of copper oxide forming on the surface of waste rock at the Central ore body location.

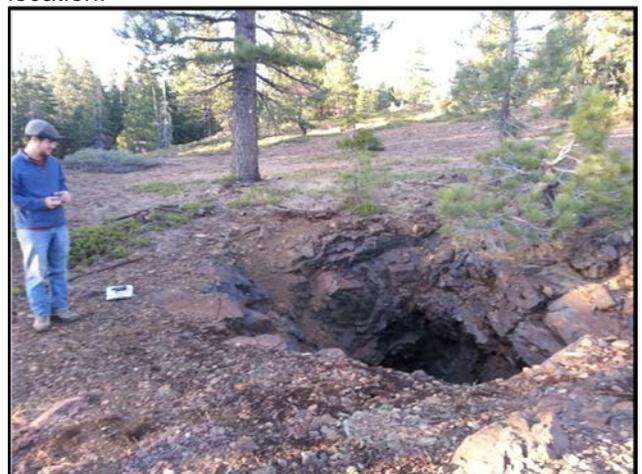
Photo 34. Open ventilation shaft located on the hillside above the Central ore body location.

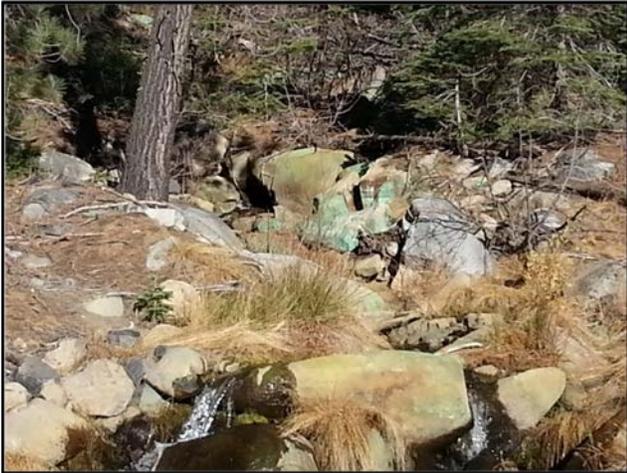
Board staff also inspected and obtained water samples from in and around the Walker Mine tailings facility (see photos 35-39) located on adjacent public lands administered by the United States Department of Agriculture Forest Service (USFS). Copper oxides continue to be observed on large boulders (photo 36) just above the Dolly Creek diversion head-works located just east of the Walker Mine tailings. The tailings, shown in photos 37-39, are sparsely vegetated and wind-blown erosion of the tailings continues pose a threat to water quality.

Photo 36. Close-up view of prior photo. Copper oxide can be seen on the large boulders in the center of the photo.

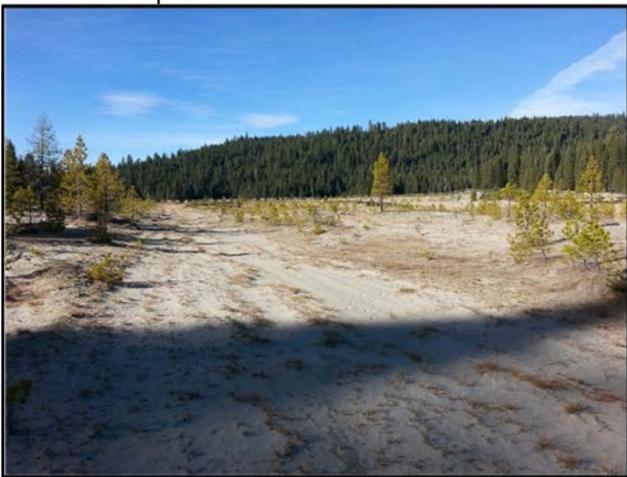
Photo 37. Walker Mine Tailings facility showing scarcity of vegetation to control erosion of the tailings.

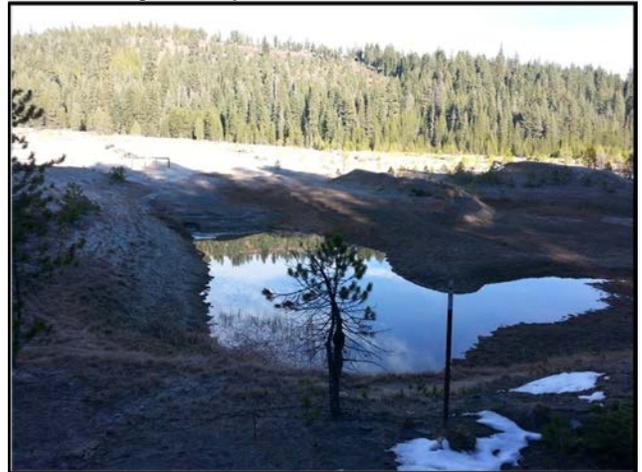
Photo 39. Walker Mine Tailings settling pond. No drainage path to the settling pond was observed which would indicate that the water shown is the saturation level in the tailings.
