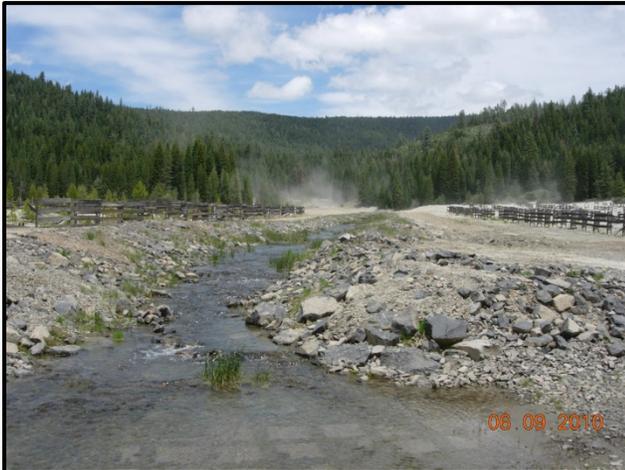
Photo 1. Walker Mine tailings near WM-7b, looking upgradient at the Dolly Creek diversion channel showing wind born tailings.

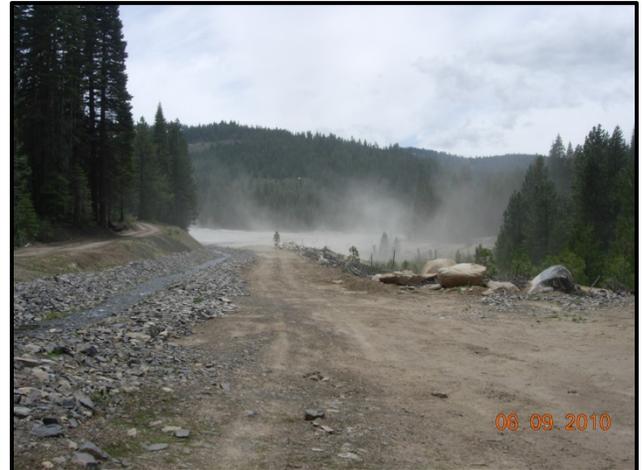
Photo 4. Photo taken approximately 100 yards downgradient of WM-7a. Showing wind born tailings over the Dolly Creek diversion channel.

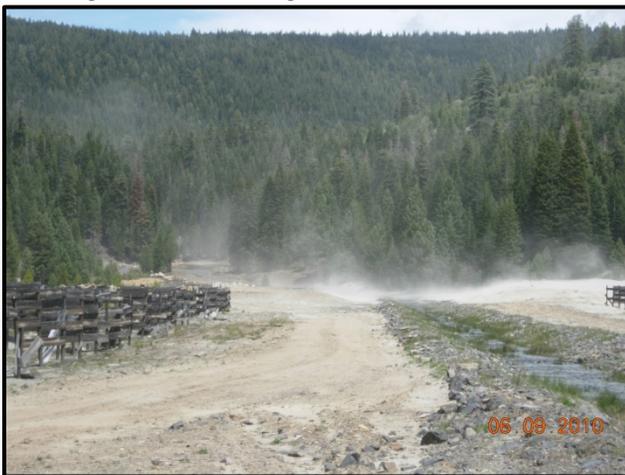
Photo 2. Close-up picture of prior photo.

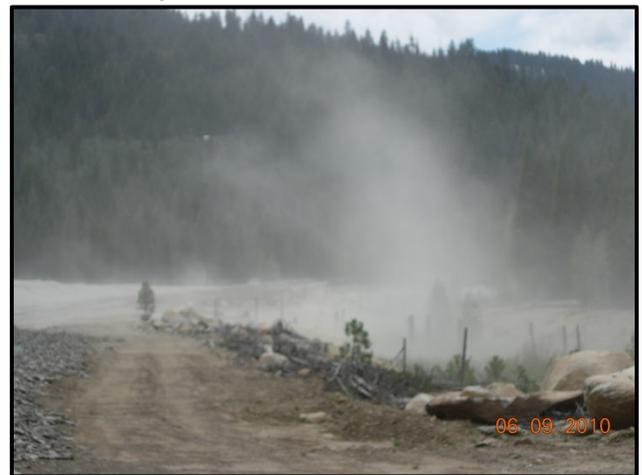
Photo 5. Close-up picture of prior photo.

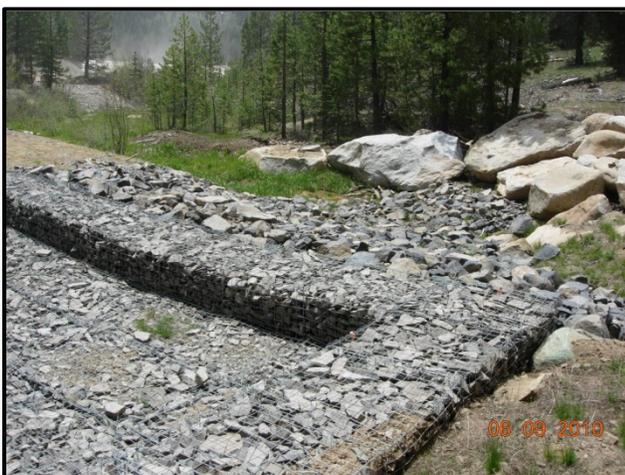
Photo 3. Near WM-7a looking downgradient toward the Walker Mine tailings. Dolly Creek diversion structure in the foreground. Wind born tailings in the background.

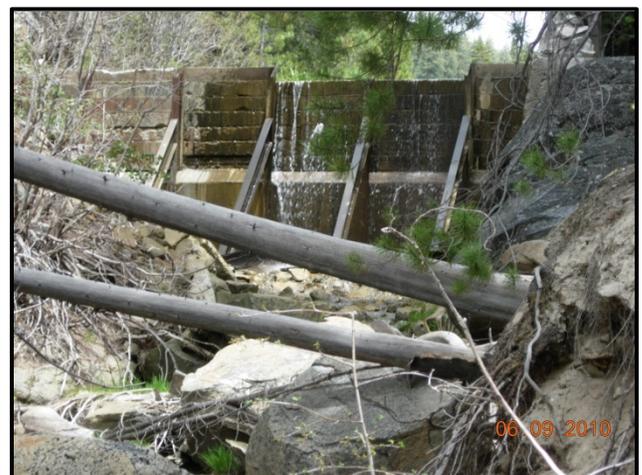
Photo 6. Walker Mine Tailings, USFS Dam (WM-6). Showing water from the old Dolly Creek channel spilling over the USFS Dam.
