California Regional Water Quality Control Board Central Valley Region

7 APRIL 2010 INSPECTION REPORT—COMPOSTING AREA, RECOLOGY HAY ROAD LANDFILL, SOLANO COUNTY

INSPECTION REPORT

DISCHARGER: Recology Hay Road

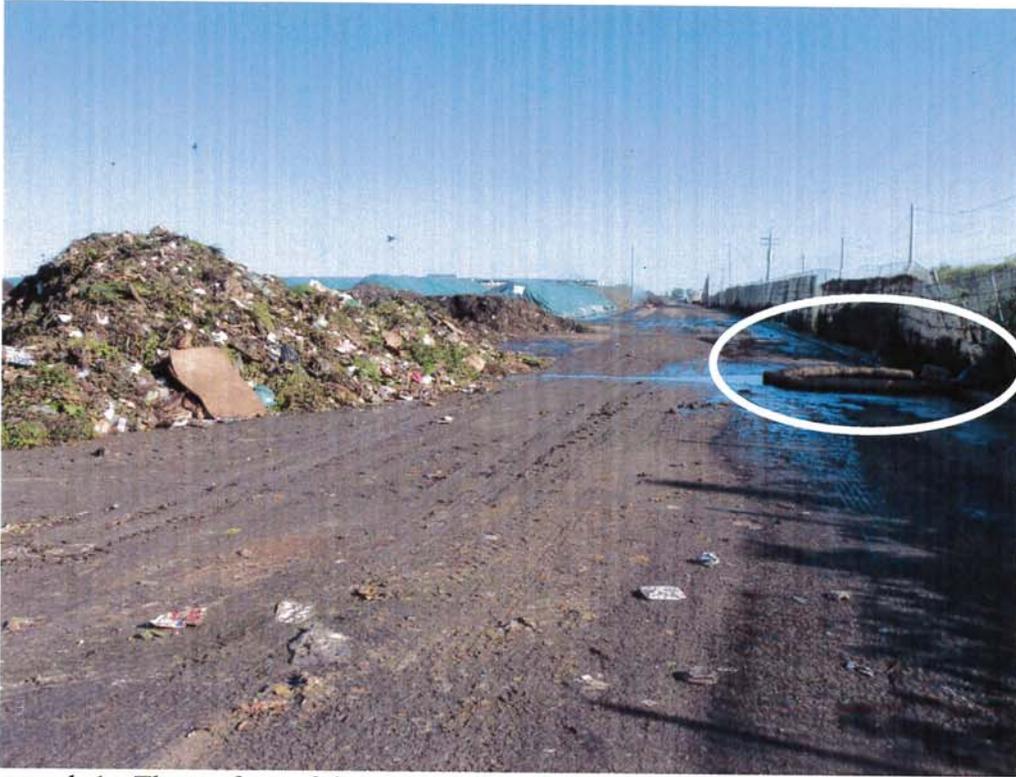
Photograph 1: The surface of the compost area is sloped to drainage ditch inlets (circled in photo) located along a concrete lined drainage ditch.

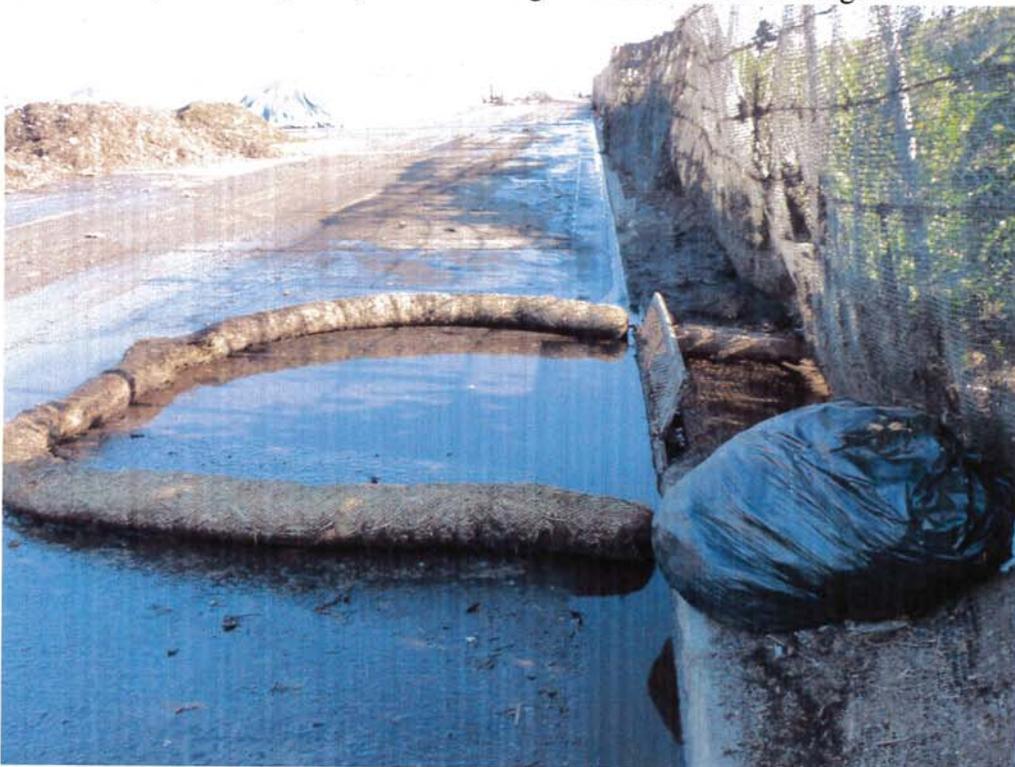
Photograph 2: Close up view of drainage ditch inlets. Concrete lined drainage ditch is located just beyond the cyclone fence on the right side of the photograph.

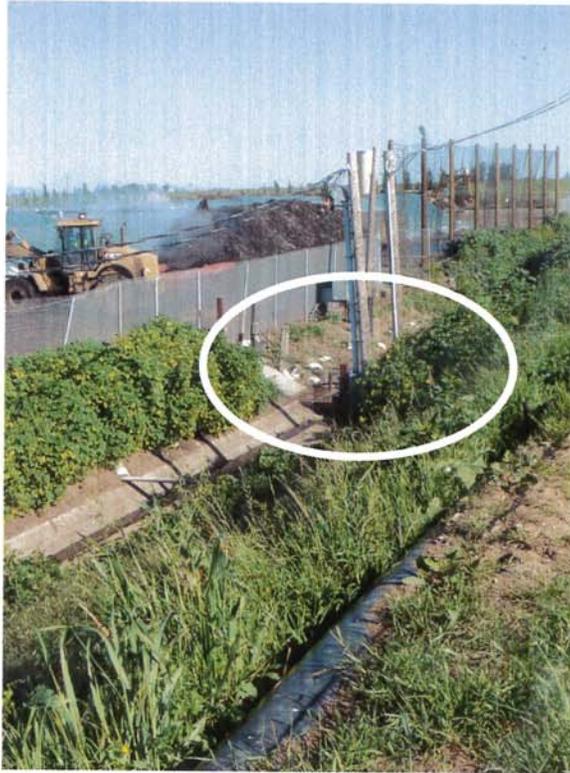
Photograph 3: Concrete lined drainage ditch. The location of a 4,200-gallon sump with pump is circled in the photo. Leachate is pumped to the compost area pond.

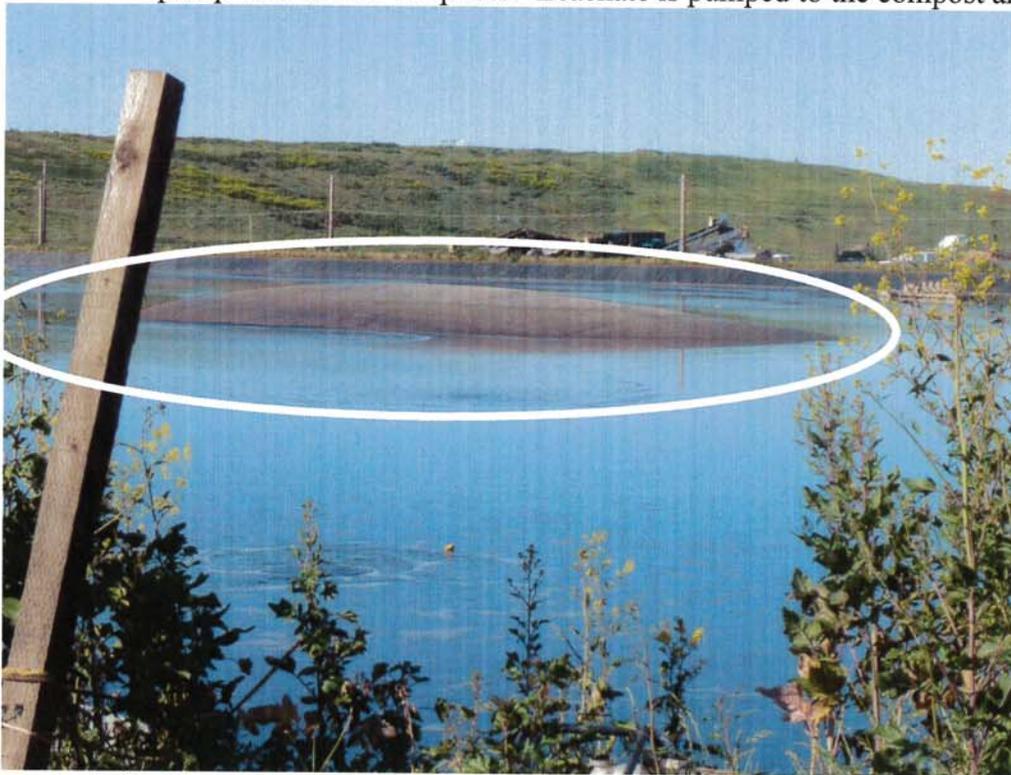
At the pond, I observed that that the HDPE pond liner has ballooned up above the water line, a possible indication of landfill gas intrusion between the liner and soil foundation. WDRs Section C.8, *Facility Specifications*, requires that methane and other landfill gases be adequately vented, removed from a unit, or otherwise controlled to prevent the danger of adverse health effects, nuisance conditions, degradation, or impairment of the beneficial uses of surface water or groundwater due to migration through the unsaturated zone. Therefore, Recology must investigate the cause of the ballooning and provide a report with its investigation results. Recology's investigation must include, but not be limited to, testing the gas space at nearby groundwater monitoring wells and landfill gas detection probes.

Photograph 4: Compost area pond with "balloon" (circled in photo above) possibly indicating intrusion of landfill gas. The pond is lined with 80-mil HDPE.

By **4 June 2010**, Recology must provide a report with its investigation results. If landfill gas is the cause of the ballooning, as determined by Central Valley Regional Water Quality Control Board staff, corrective action may be required.
