**NOTICE OF VIOLATION: SITE INSPECTION OF THE YUBA SUTTER DISPOSAL INC.,  
LANDFILL, YUBA COUNTY**

## INSPECTION REPORT

LOCATION & COUNTY: Yuba Sutter Disposal, Inc., Yuba County

INSPECTION DATE: 29 June 2011

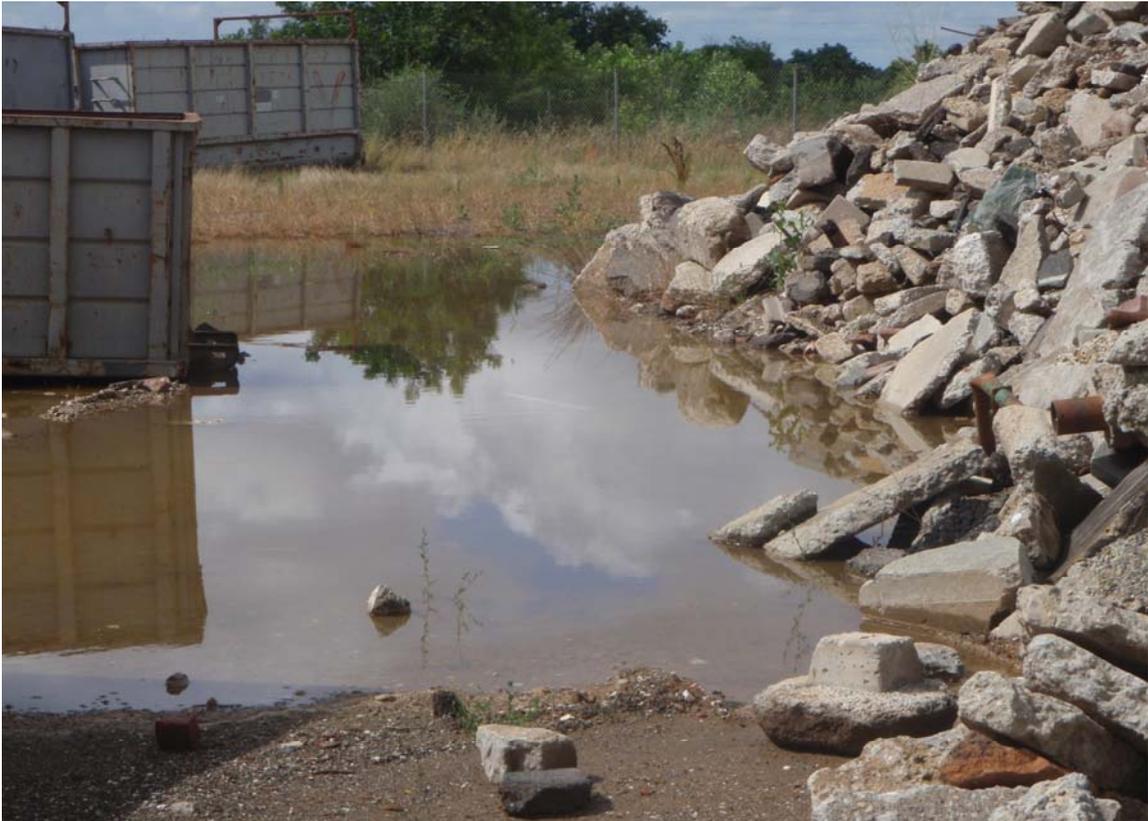
Staff inspected the southern area of LF-1, which is being used as a storage yard for debris bins, concrete rubble, white goods, dimensional lumber, and assorted scrap metal. An area of concern on LF-1 was the standing water observed. It is apparent that settlement of the waste mass has occurred thus allowing storm water to pond. Facility Specification, B.12 of WDR R5-2003-0093, states: *Closed landfill units shall be maintained to promote runoff and to prevent ponding.*

Photo 2: Standing water over LF-1 due to lack of drainage.

Based on observations made during this site visit, the facility uses WMU LF-1 as a storage yard for concrete rubble, debris boxes, scrap metal, white goods, and dimensional lumber. It was evident that drainage of WMU LF-1 has not been maintained and that settlement of the cover has occurred. To address Facility Specification B.12, staff is requesting the Discharger to submit a work plan by **15 September 2011** that restores drainage to WMU LF-1. The work plan should include a schedule of activities that will be performed during this construction season.

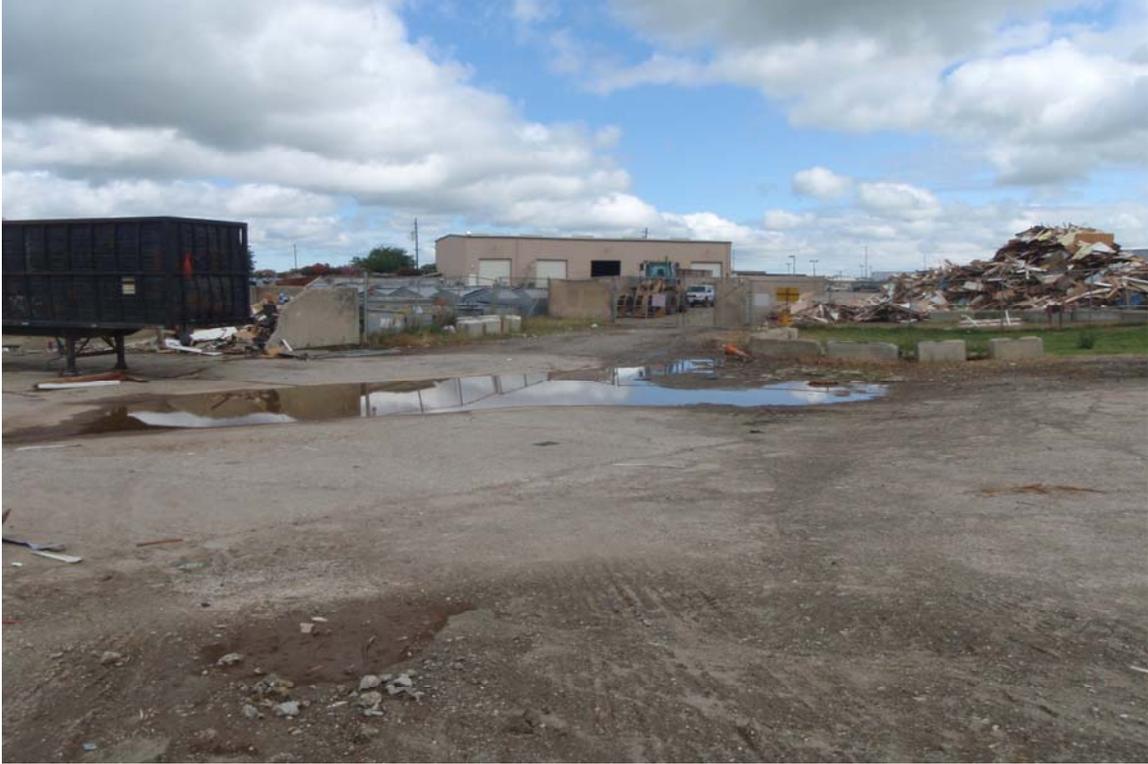
Photo 3: Standing water over LF-1. Note low spot due to settlement of waste mass.

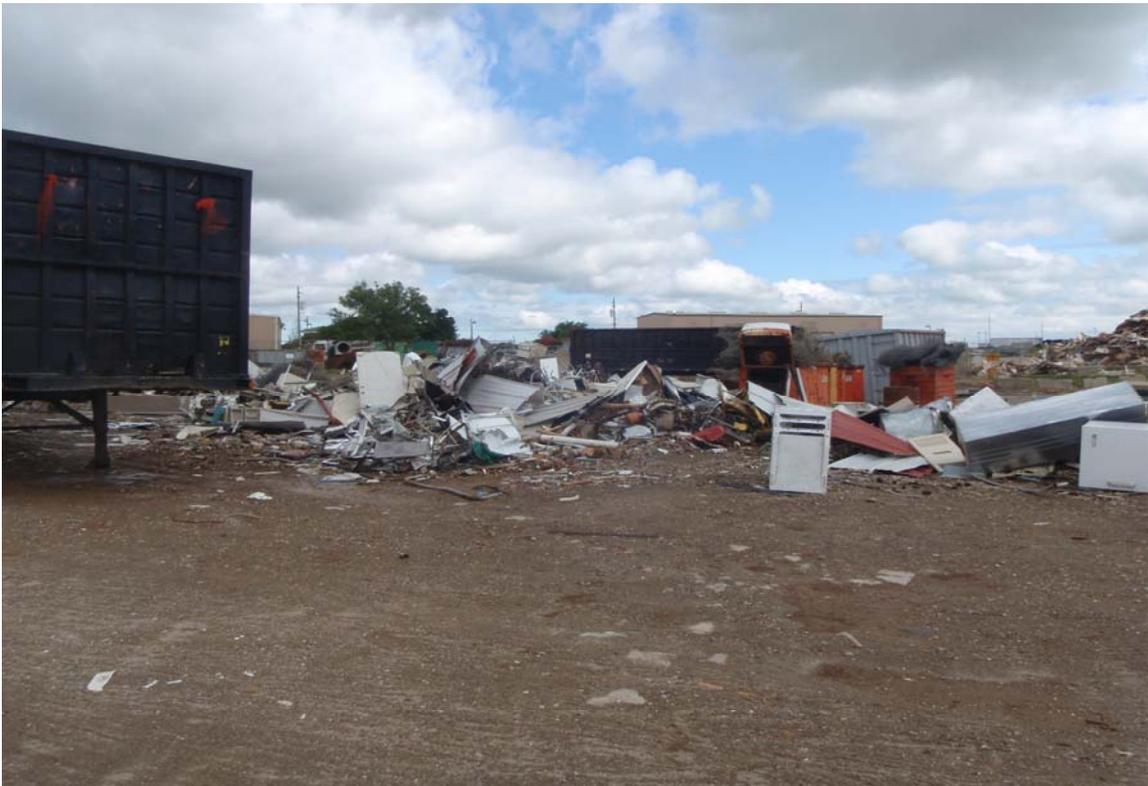
Photo 4: Scrap metal stockpiled over LF-1.

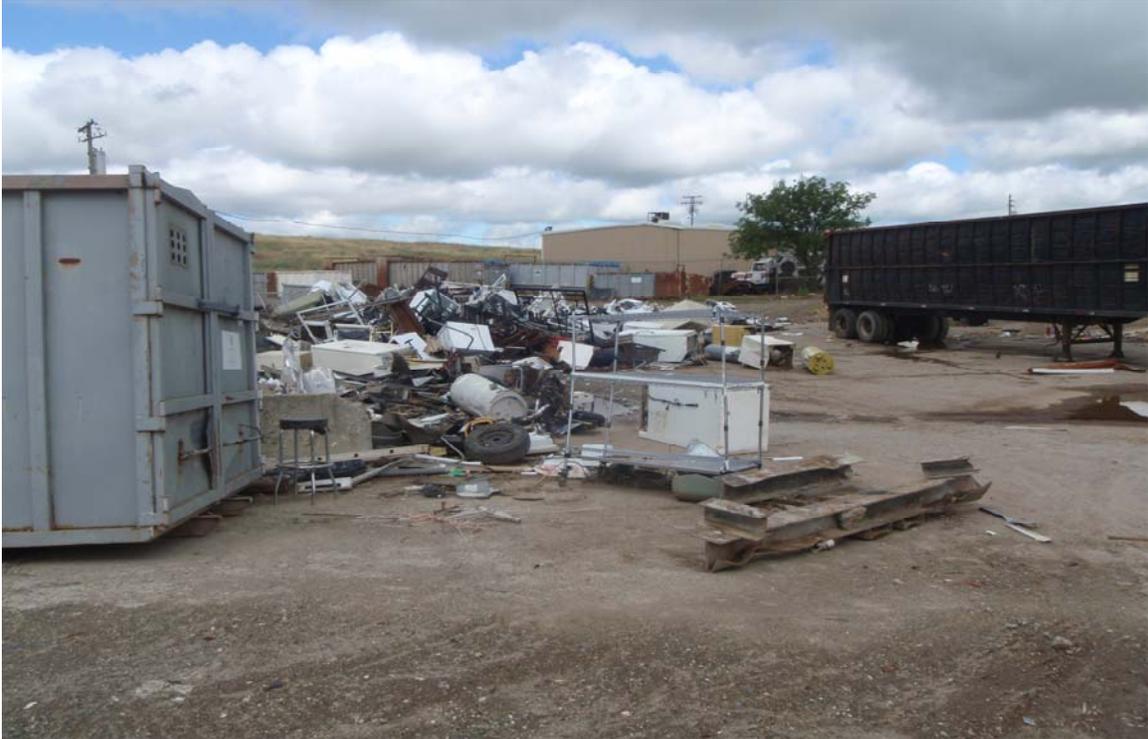
Photo 5: White goods storage over LF-1.

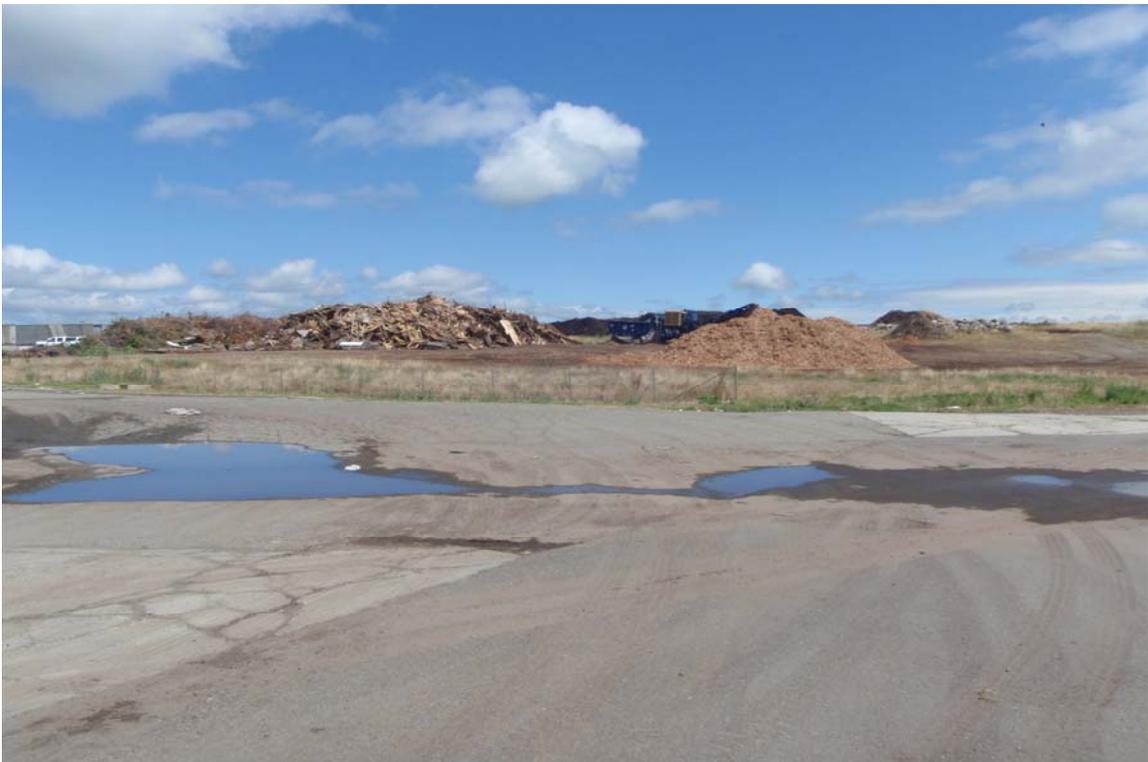
Staff inspected the north-northeastern area of LF-1 where the composting operation is located. As shown in the photographs settlement of the waste mass has created low spots that are collecting storm water. A portion of the surface area of this part of LF-1 is paved with asphalt for drive paths. Settlement and ponding is the main issue and area of concern. Composting is performed on a soil surface and leachate is ponding as shown in the photographs.

Photo 6: Low spots as a result of settlement. Note cracked concrete.

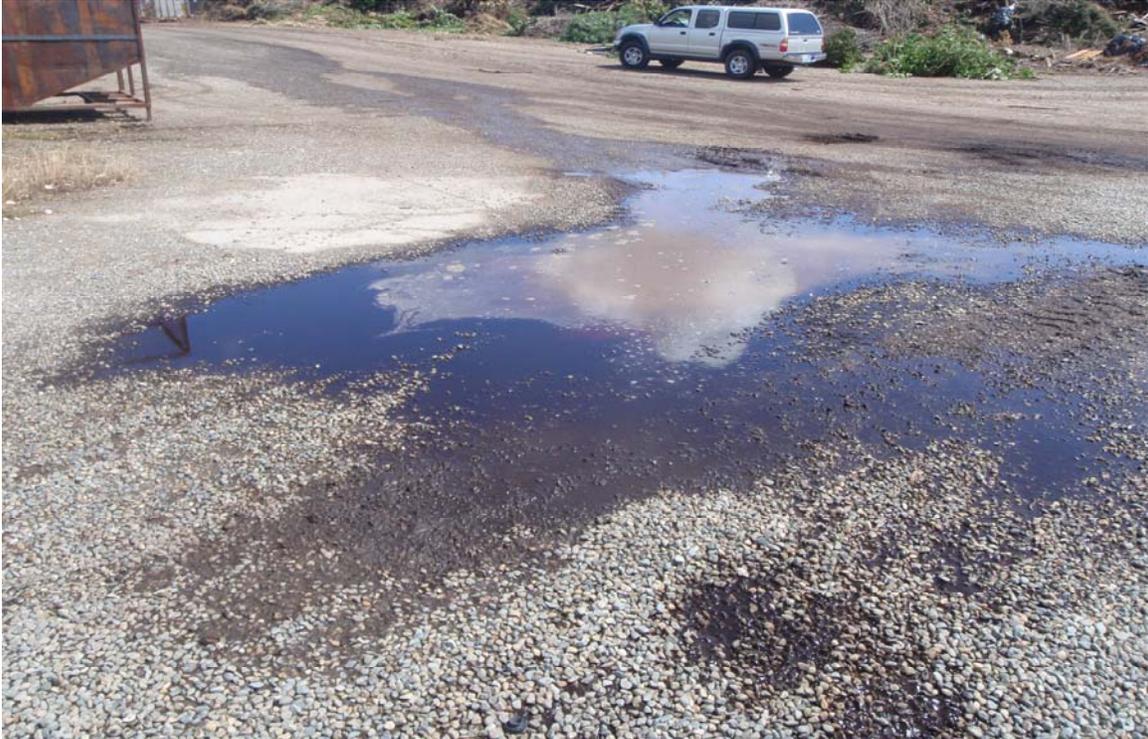
Photo 7: Leachate ponding from compost area. Note drainage from the upper left to this low spot on LF-1.

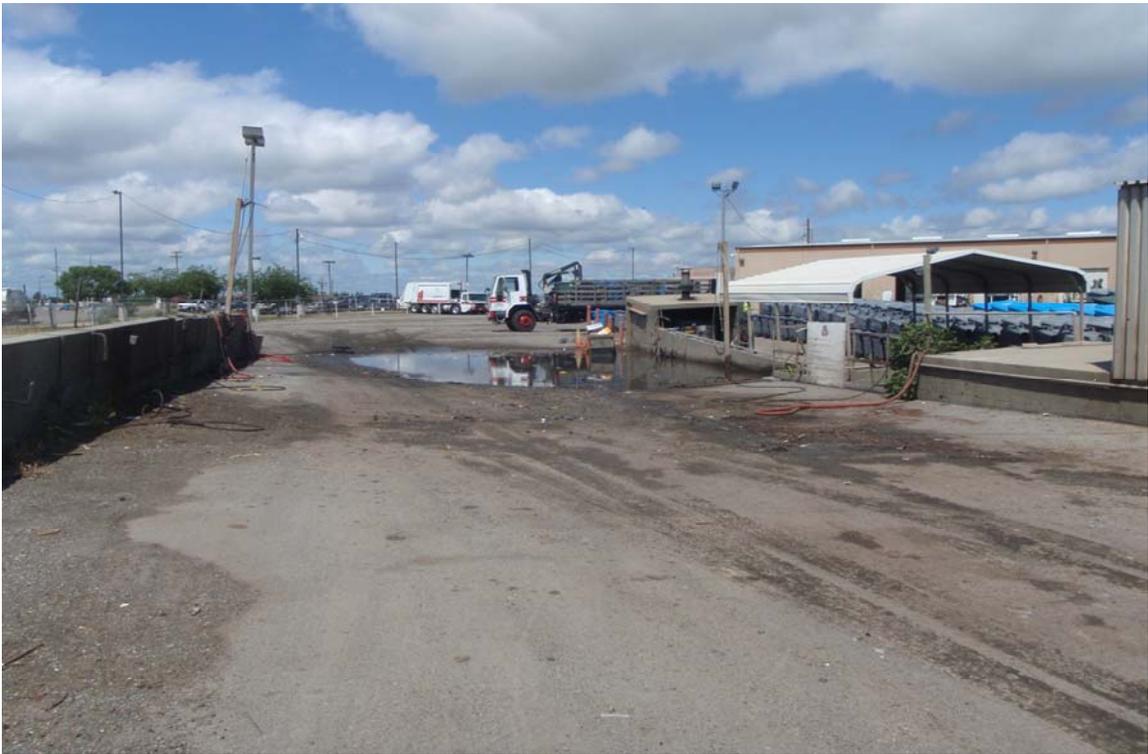
Photo 8: Standing water over low spot of LF-1.

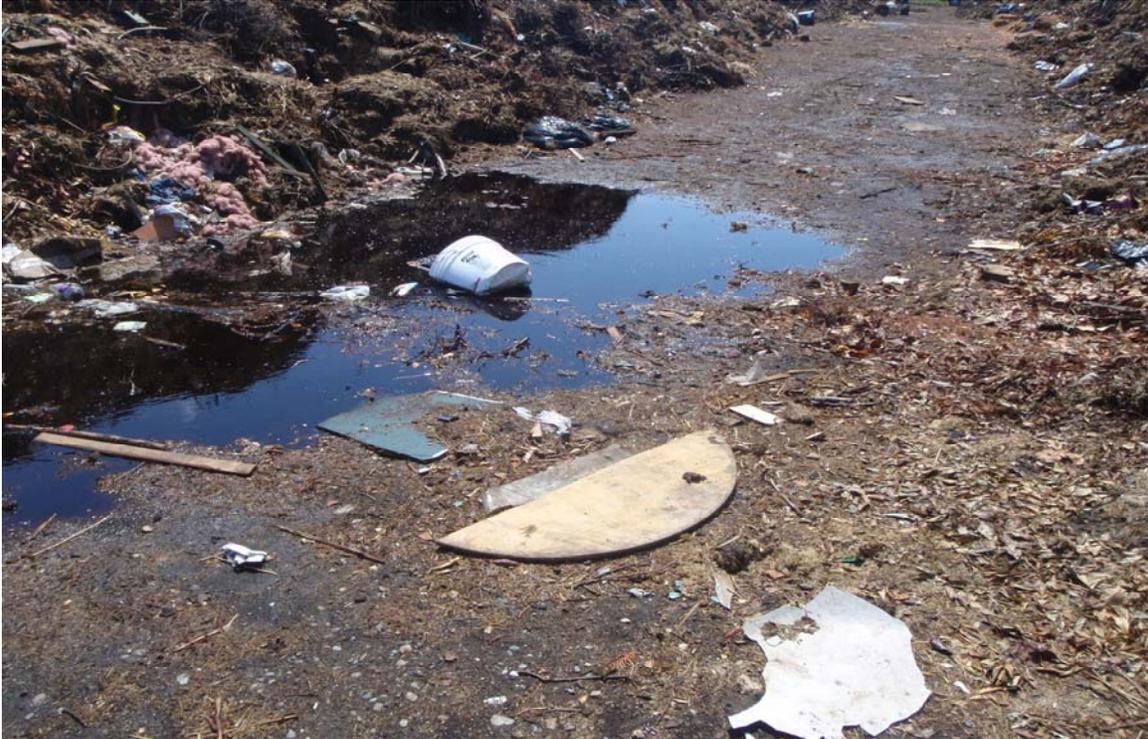
Photo 9: Leachate ponding at base of compost piles.

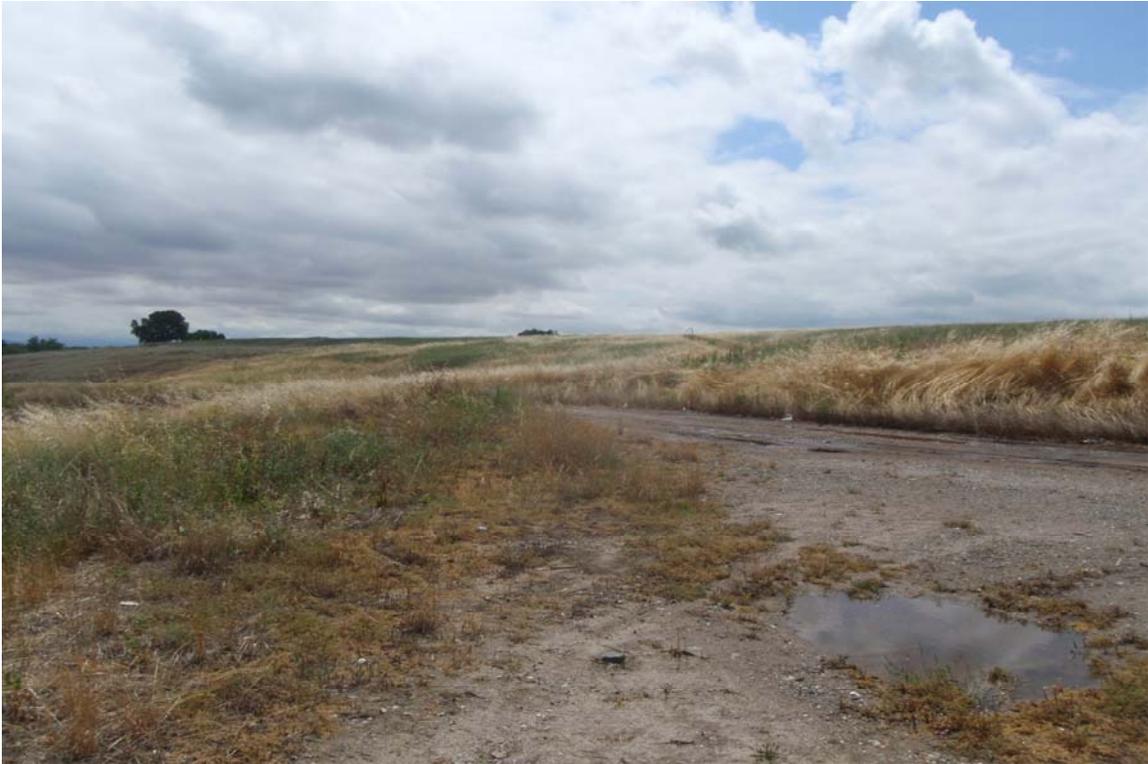
Staff inspected LF-2 and LF-3. Both are closed landfills and have robust vegetative covers where no operations are conducted. As shown in photographs, both cover systems are competent and show no signs of erosion or wet season damage. Groundwater monitoring wells inspected were locked and secure. Fencing around the landfill site was intact and secure.

Photo 11: Robust vegetative cover over LF-2.

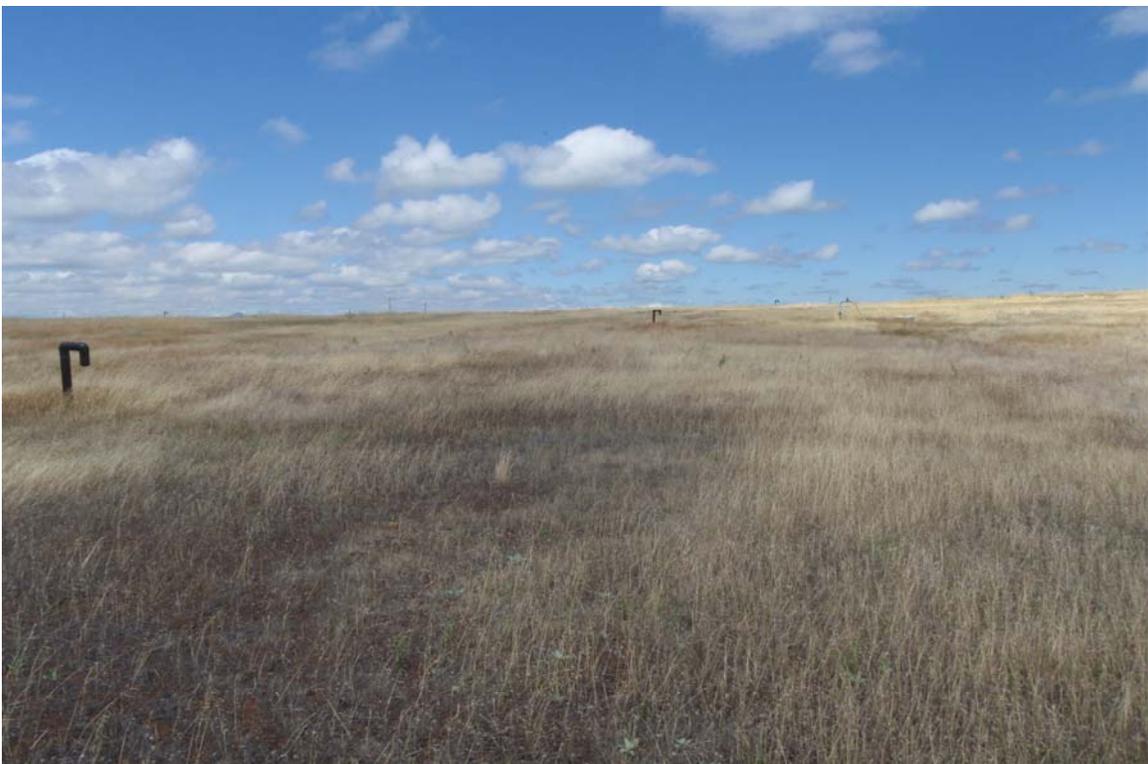
Photo 12: Top deck of LF-3.
