December 1, 2014

Project No. 1301525

**RE: COMPOST AREA IMPROVEMENT REPORT FOR THE FEATHER RIVER ORGANICS
COMPOSTING OPERATION, RECOLOGY YUBA SUTTER FACILITY, MARYSVILLE,
CALIFORNIA**

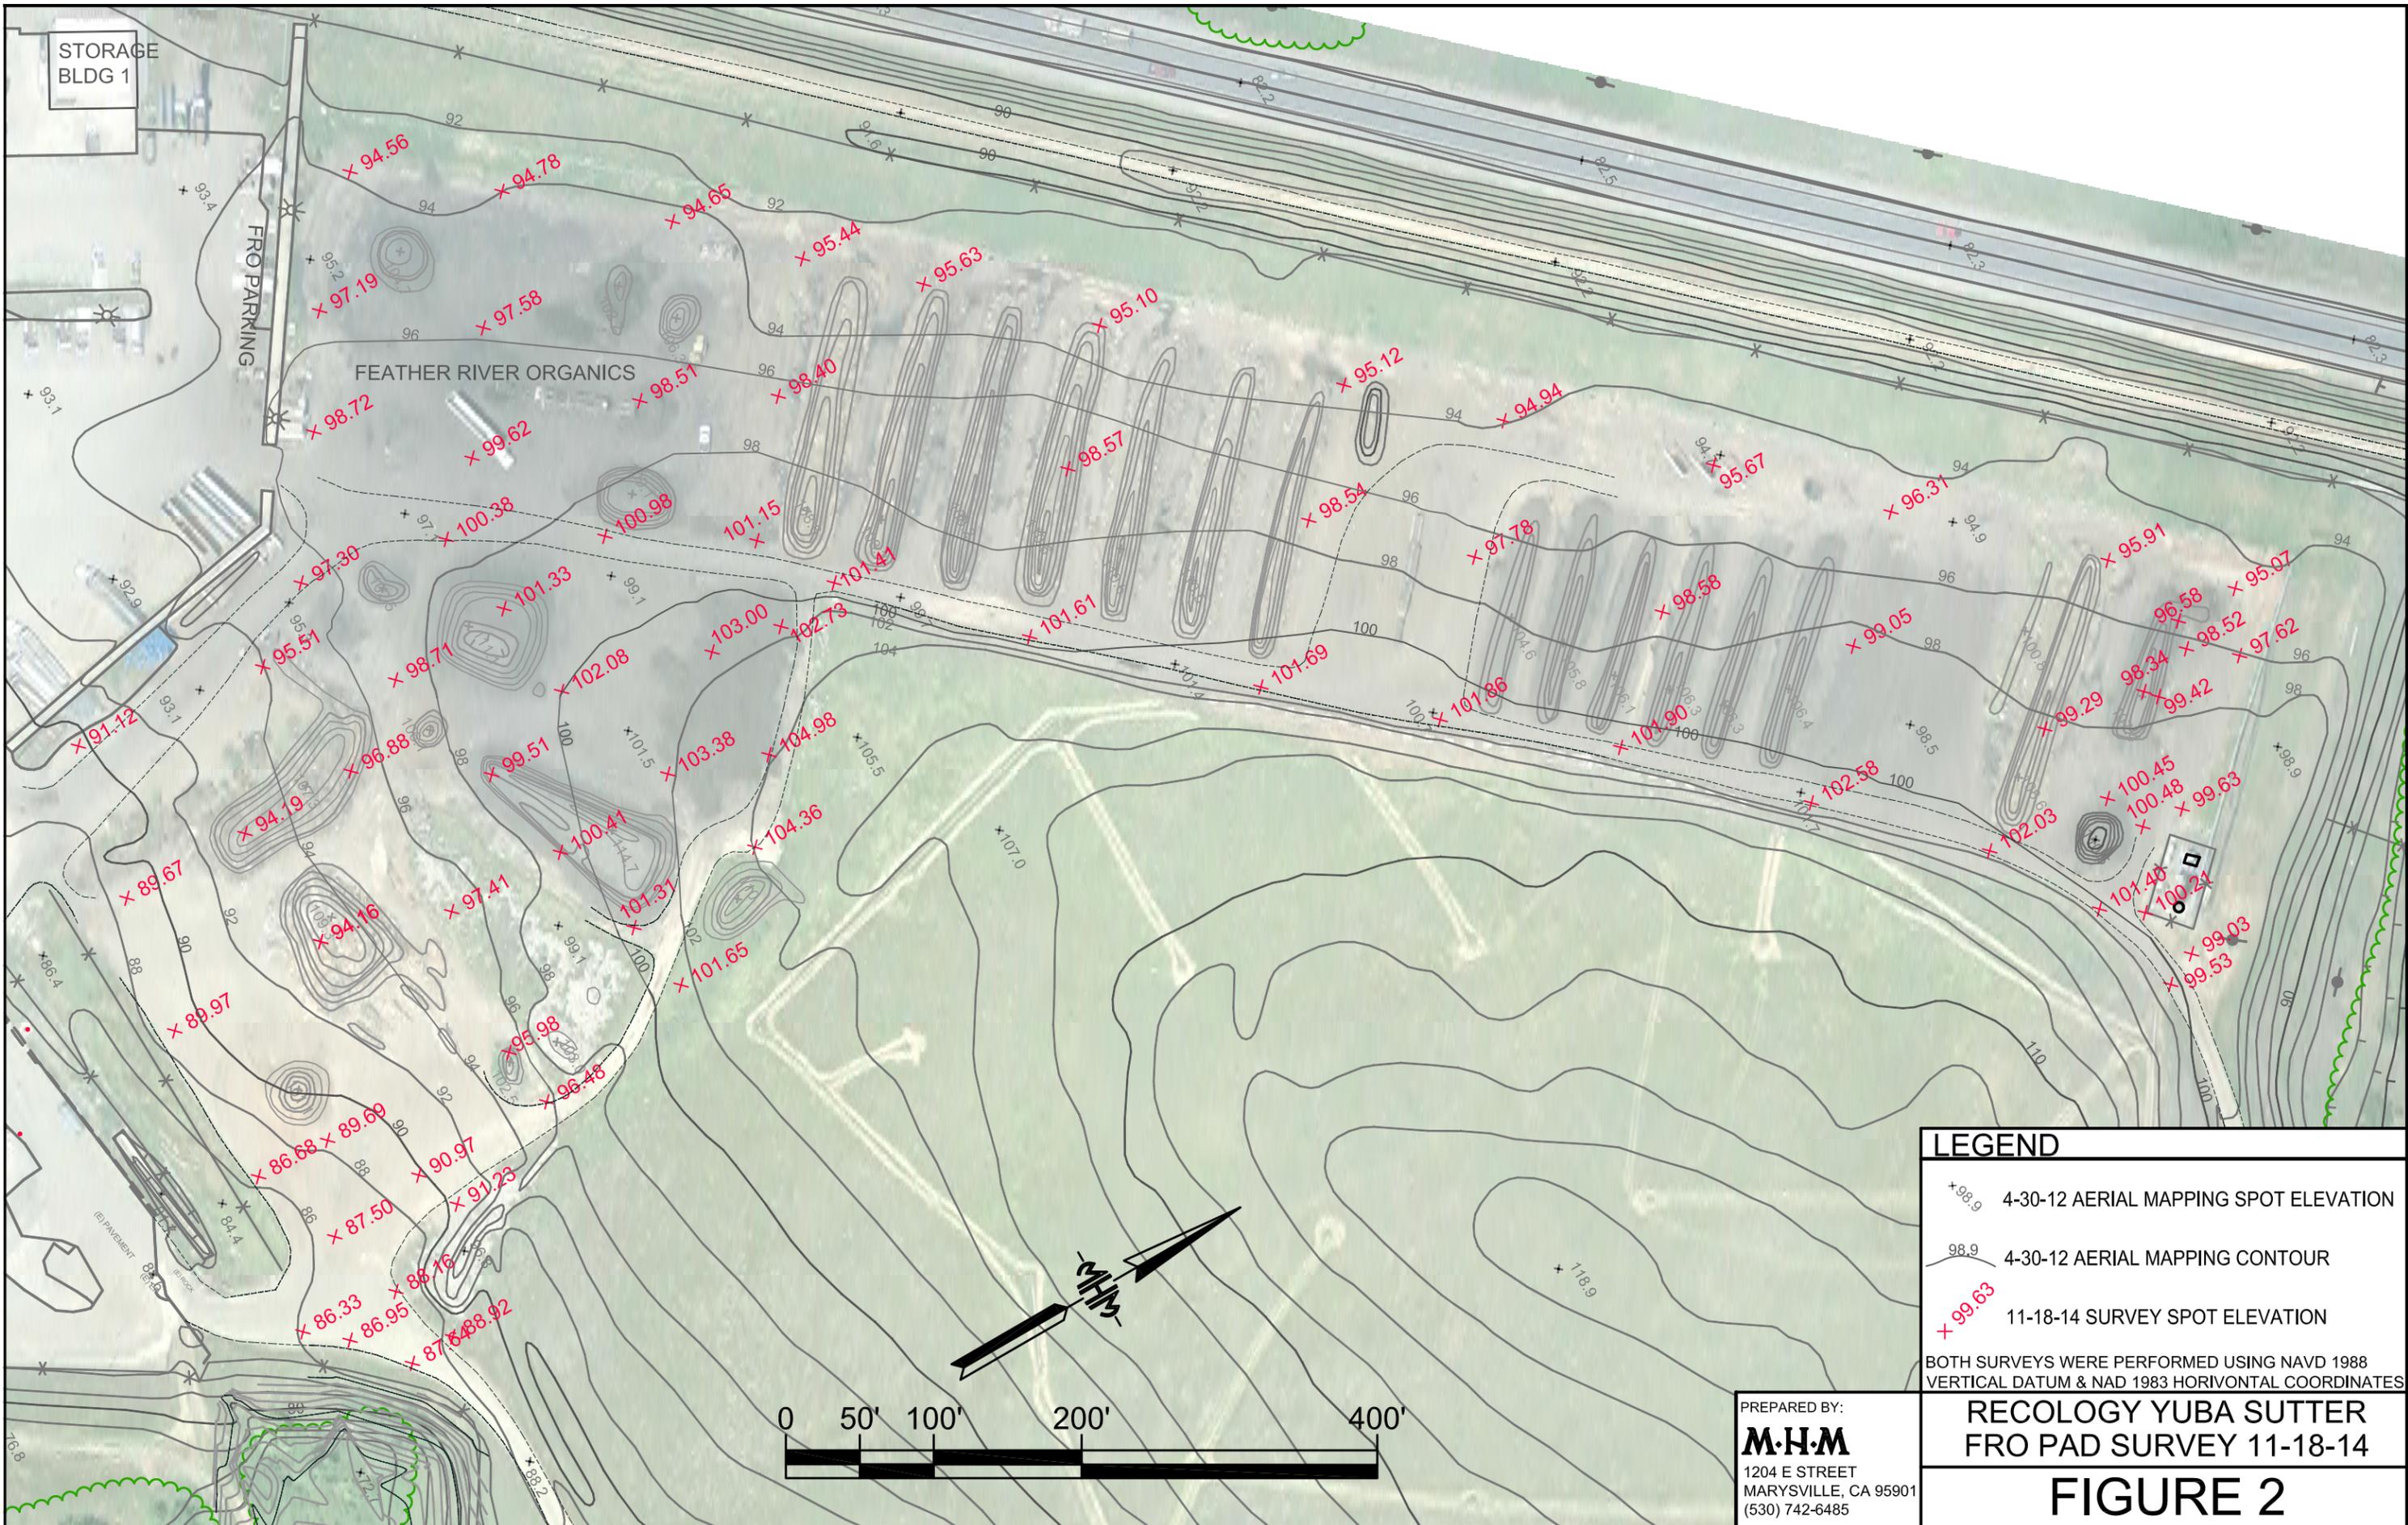
FIGURE 2

- The 9-inch thick compost pad surface exceeds the minimum required thickness of Six (6) inches
- As indicated in Figure 2, the compost pad thickness was actually increased by up to one to two feet to establish minimum drainage grades. The compost pad fill placement occurred primarily in August and September and was initially staked and graded to a minimum three (3) percent grade. The November 18, 2014 survey in Figure 2 was completed two to three months after the additional fill was placed, and therefore reflects some additional minor settlement that has occurred following fill placement. The November 18, 2014 survey shows that the overall surface grades are approximately three (3) percent or greater.

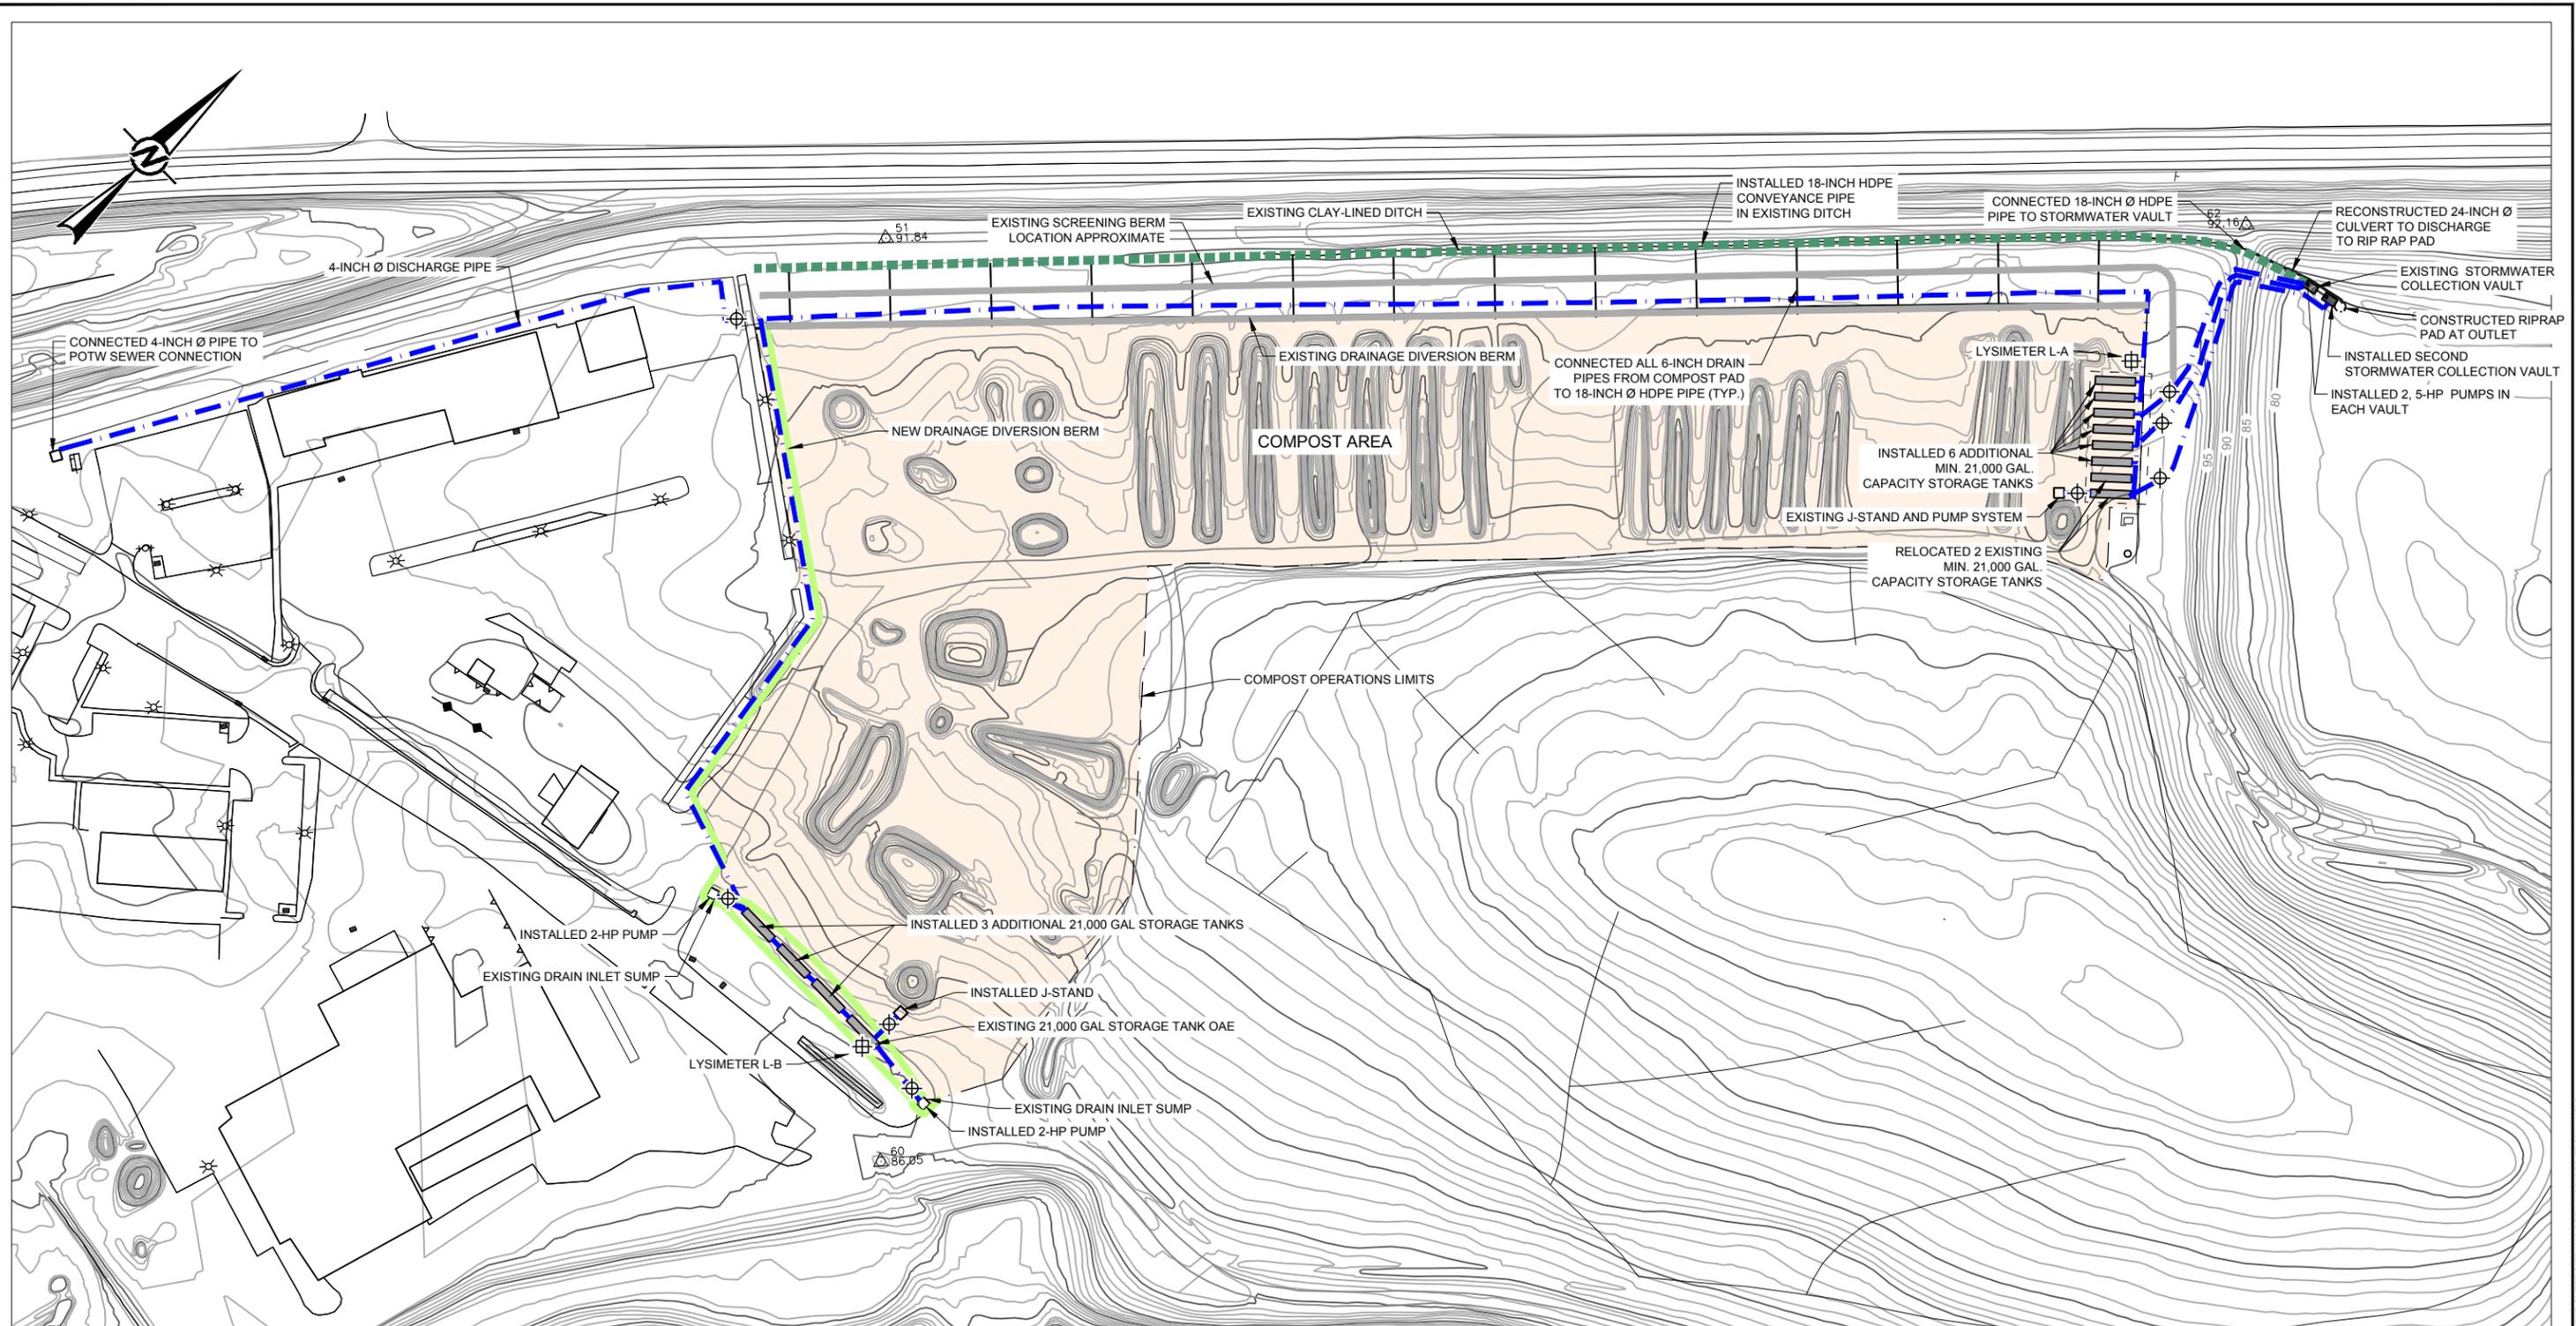
FIGURE
 3

terminates near the southeast sump to limit surface water run-on. Golder also installed one (1) suction lysimeter near each storage tank group location to monitor any potential contamination within the vadose zone. Figure 3 shows the key drainage improvements and the lysimeter installation locations. Lysimeter installation logs are presented in Attachment 2 and a photograph log illustrating key drainage improvements is included in Attachment 3.

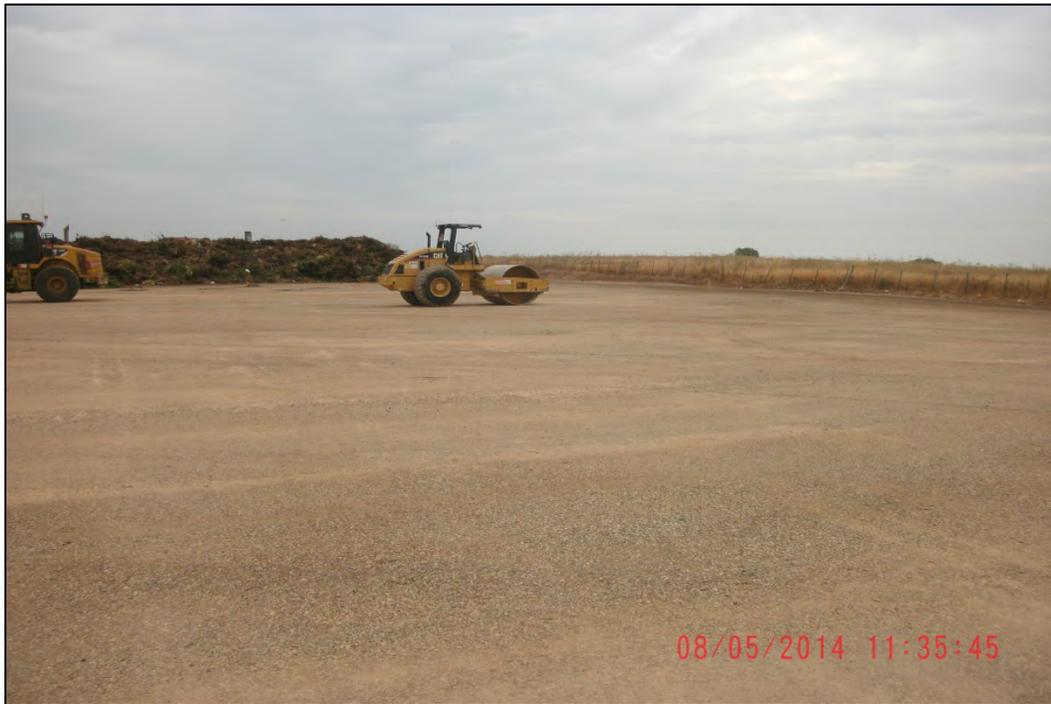
Photo 1: Operator compacting compost pad. Low-permeability aggregate.

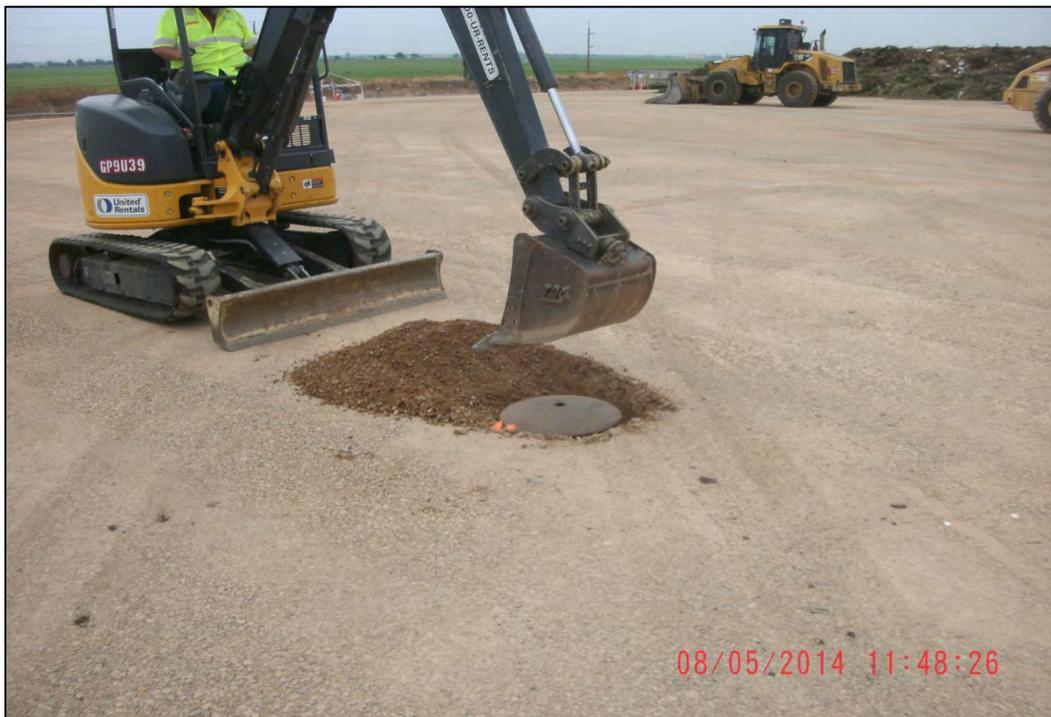
Photo 2: Operator excavating compost pad to install thickness marker.

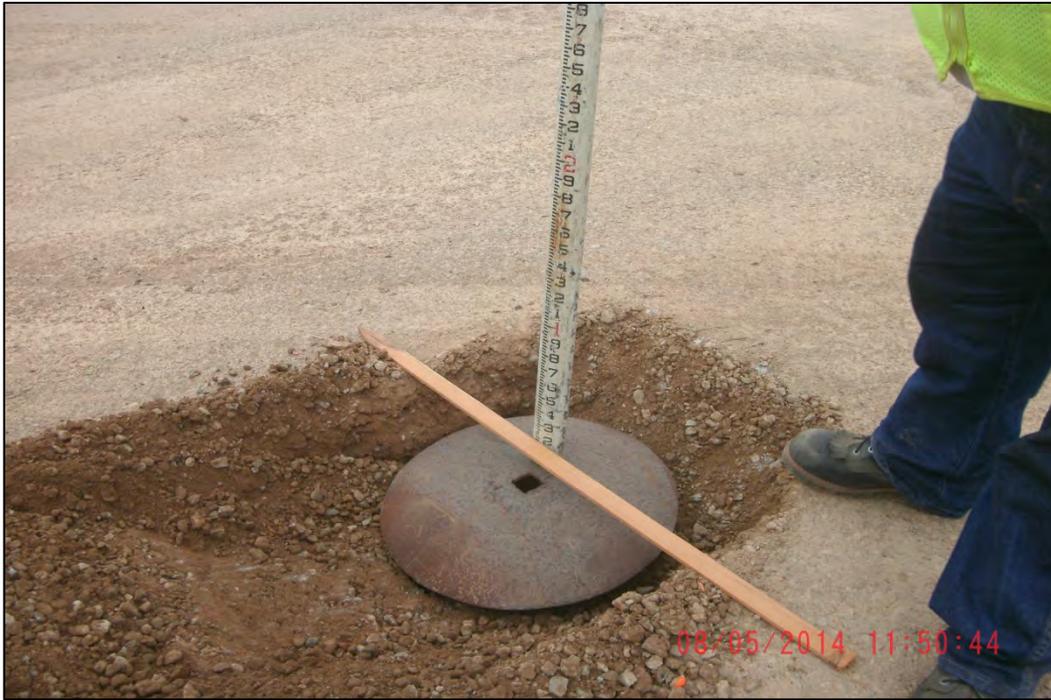
Photo 3: Laborer installs thickness marker.

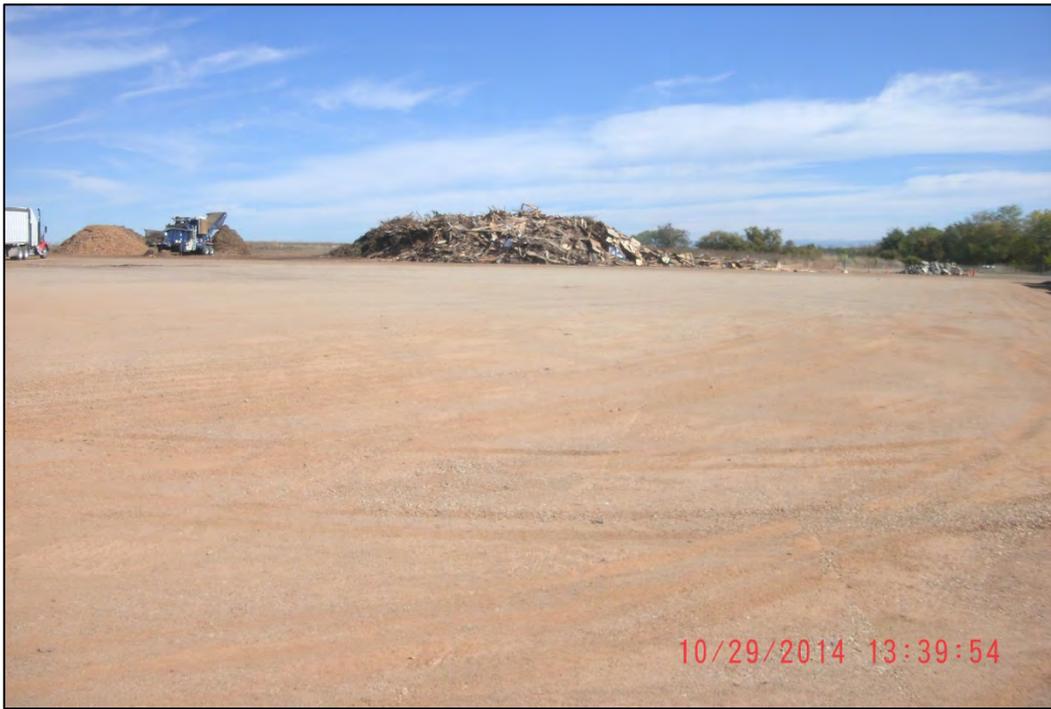
Photo 4: View of improved compost pad in the southern area of compost operations.

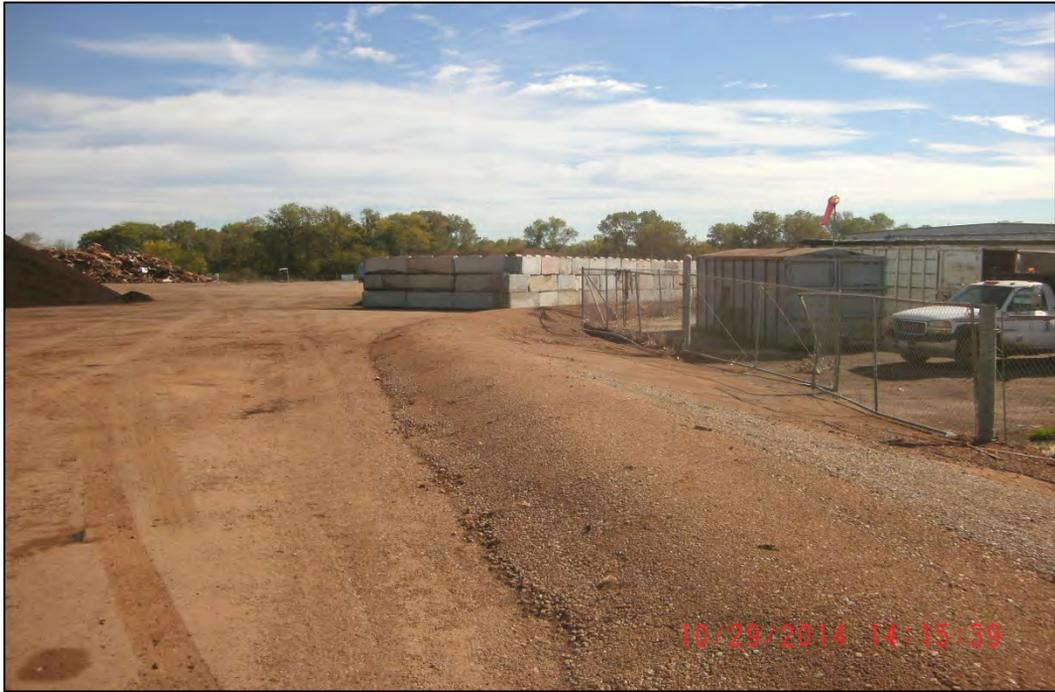
Photo 5: Diversion berm along southern perimeter of compost operations area.

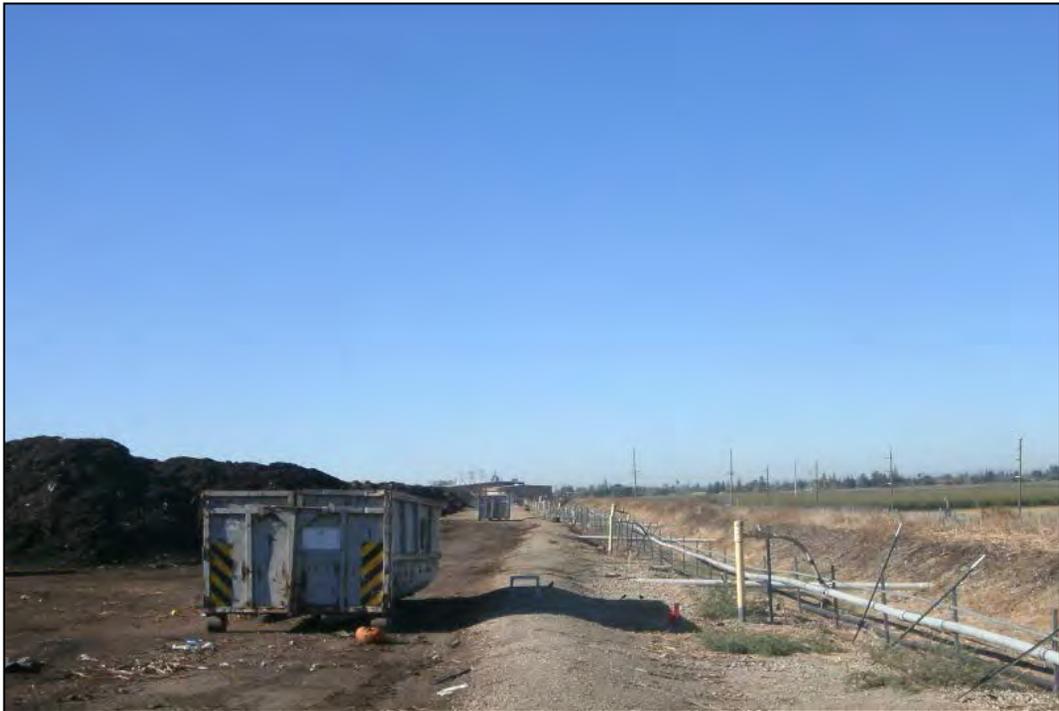
Photo 6: Diversion berm along western perimeter of compost operations area.

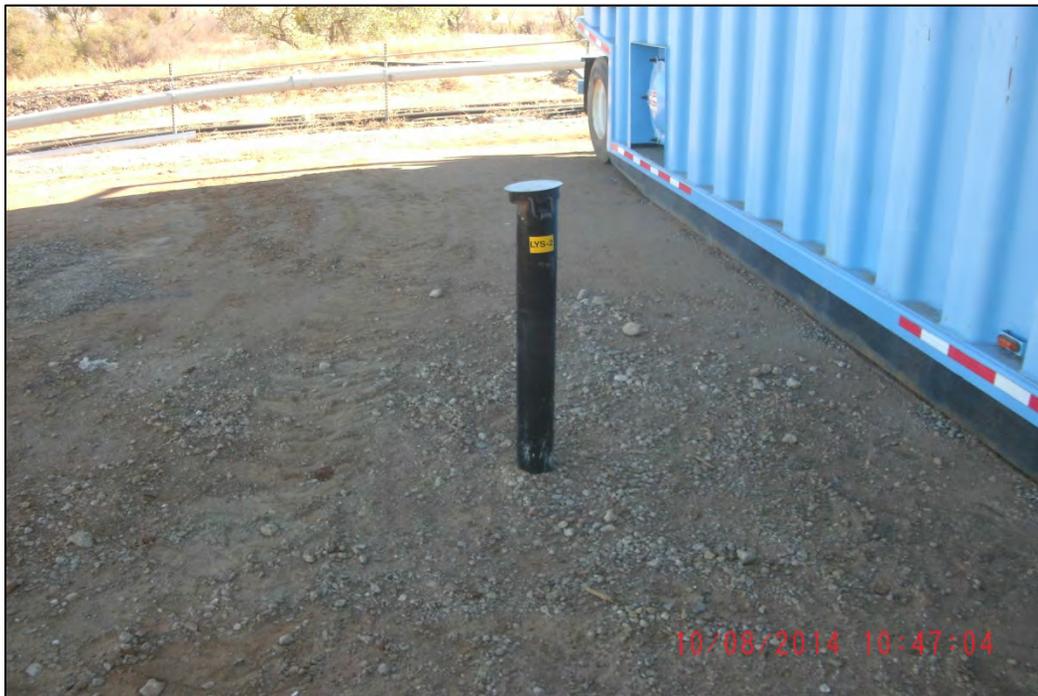
Photo 7: Typical installed Lysimeter.

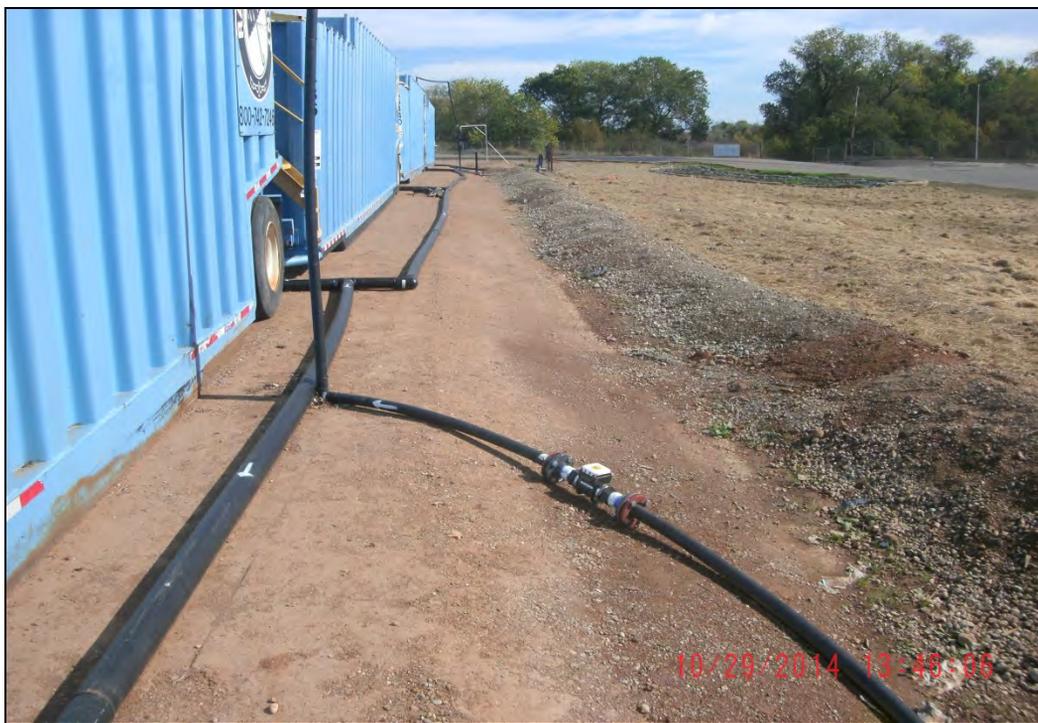
Photo 8: Typical installed flow meter.

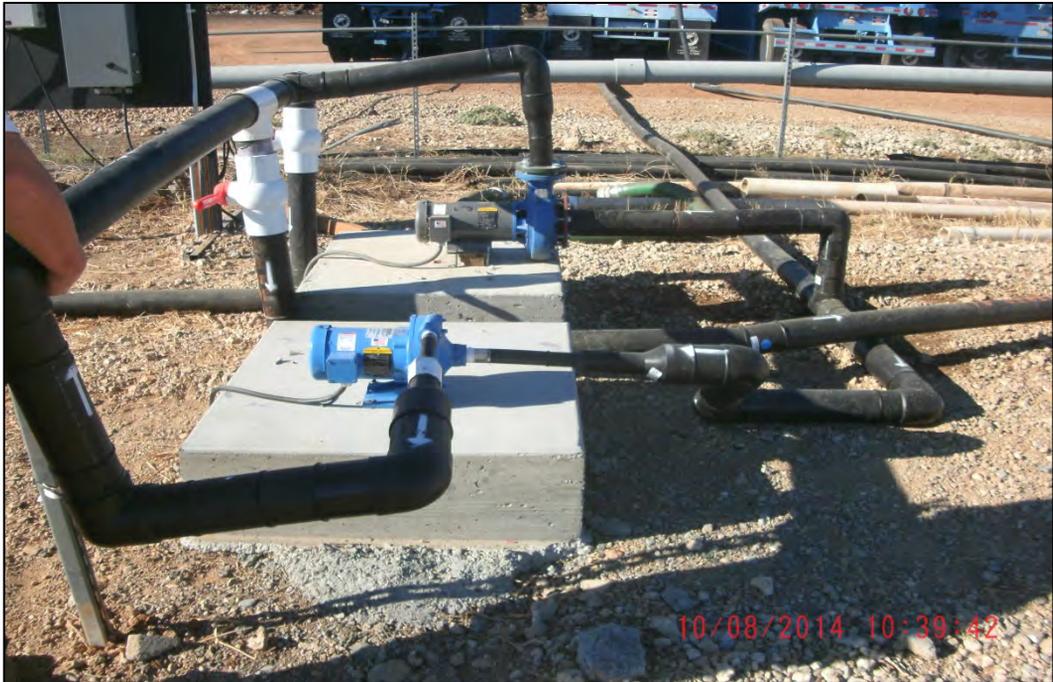
Photo 9: View of northern pumps and piping associated with POTW discharge and J-stand fill station.

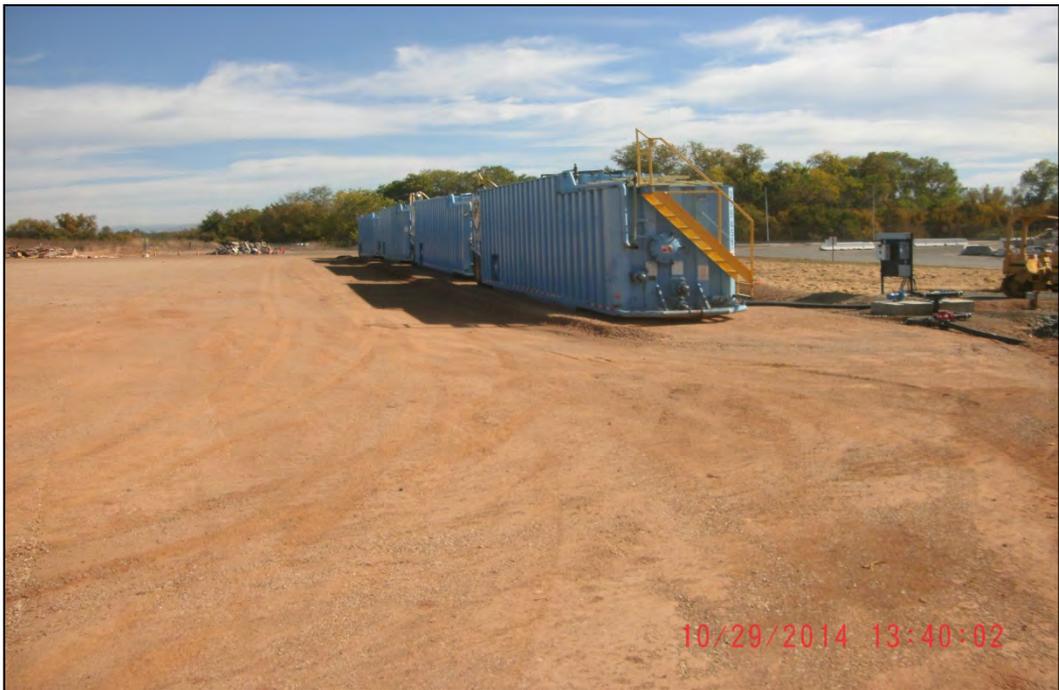
Photo 10: View of four Baker tanks located in the southern portion of the compost operations area.

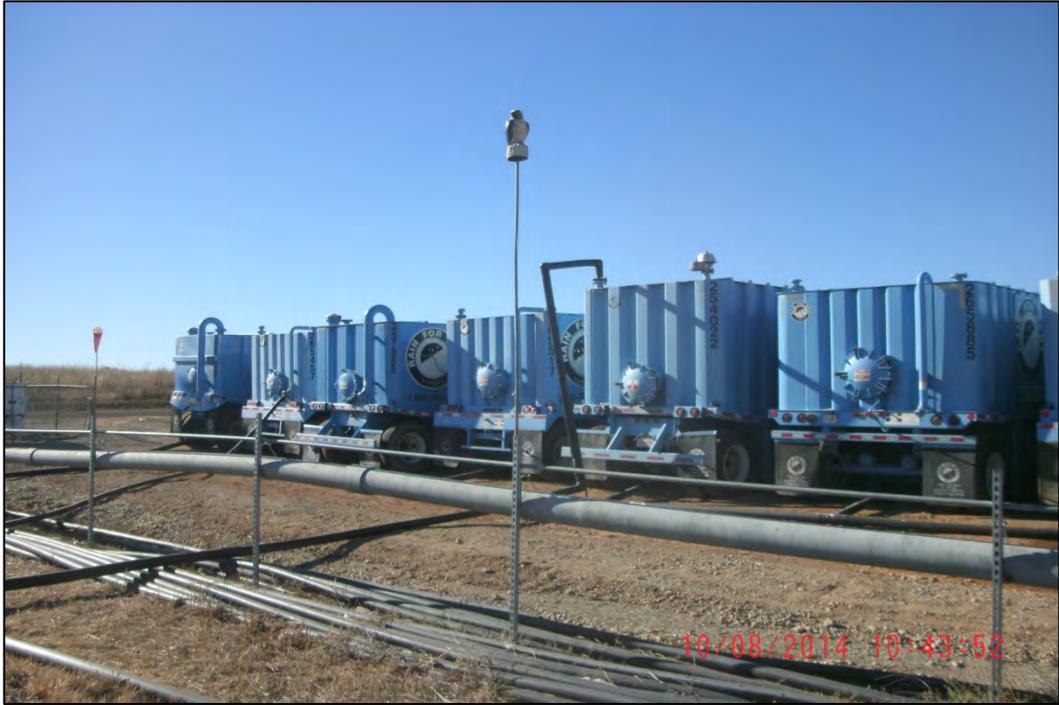
Photo 11: View of a portion of the 8 tanks located near the Hog farm .

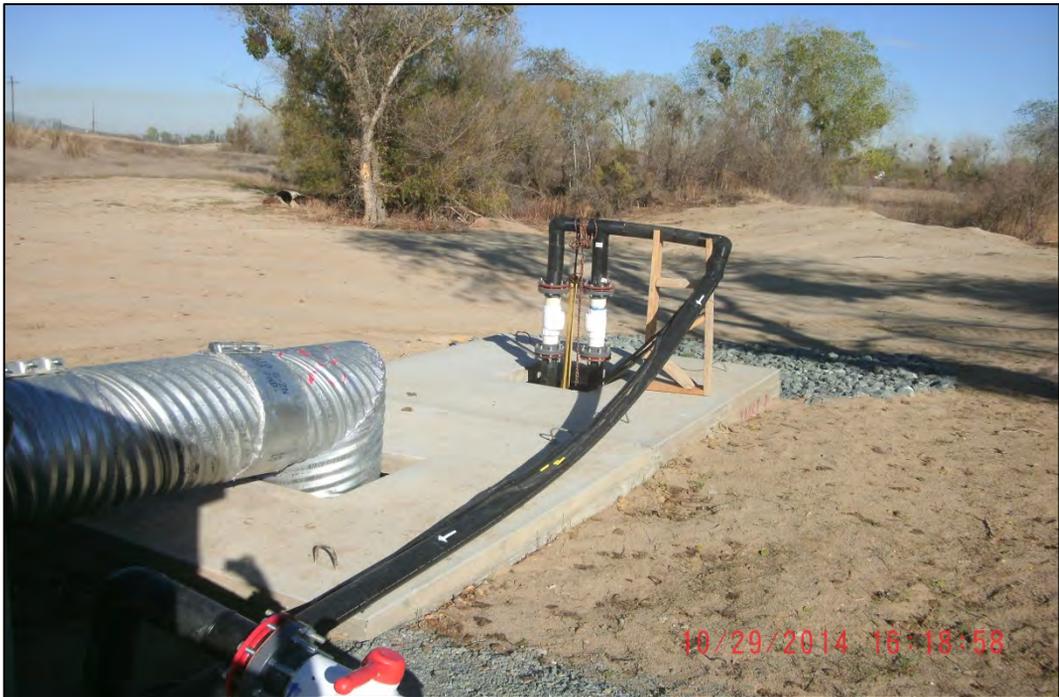
Photo 12: View of the second vault and associated pipes.
