ADMINISTRATIVE CIVIL LIABILITY R5-2012-0515
ATTACHMENT C
DISCHARGE EVENT PHOTOS
 19 May, 06 July, and 19 July 2011

19 May 2011 Event Photos (1 thru 4)

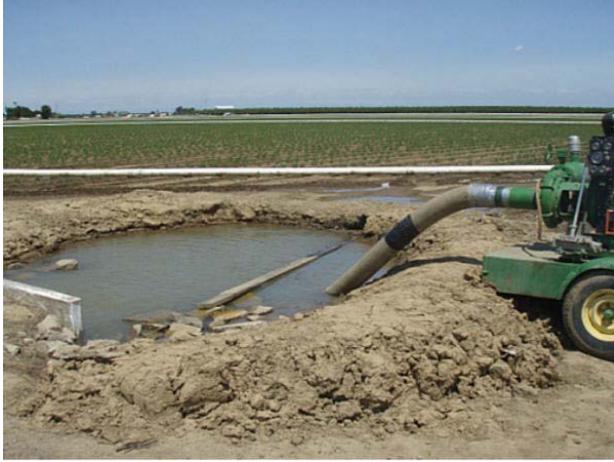
<p>Photo 1 of 4: Irrigation supply water to the cropland. Turbidity – 42.7 NTU</p>	<p>Photo 2 of 4: Field drainage water discharging to the area drain from the cropland. Turbidity – 544 NTU Flow rate was determined at the outfall to the river, the flow rate of the field discharge was similar to the 19 July 2011 event (see 19 July 2011 Event Photo 2)</p>

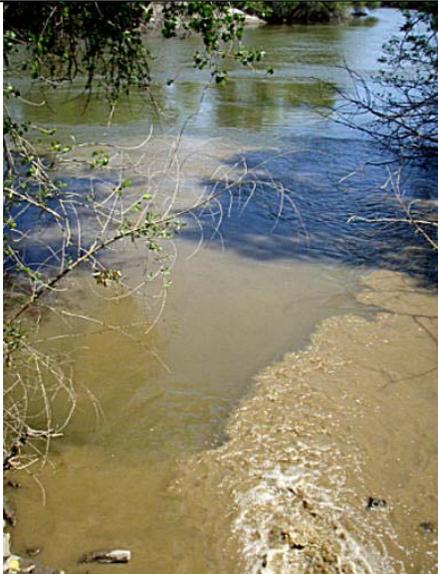
<p>Photo 3 of 4: Flow into the San Joaquin River looking southeast. Up River Turbidity – 25.6 NTU Outfall Turbidity – 671 NTU Down River prox. 100 feet Turbidity – 52.1 NTU</p>	<p>Photo 4 of 4: Flow into the San Joaquin River looking northeast; outfall flow rate 315 cuft/min (141,381 gl/hr Estimated (using the cross section, velocity, and 0.70 friction coefficient)); Duration - 2 hrs. minimum (duration of staff's inspection).</p>

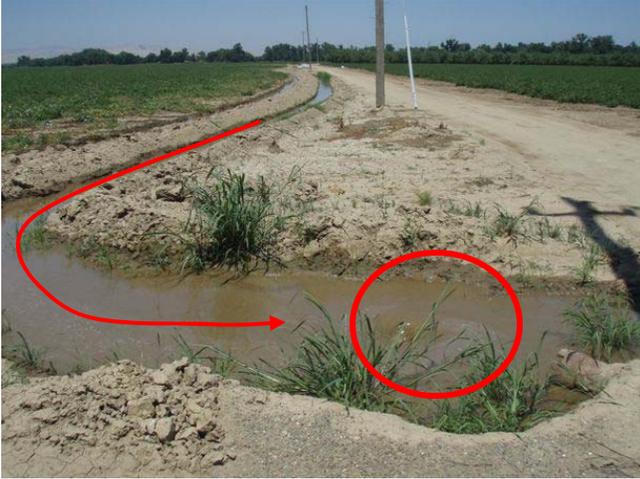
Photo 1 of 14: Looking north from JT Crow Road toward the tomato cropland and cropland drainage. The field tailwater was flowing from the cropland, into the underground drainage system (Amaral Line)

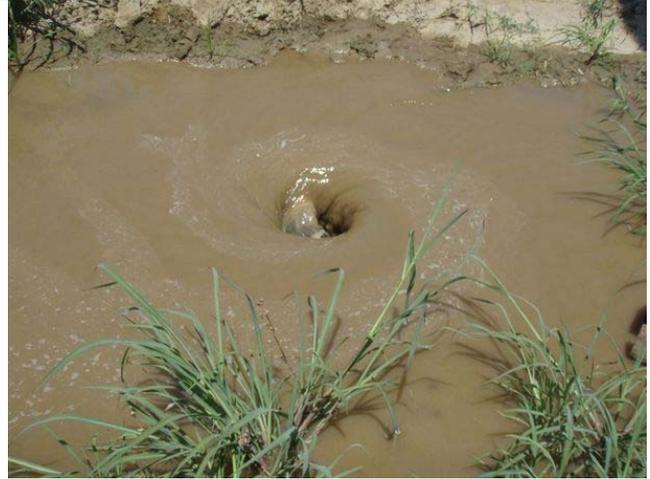
Photo 2 of 14: Close-up of the cropland tailwater drain in Photo 1.

At 13:00 hrs, **Turbidity = 668 NTU**

Flow rate into the drain of approximately **157 cuft/min (70,594 gl/hr)** using cross section, flow velocity, and friction coefficient of 0.70.

At 14:25 hrs, **Turbidity = 585 NTU** (similar flow rate based on observation).

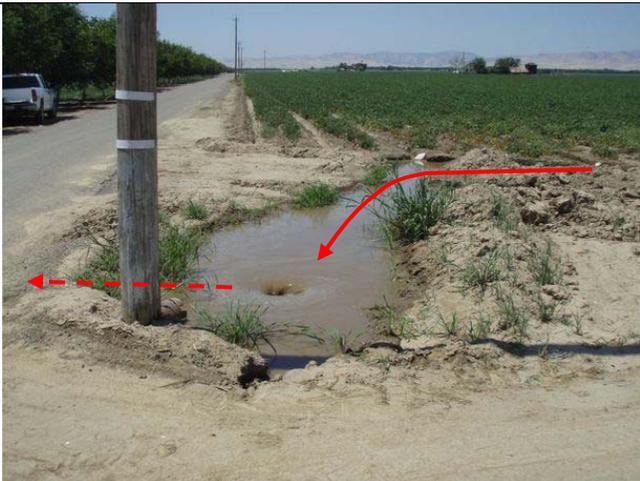
Photo 3 of 14: Looking west along JT Crow Road at the drain inlet. The water flows into the underground pipe, then south under JT Crow Road to the Amaral Line.

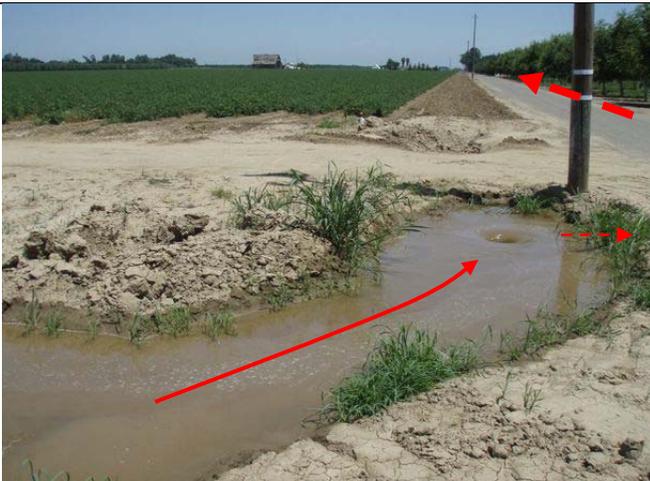
Photo 4 of 14: From Photo 3, the drainage flows east in an underground pipe along the south side of JT Crow Road toward the San Joaquin River. The tailwater mixes with Central California Irrigation District (CCID) supply water via the Main Canal. Constituents discharged into the line impact the supply water to downstream users and eventually the San Joaquin River.

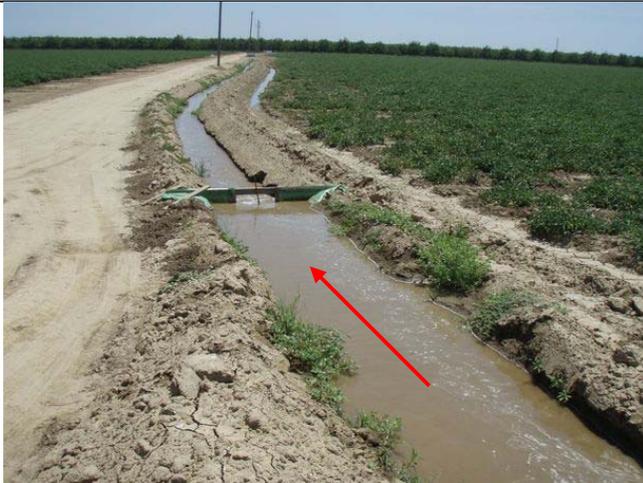
Photo 5 of 14: Looking south from the cropland toward JT Crow Road and the field drain.

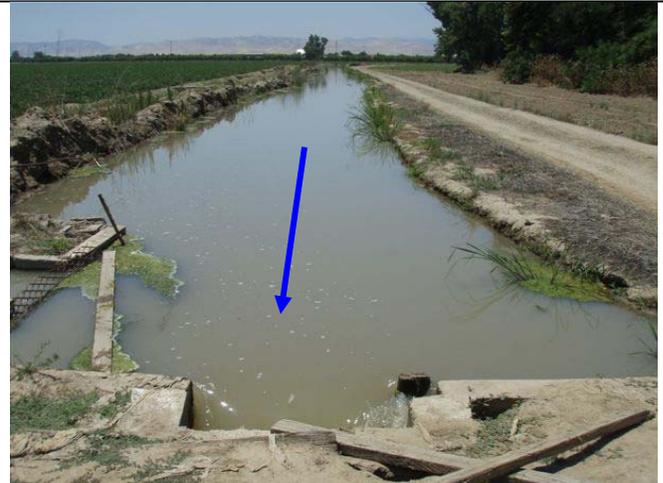
Photo 6 of 14: CCID irrigation supply water to the cropland (north side).

Turbidity = 111 NTU

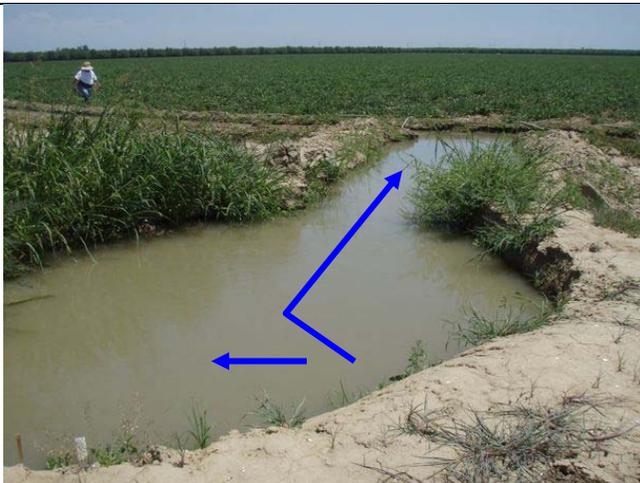
Photo 7 of 14: The supply water then flowed to the cropland in the areas seen in the photo. It also continued east to the other cropland (see Photo 8).

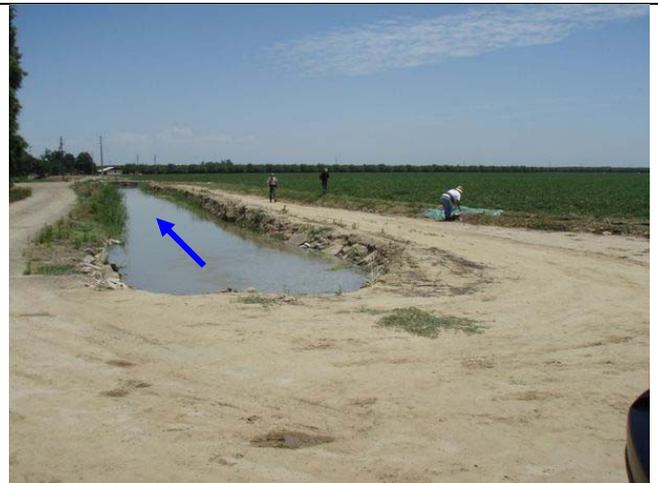
Photo 8 of 14: Irrigation supply water continued east toward the other tomato cropland and other water users.

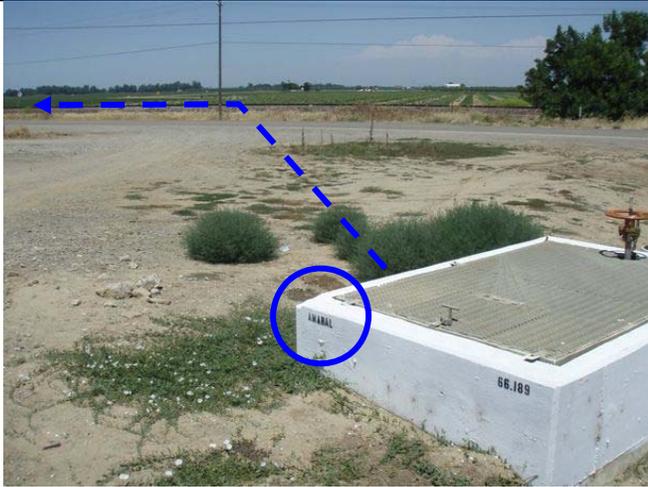
Photo 9 of 14: The supply water came from CCID via the CCID Main Canal. It was distributed via the control box shown in this photo to the line known as the Amaral Line, as well as other turnouts from the canal further north of this location.

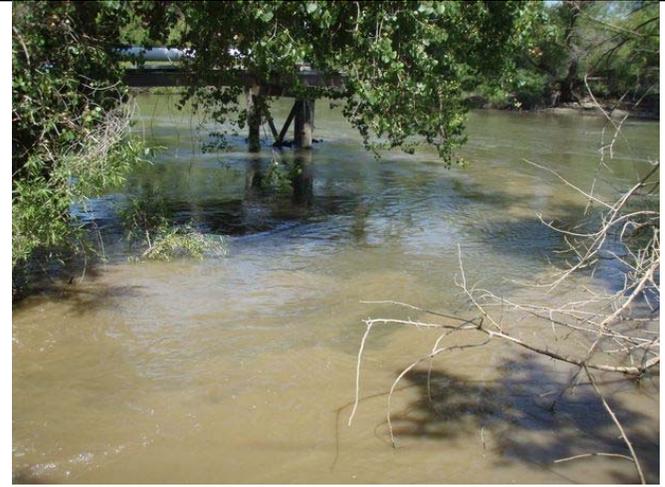
Photo 10 of 14: Looking downstream from the outfall (discharge outfall) of the Amaral Line flowing into the San Joaquin River.

Down-River: Total Suspended Solids = 63 mg/L

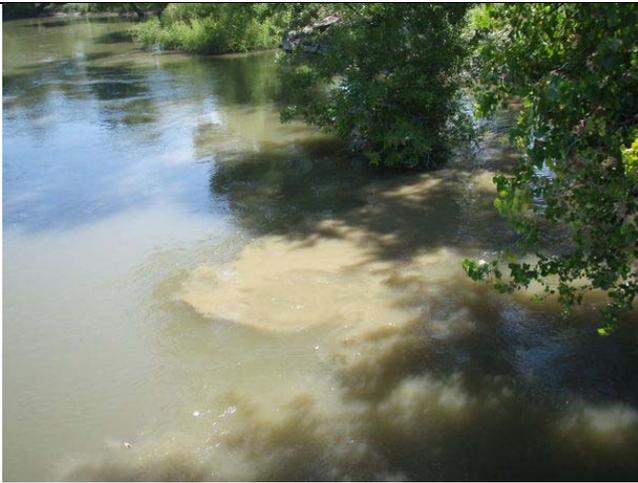
Photo 11 of 14: The sediment plume was significant and was still flowing at the time the inspection was completed at 13:30 hrs.

Outfall: Total Suspended Solids = 434 mg/L

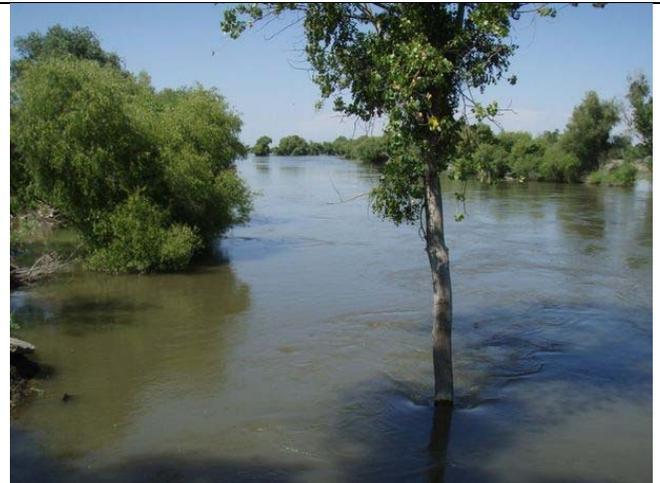
Photo 12 of 14: Looking north (downstream) at the San Joaquin River.

Up-river: Total Suspended Solids = 40 mg/L

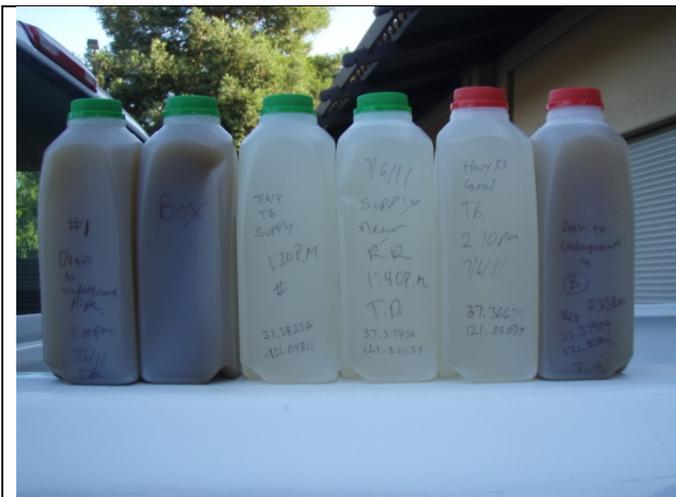
Photo 13 of 14: Photo of samples. Left to right
 #1) Field drain – 13:00 hrs, NTU 668
 #2) Field drain control box, NTU 739
 #3) Supply water north side, NTU 111
 #4) Supply water near railroad tracks, NTU 107
 #5) Supply water from Main Canal, NTU 64.2
 #6) Field drain – 14:25 hrs, NTU 584

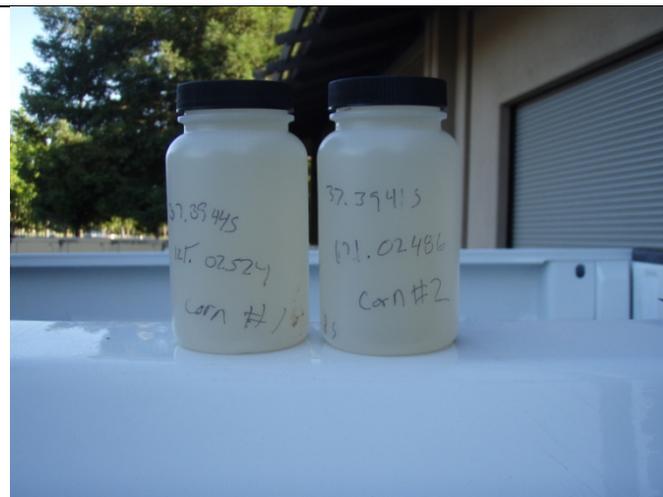
Photo 14 of 14: Photo of other furrow irrigated cropland drainage in the same general area used as a comparison. :
 #1) Corn drainage, NTU 141
 #2) Corn drainage, NTU 84.5

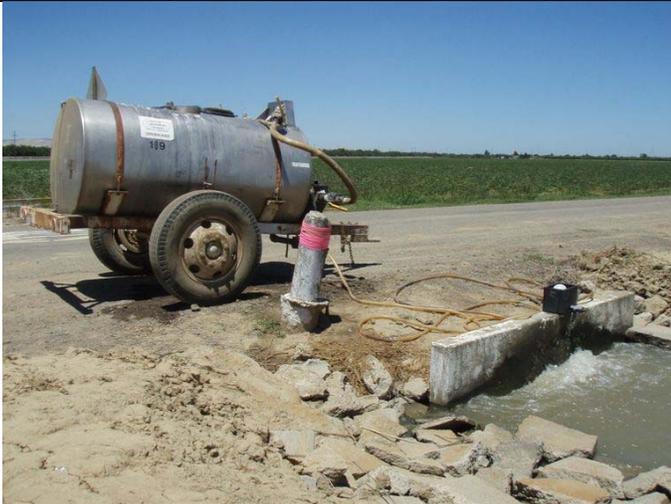
Photo 1 of 5: Irrigation water supply to the cropland.
Turbidity = 45.4 NTU

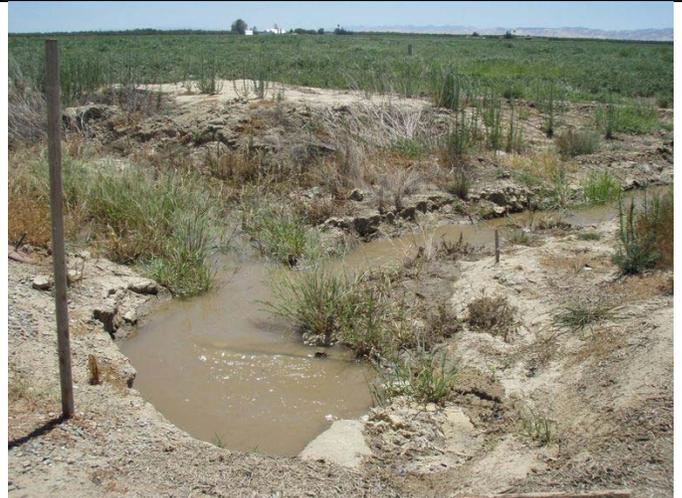
Photo 2 of 5: The tailwater drainage from the (with the fertilizer still being applied in the water) was flowing into the area drain into the Amaral Line underground pipe.

Turbidity = 332 NTU

Flow rate from the field into the drain was approximately 102 ft³/minute, or 45,704 gal/hr. (using velocity, cross section, and a 0.66 friction coefficient)

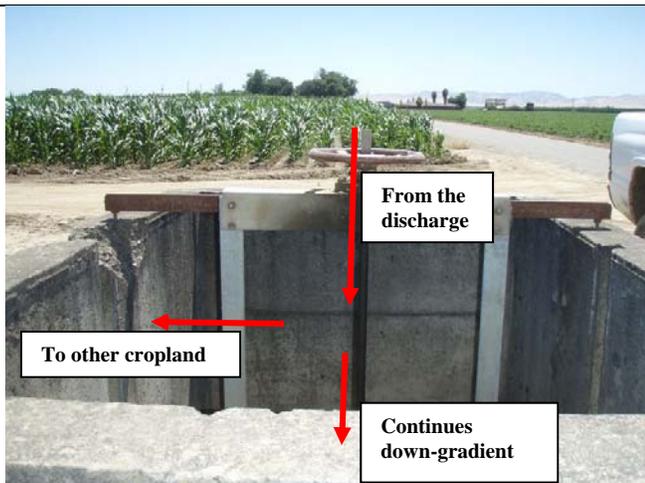
Photo 3 of 5: Looking west (up-gradient) from a control box on the Amaral Line toward the tomato field in Photos 1 and 2 (past the trees in the photo).

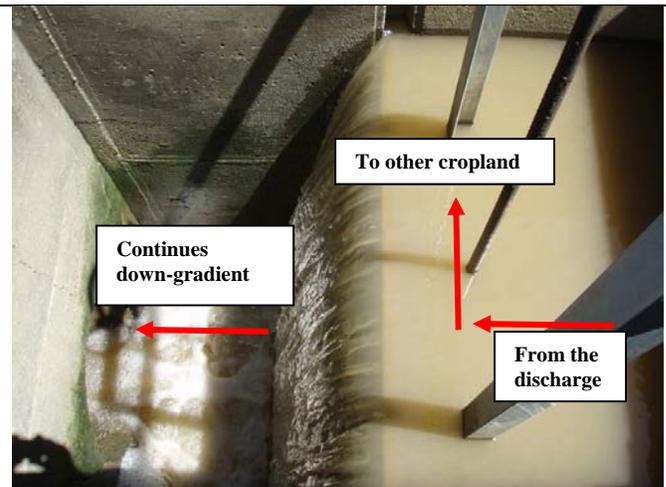
Photo 4 of 5: Looking inside the control box in Photo 5. A portion of the water in the Amaral Line (including the tailwater from the field) was being used as irrigation water by other farms to irrigate an alfalfa field (south side of the line, upper portion of the photo). The balance continued east toward the S.J. River.

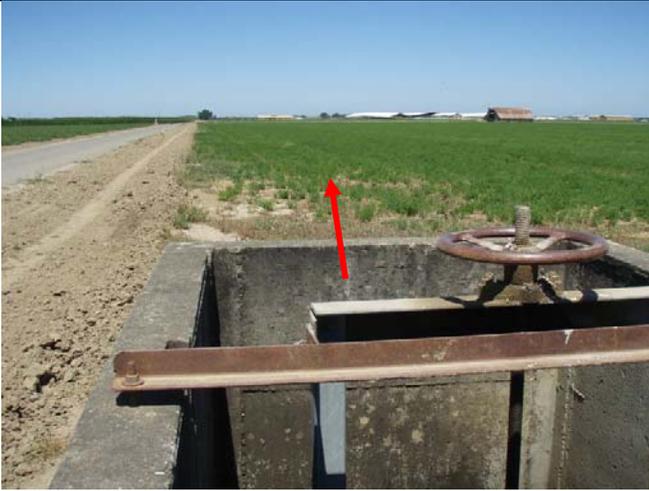
Photo 5 of 5: The balance was flowing east (left in the photo) to other properties and the San Joaquin River.

Note: The Amaral Line is used for both irrigation supply water (from the CCID Canal) and as a drain to the San Joaquin River. The sediment-laden water and other constituents discharged into the drain was picked up and redistributed to other down-gradient users.
