CENTRAL VALLEY REGIONAL WATER QUALITY CONTROL BOARD

INSPECTION REPORT

FACILITY: Del Mar Farms

**ACL Complaint R5-2012-0515
Attachment E
06 July 2012 Inspection Report**

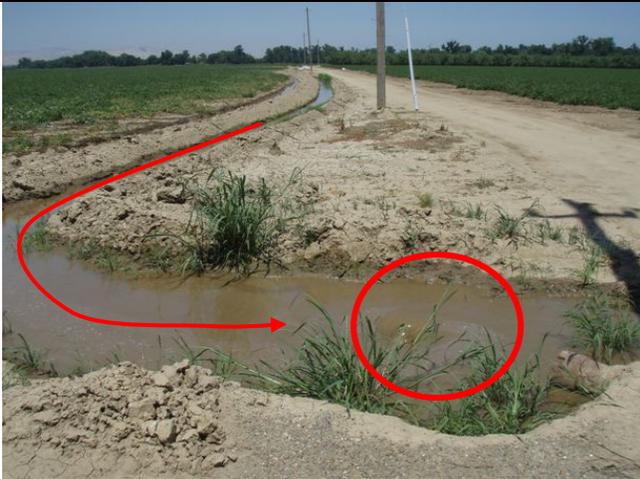
Photo 1: Looking north from JT Crow Road toward the tomato cropland and cropland drainage. The field tailwater was flowing from the cropland, into the underground drainage system (Amaral Line)

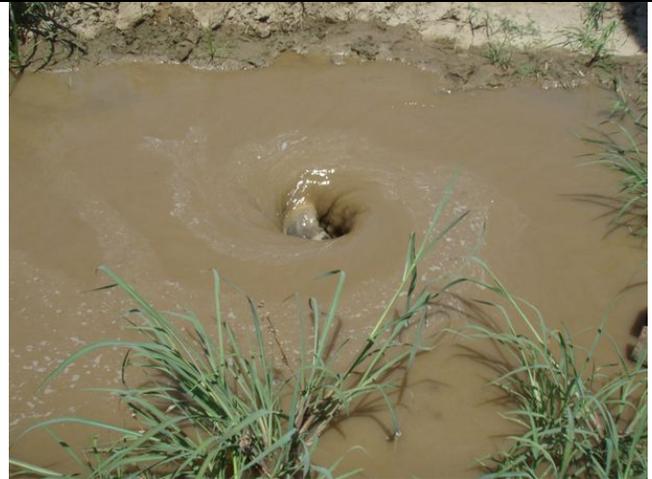
At 13:00 hrs. the flow rate from the tomato fields into the drain was measured at 28 seconds to travel approximately 48 feet (16 paces) in a ditch approximately 3 foot wide on the top, and estimated 1.6 feet wide on the bottom of the ditch, by 1 ft deep. The estimated cross section is 2.35 ft². Reducing the dimensions of each cross section measurement to 70 percent to allow for potential field measurement variability, and adjusting the flow velocity by a 0.66 friction coefficient, the adjusted flow volume was 572.31 gallons per minute (34,339 gal/hr).

Photo 2: Close-up of the cropland tailwater drain in Photo 1. Turbidity = 668 NTU at 13:00 hrs and 585 NTU at 14:25 hrs. The flow rate at 13:00 hrs was approximately 157 cuft/min.

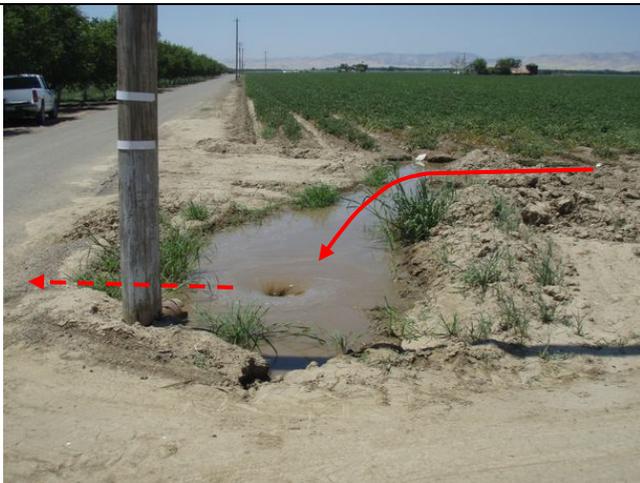
Photo 3: Looking west along JT Crow Road at the drain inlet. The water flows into the underground pipe, then south under JT Crow Road to the Amaral Line.

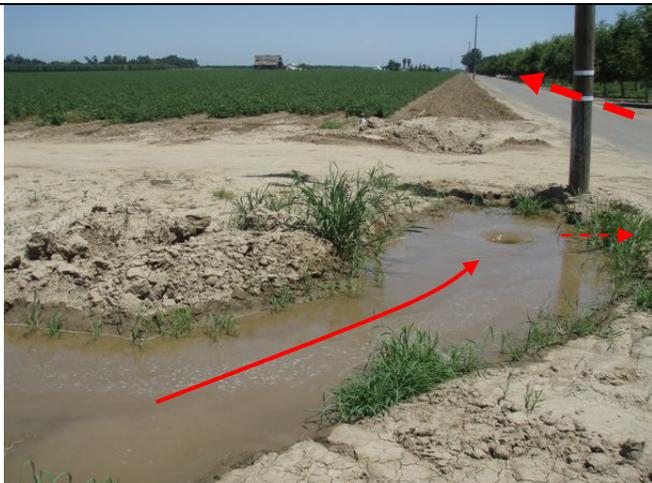
Photo 4: From Photo 3, the drainage flows east in an underground pipe along the south side of JT Crow Road toward the San Joaquin River. The field drain water mixes with Central California Irrigation Dist (CCID) supply water via the Main Canal. It is then used by other downstream users. The surplus flows into the San Joaquin River.

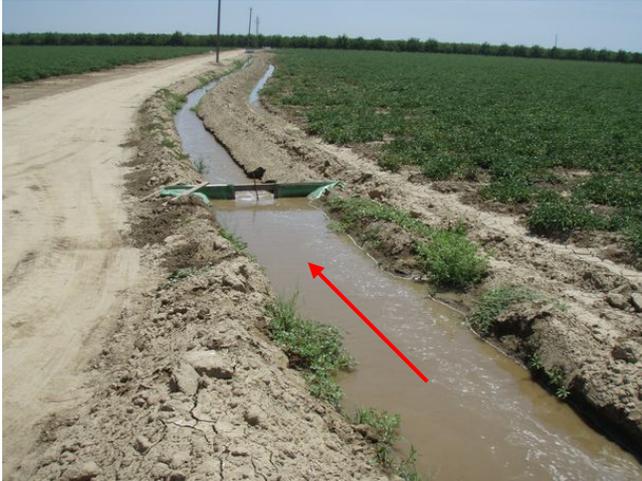
Photo 5: Looking south from the cropland toward JT Crow Road and the field drain.

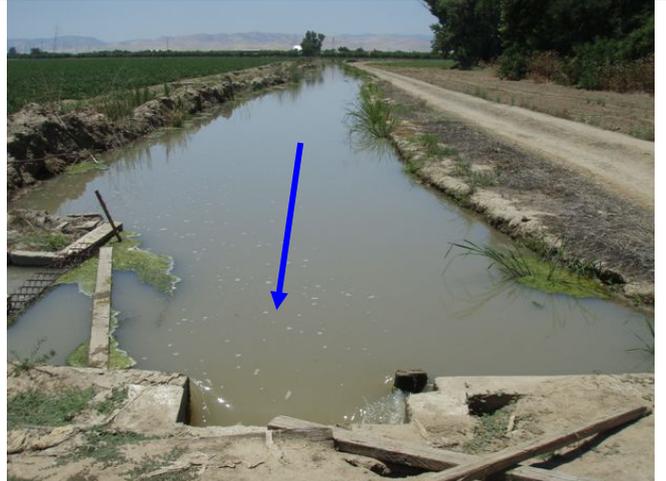
Photo 6: CCID irrigation supply water on the north side of the tomato cropland. Turbidity = 111 NTU

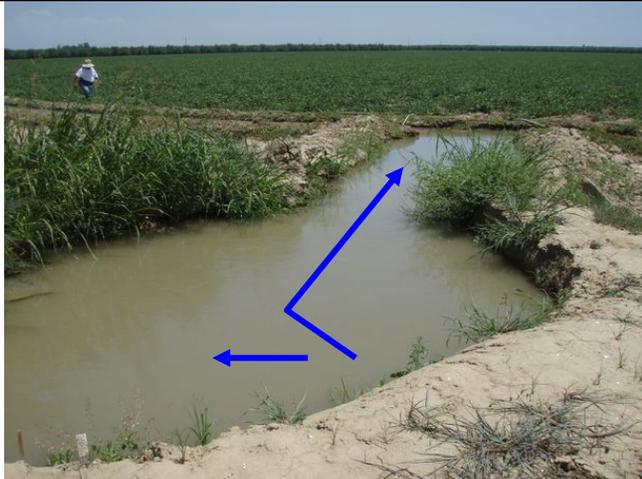
Photo 7: The supply water then flowed to the cropland in the areas seen in the photo. It also continued east to the other cropland (see Photo 8).

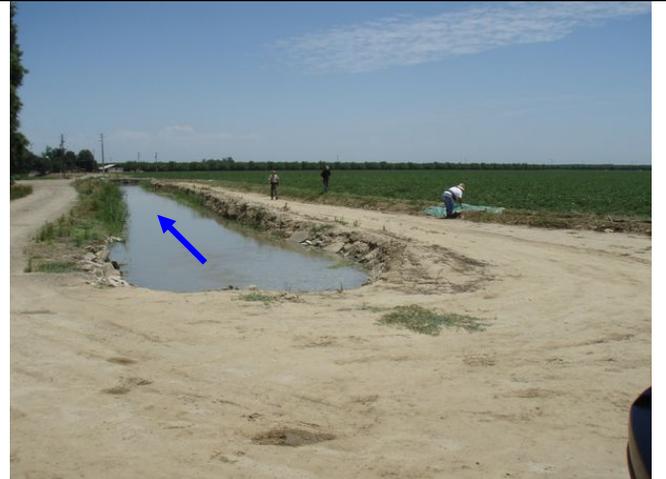
Photo 8: Irrigation supply water continued east toward the other tomato cropland and other water users.

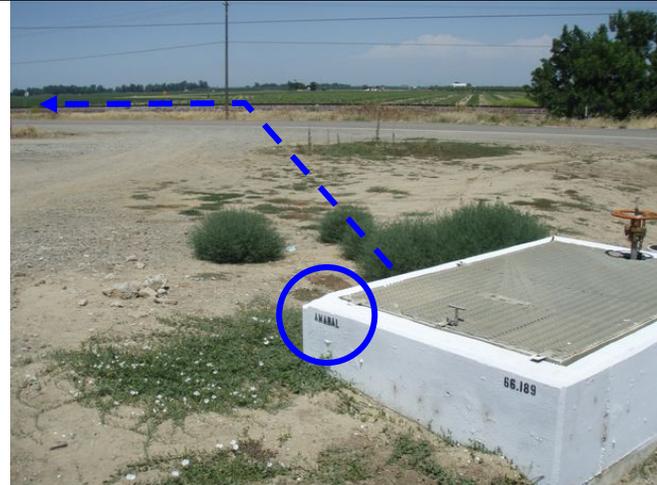
Photo 9: The supply water came from CCID via the Main Canal. It was distributed via the control box shown in this photo, as well as other turnouts from the canal to the north (see map)

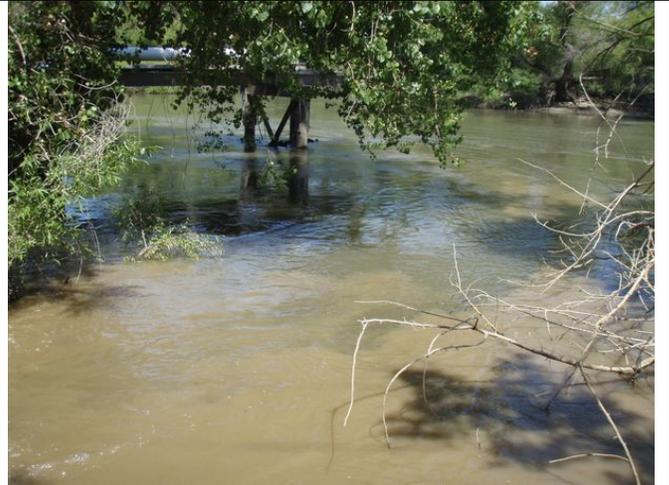
Photo 10: Looking downstream from the outfall (discharge outfall) of the Amaral Line flowing into the San Joaquin River.

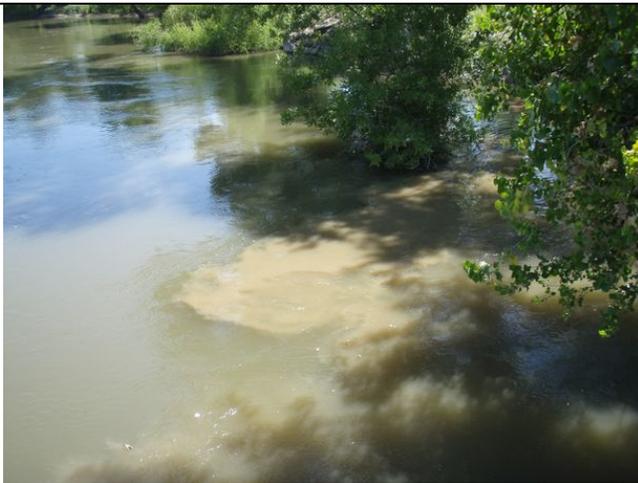
Photo 11: The sediment plume was significant and was still flowing at the time the inspection was completed at 13:30 hrs.

Up-river: Total Suspended Solids = 40mg/L

Outfall: Total Suspended Solids = 434mg/L

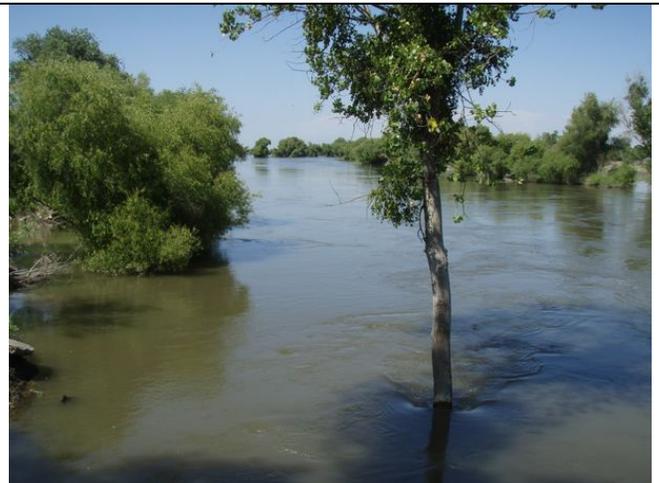
Photo 12: Looking north (downstream) at the San Joaquin River.

Down-River: Total Suspended Solids = 63mg/L

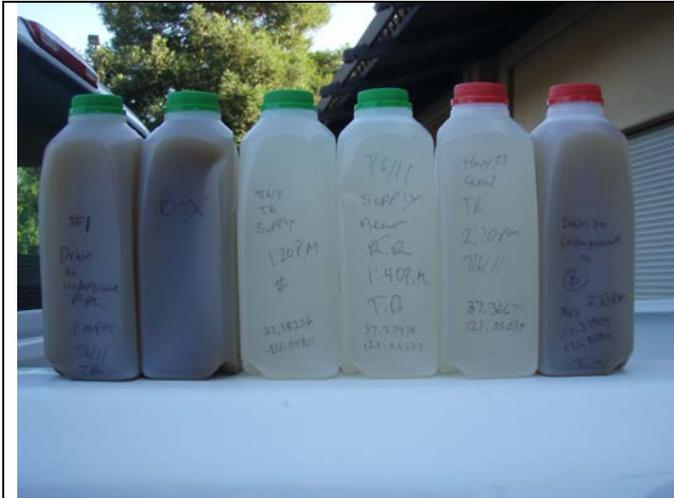
Photo 13: Photo of samples. Left to right
#1) Field drain – 13:00 hrs, NTU 668
#2) Field drain control box, NTU 739
#3) Supply water north side, NTU 111
#4) Supply water near railroad tracks, NTU 107
#5) Supply water from Main Canal, NTU 64.2
#6) Field drain – 14:25 hrs, NTU 584

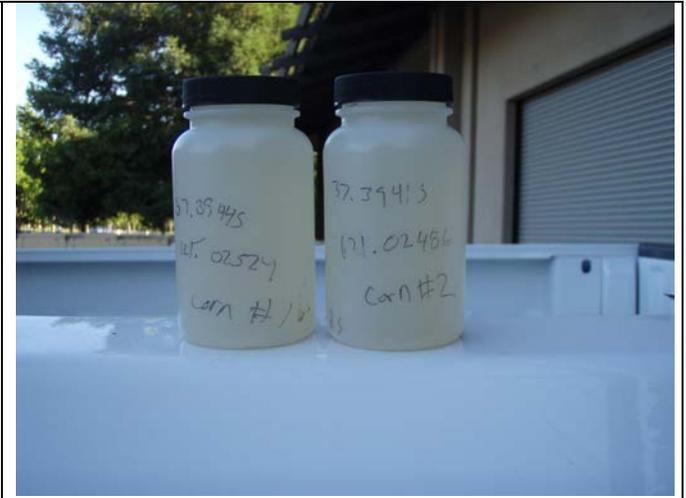
We found a nearby corn field that was currently being irrigated in a similar manner (row crop, furrow irrigated, and from the same irrigation supply source) to compare the turbidity of the tailwater (see the “Corn” samples in the table below. The NTUs from the corn field was checked in two locations with turbidity results of 84.6 and 141 NTUs compared to the tomato field of 668 and 584 NTUs.

Photo 14: Photo of other furrow irrigated cropland drainage in the area. Left to right:
#1) Corn drainage, NTU 141
#2) Corn drainage, NTU 84.5
