CENTRAL VALLEY REGIONAL WATER QUALITY CONTROL BOARD

INSPECTION REPORT

LOCATION & COUNTY: Henry Tosta Dairy
20662 San Jose Road, Tracy
San Joaquin County

INSPECTION DATE: 7 May 2013

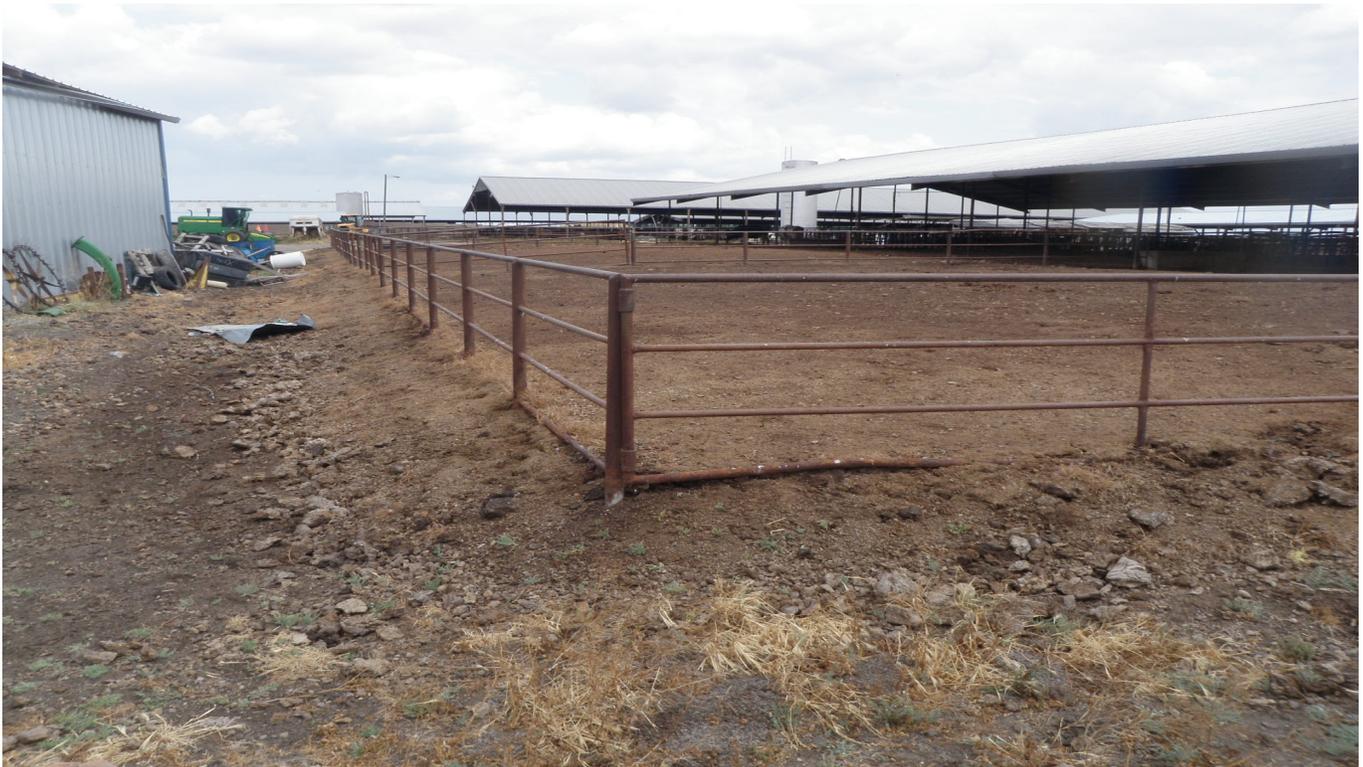
Photo 1: Select corrals have been cleaned (dry manure removed).

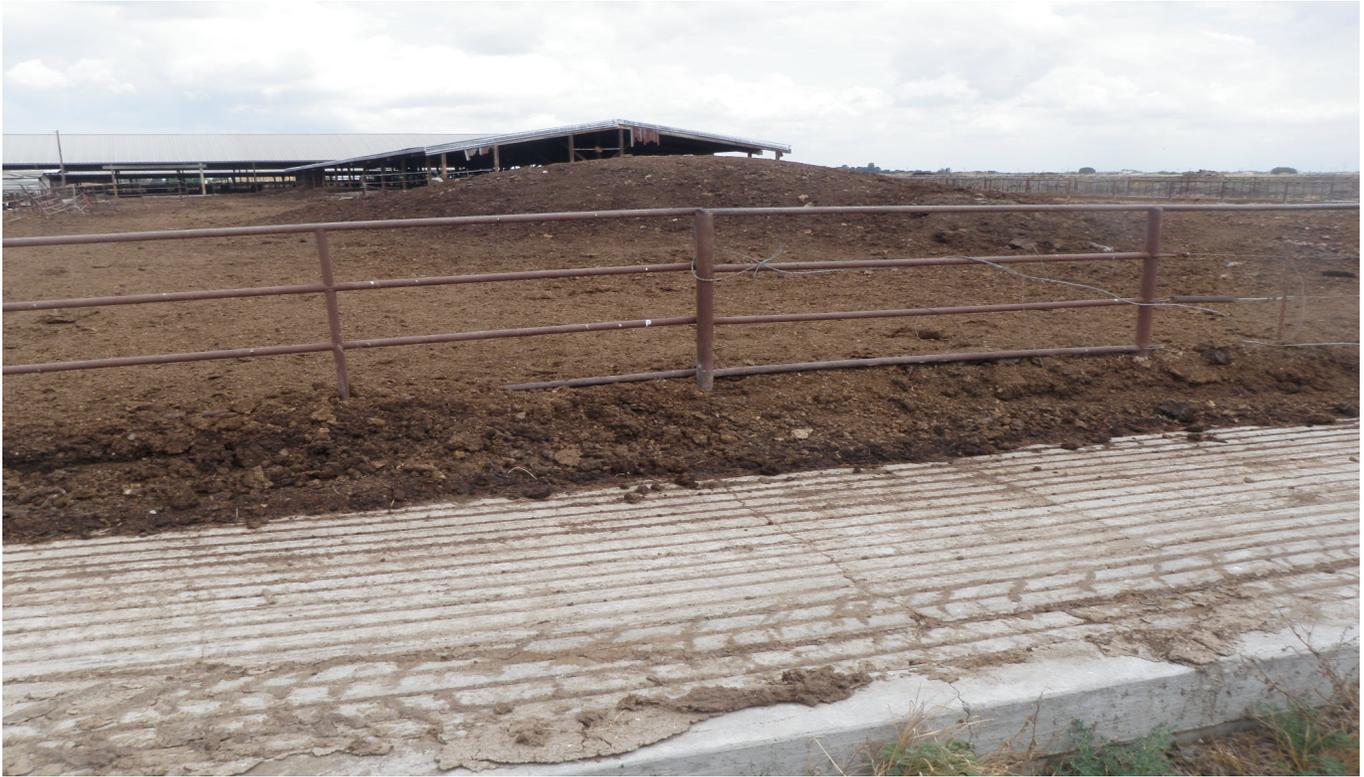
Photo 2: Select corrals have been cleaned (dry manure removed).

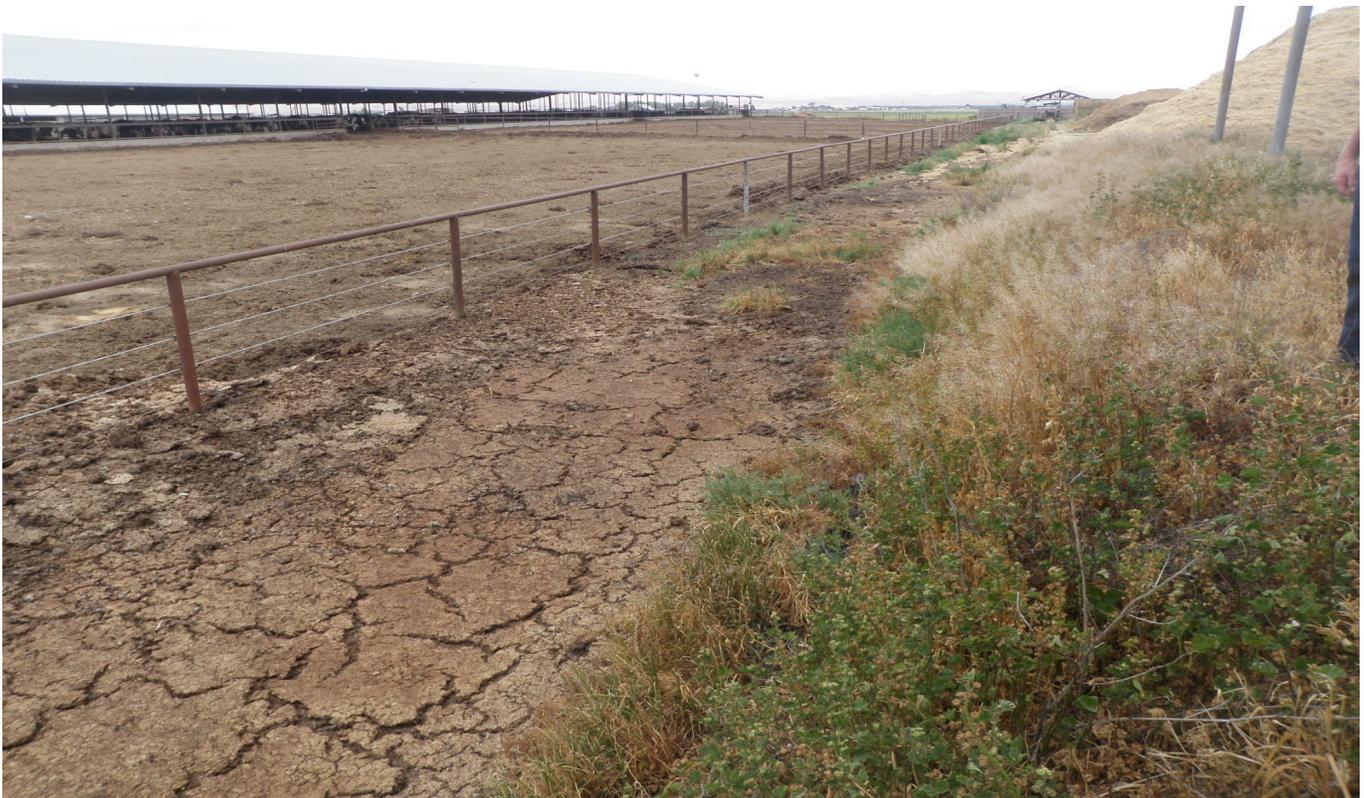
Photo 3: Select corrals have been cleaned (dry manure removed). Note solid manure in transfer lane just outside the fenceline.

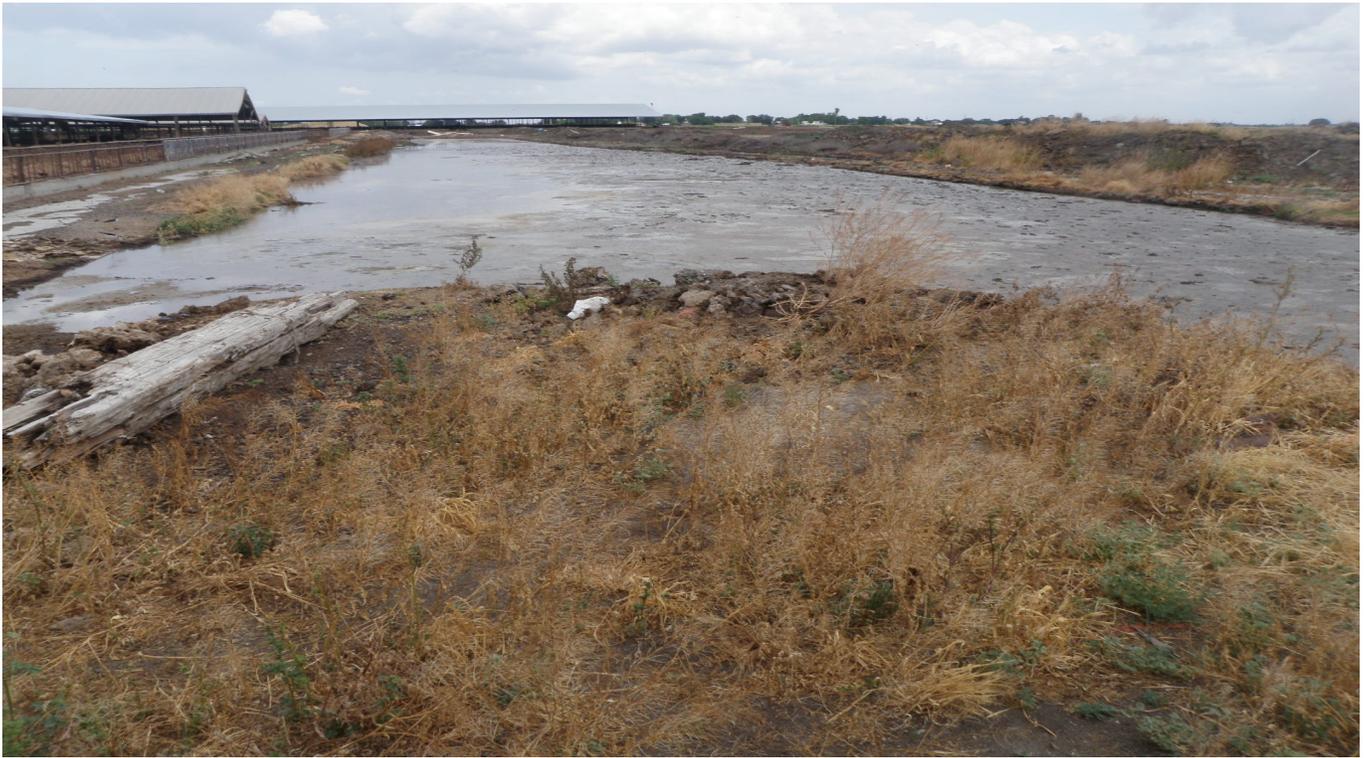
Photo 4: Looking north at Settling Basin #1. At the time of the inspection Settling Basin #1 was at capacity and there was evidence that wastewater had recently overtopped the embankments to the east (see Photo 5).

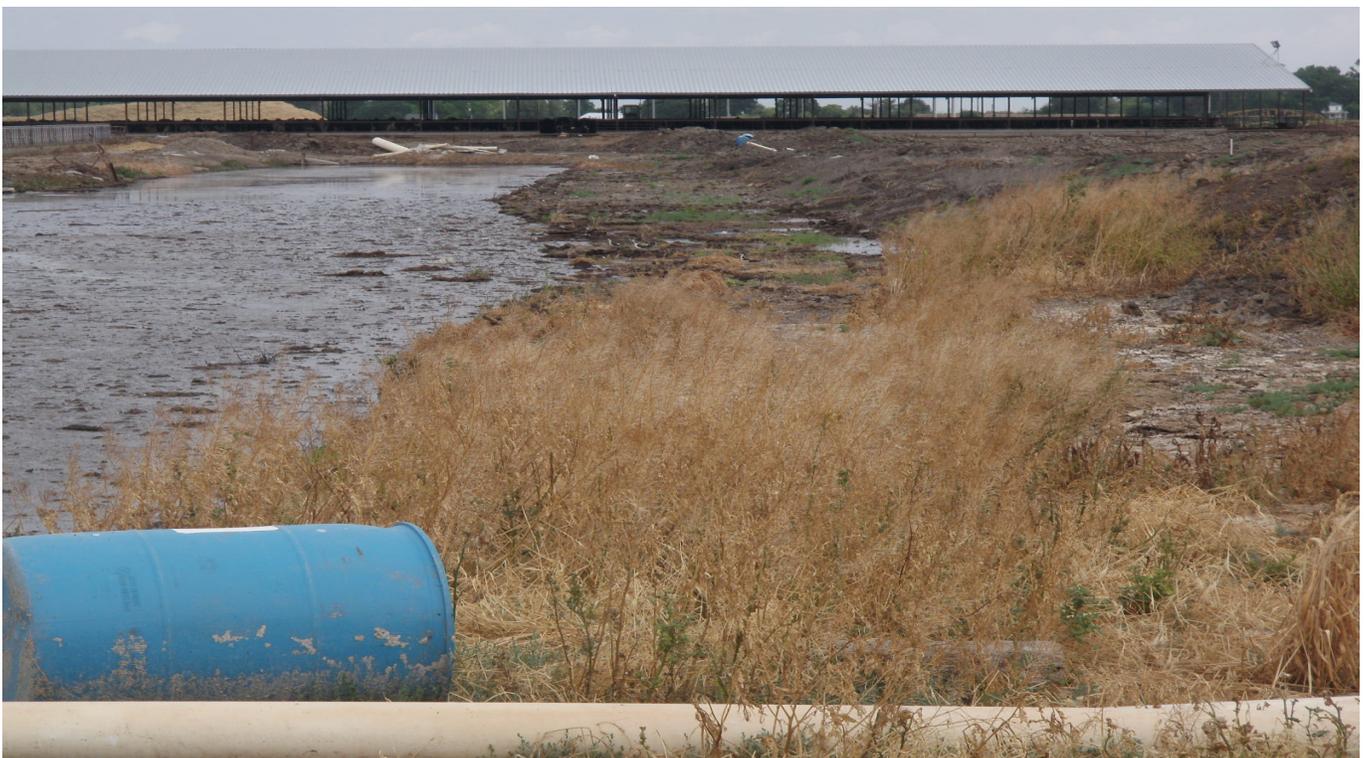
Photo 5: Looking north at Settling Basin #1. Note puddles of wastewater on the eastern embankment; evidence that wastewater has recently overflowed to the east.

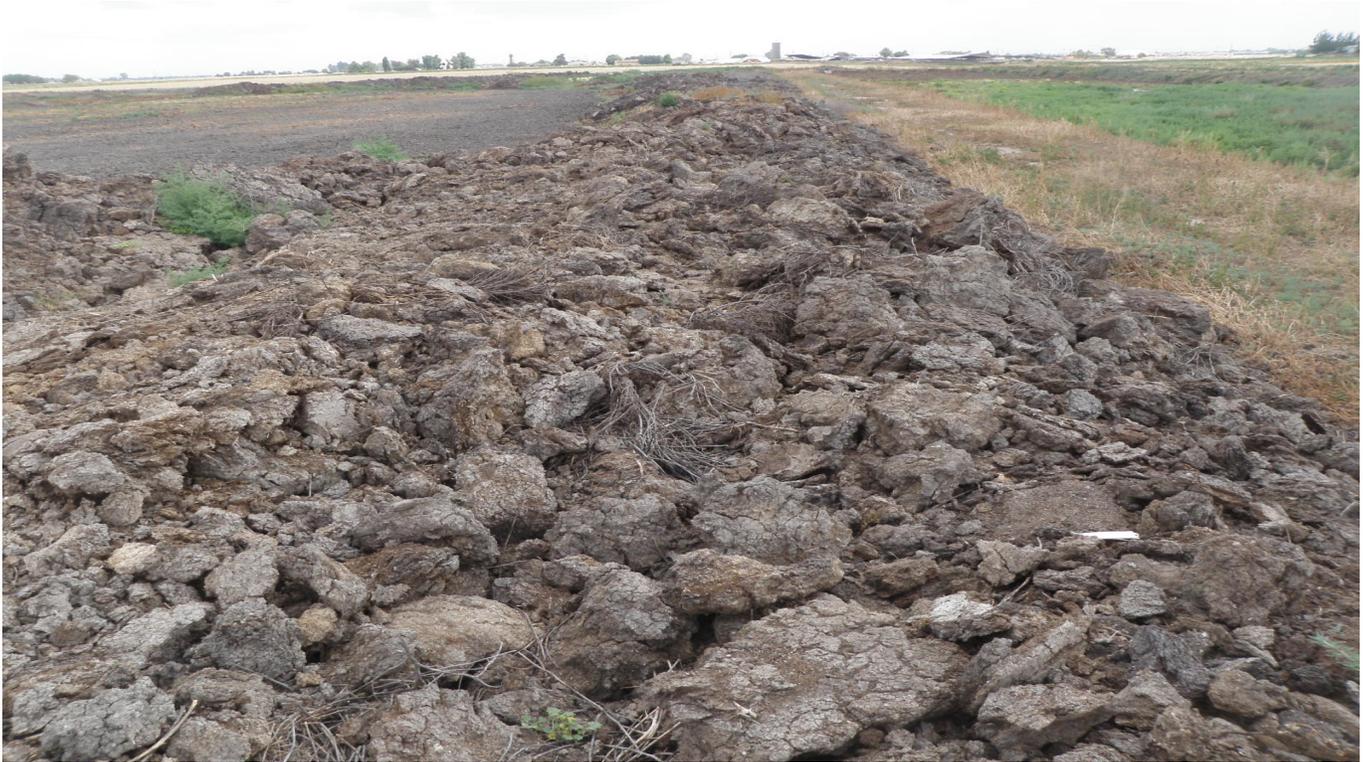
Photo 6: Looking east at the southern edge of Wastewater Lagoon #1; significant amounts of dry manure are still present (the pictured dry manure is approximately 2'-3' deep).

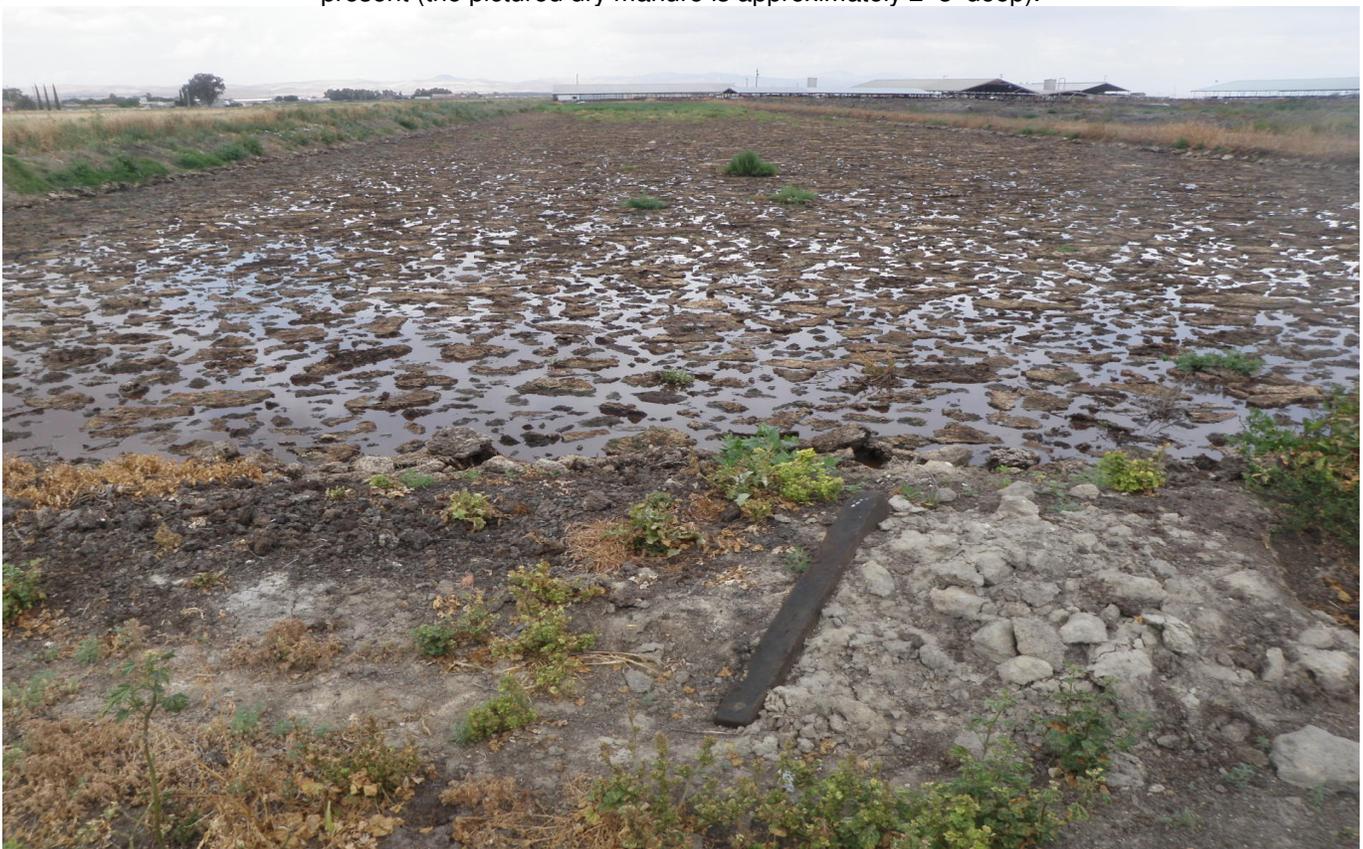
Photo 7: Looking west at Settling Basin #2. Significant amounts of liquid manure and solid manure are still present in Settling Basin #2.

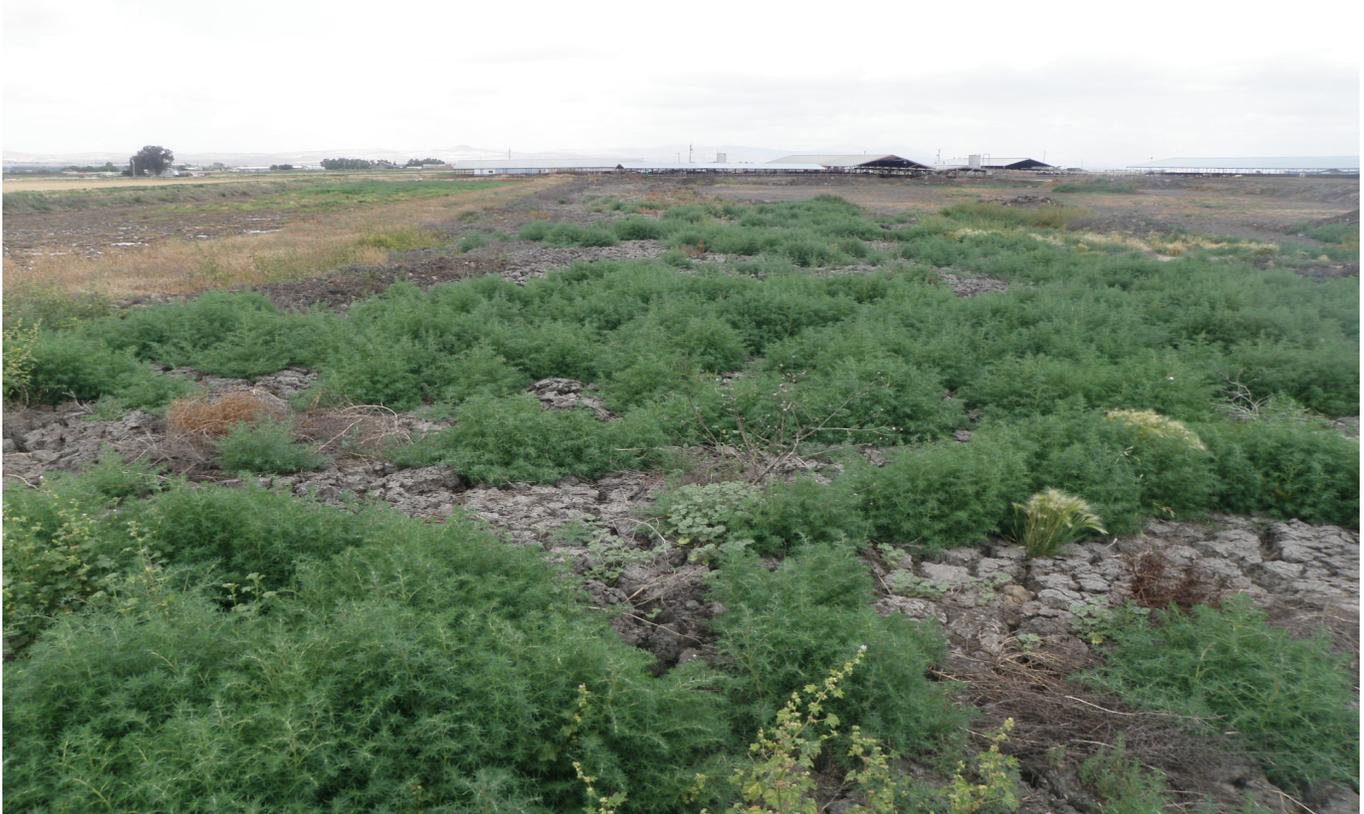
Photo 8: Looking west at the southern edge of Wastewater Lagoon #1; still significant solid manure present in the southern portion Wastewater Lagoon #1.

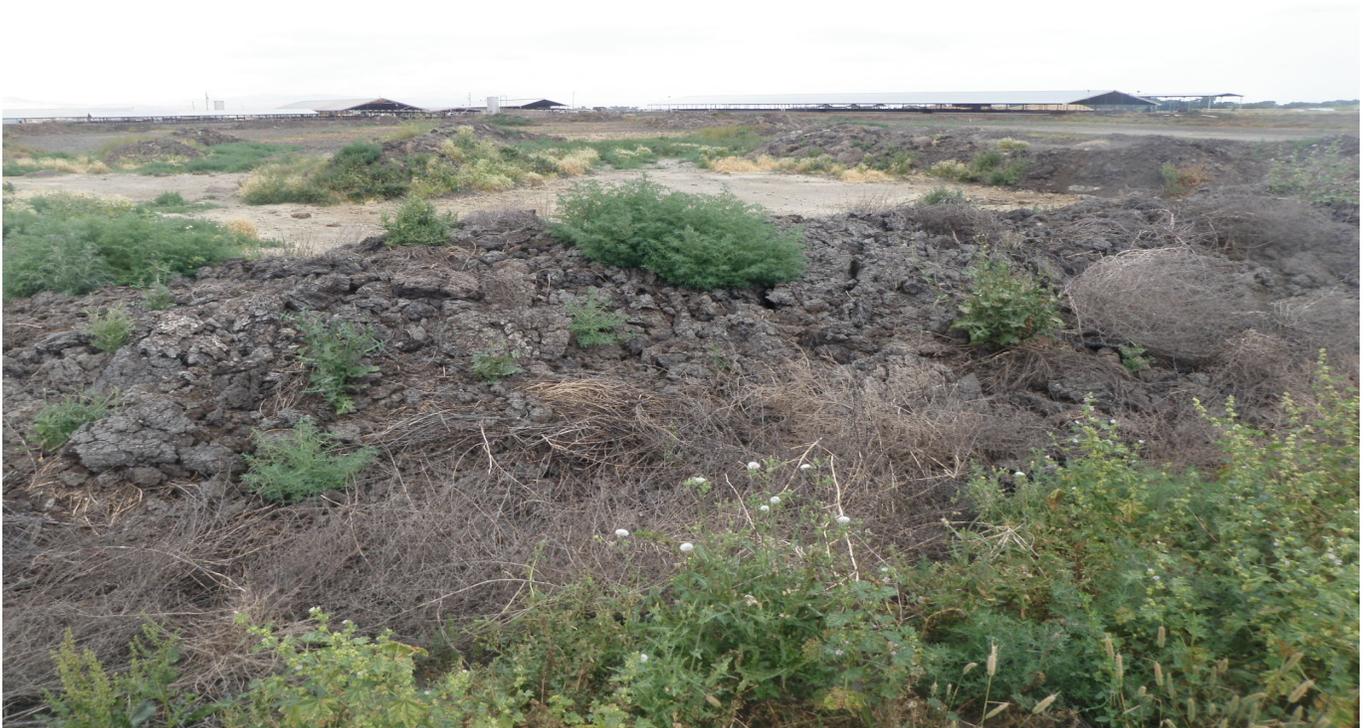
Photo 9: Looking west at the central portion of Wastewater Lagoon #1. Several piles of dry solid manure were observed inside the central portion of Wastewater Lagoon #1.

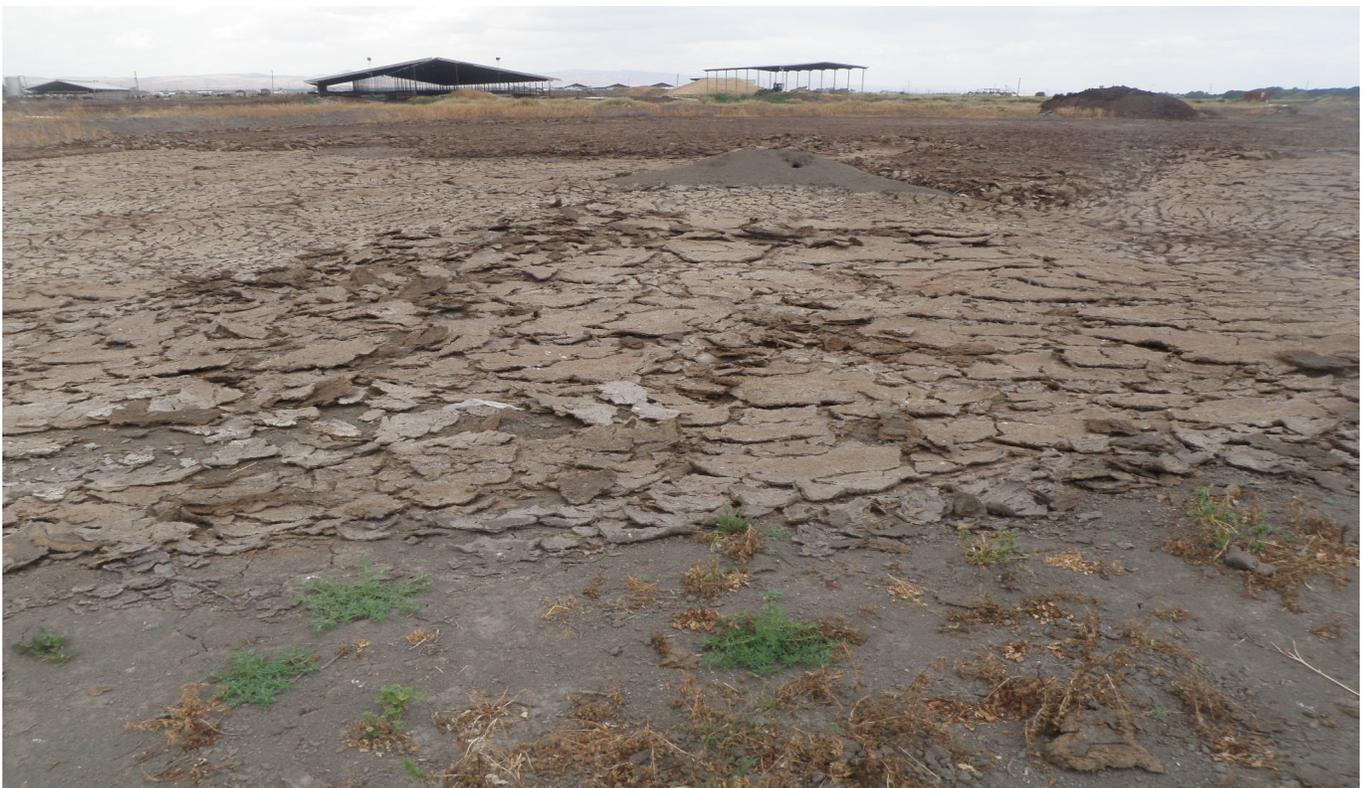
Photo 13: Looking west at Wastewater Lagoon #5. A small amount of dry manure and slurry manure was present inside Wastewater Lagoon #5.

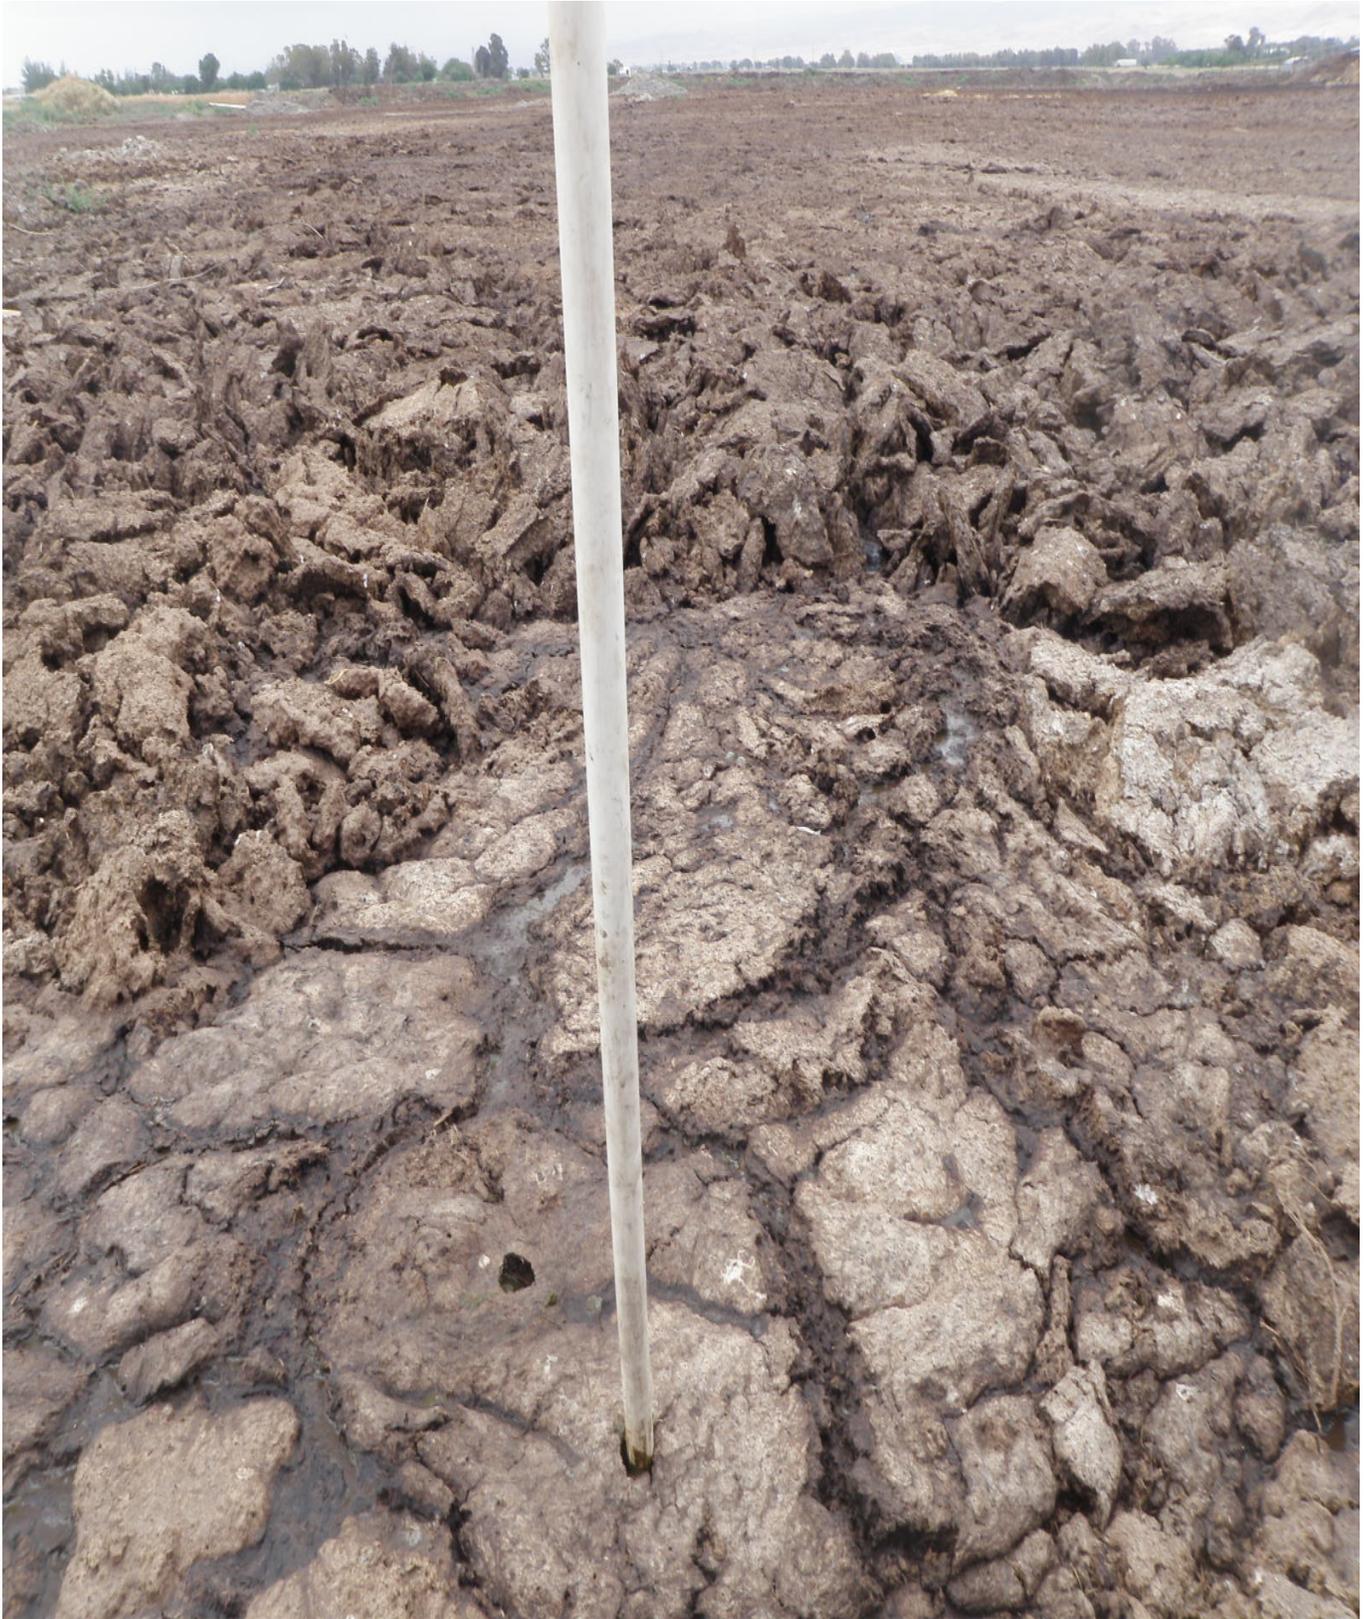
Photo 14: Looking south at the 3-4 acre slurry area from the northeast portion of the production area; I'm using the pole to try and gauge the depth of the slurry manure (at the edge where it's likely the shallowest).

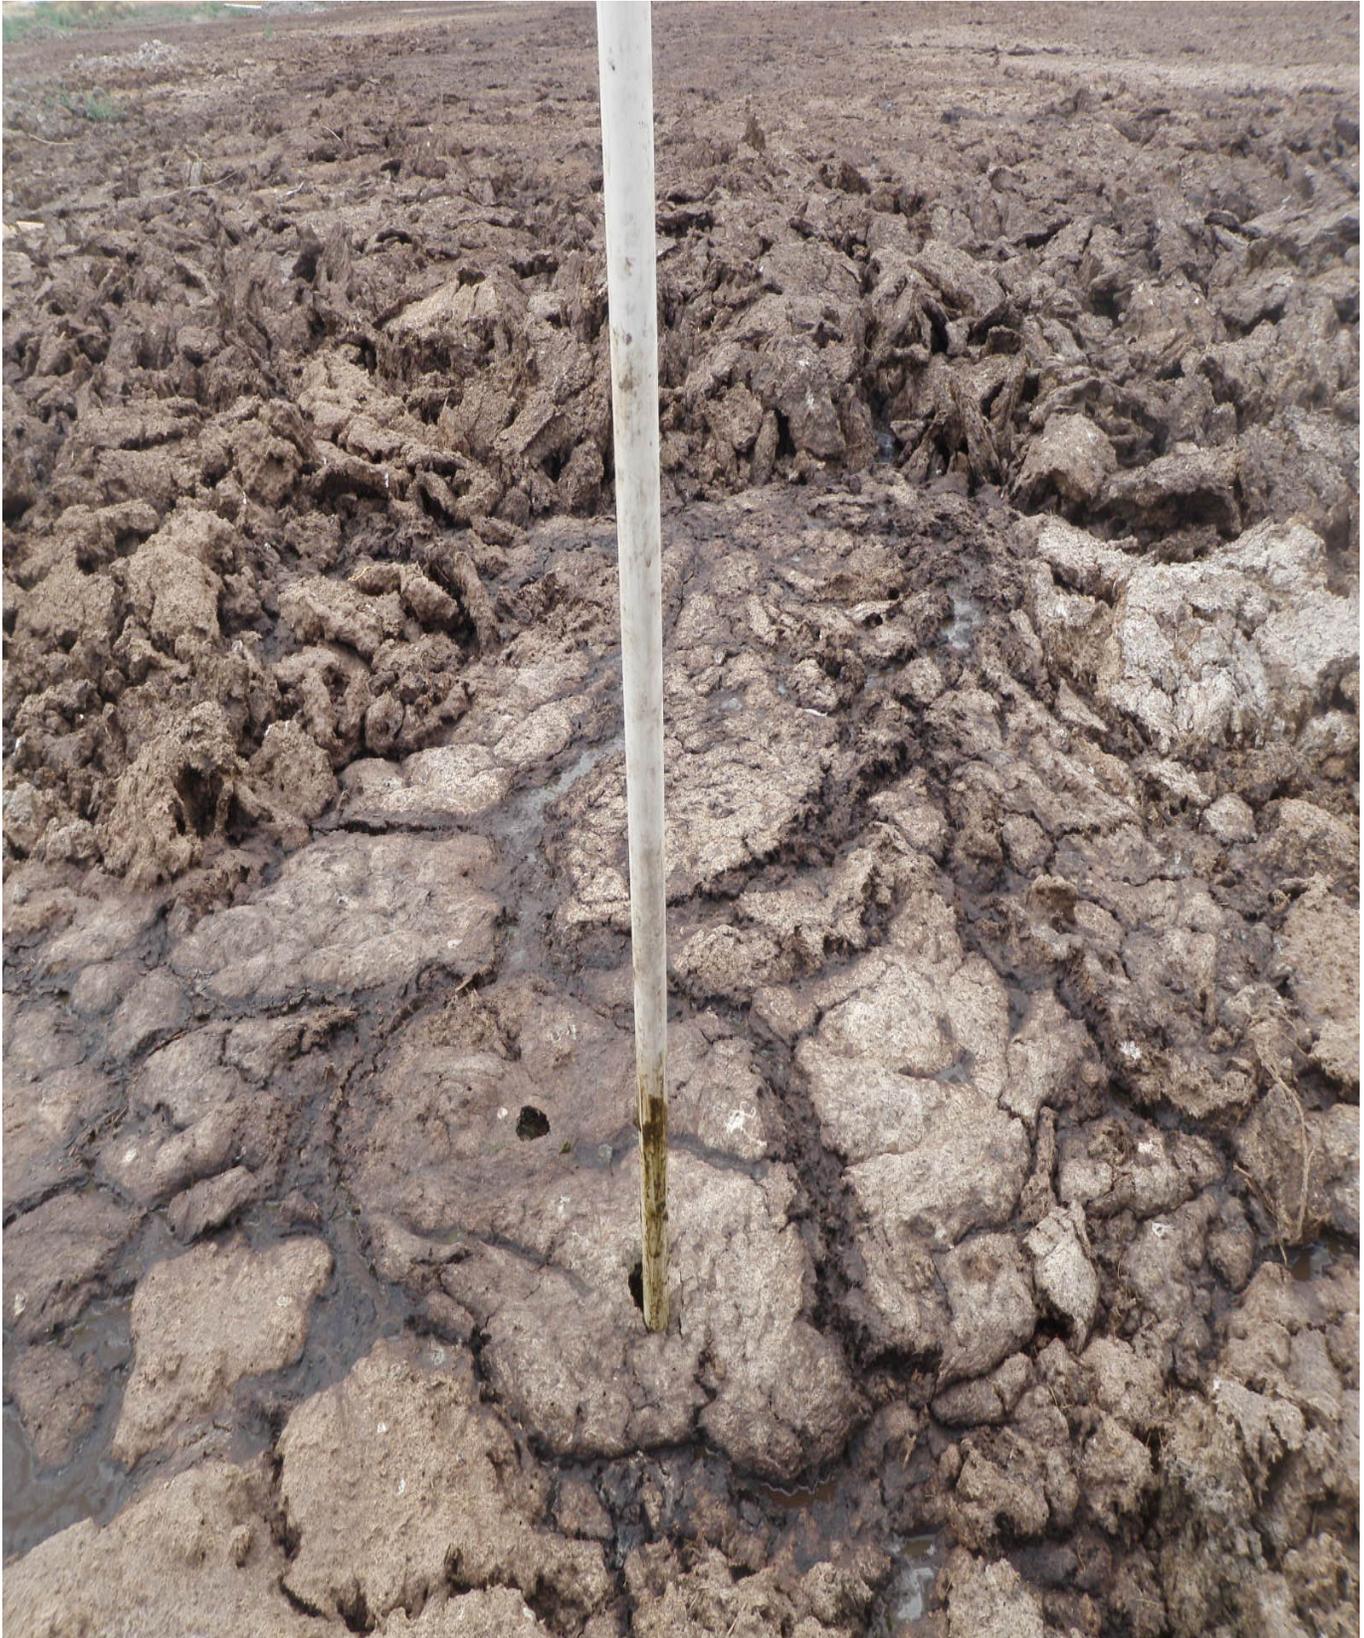
Photo 15: Approximately 10"-12" deep at the edge. Still significant amounts of slurry manure, solid manure, and wastewater present at the 3-4 acre slurry area.

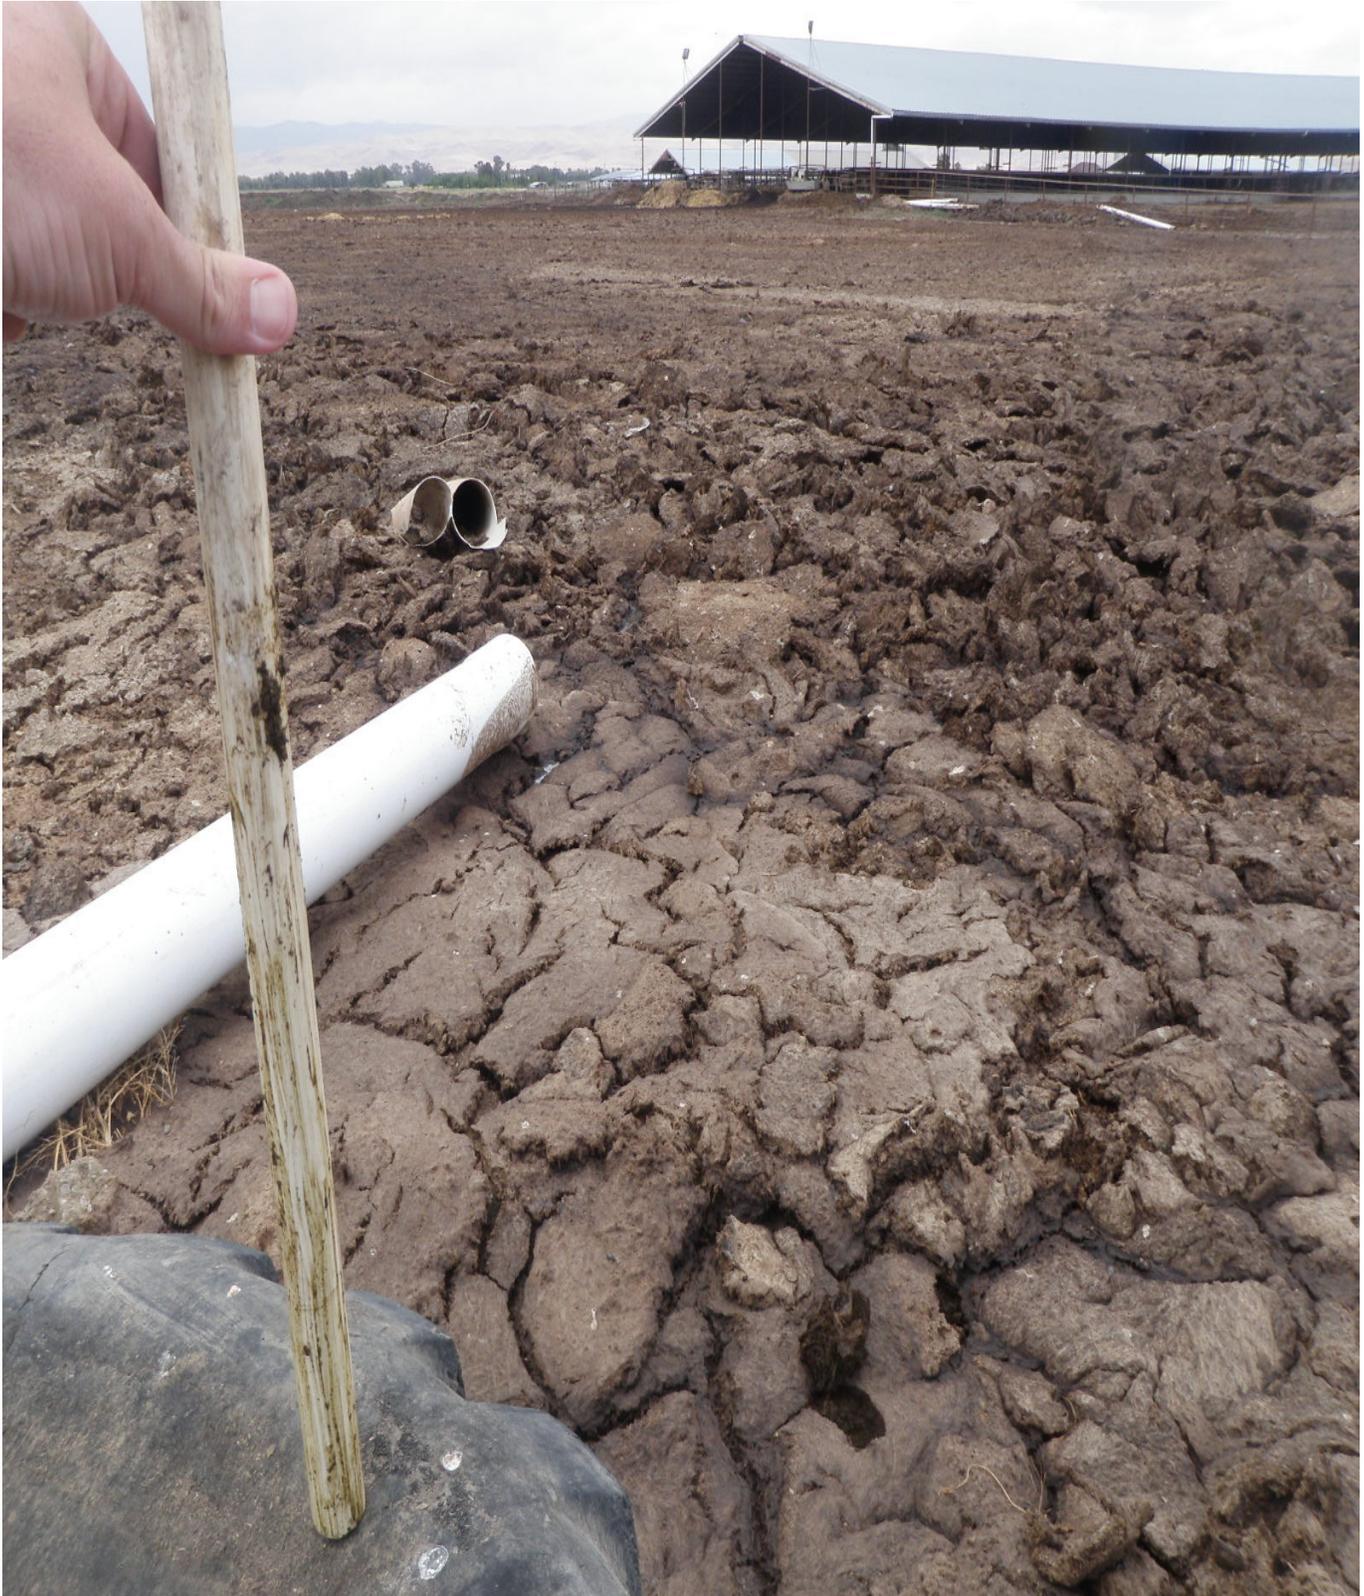
Photo 16: Looking southwest at the 3-4 acre slurry area. Still significant amounts of slurry manure, solid manure, and wastewater present at the 3-4 acre slurry area.

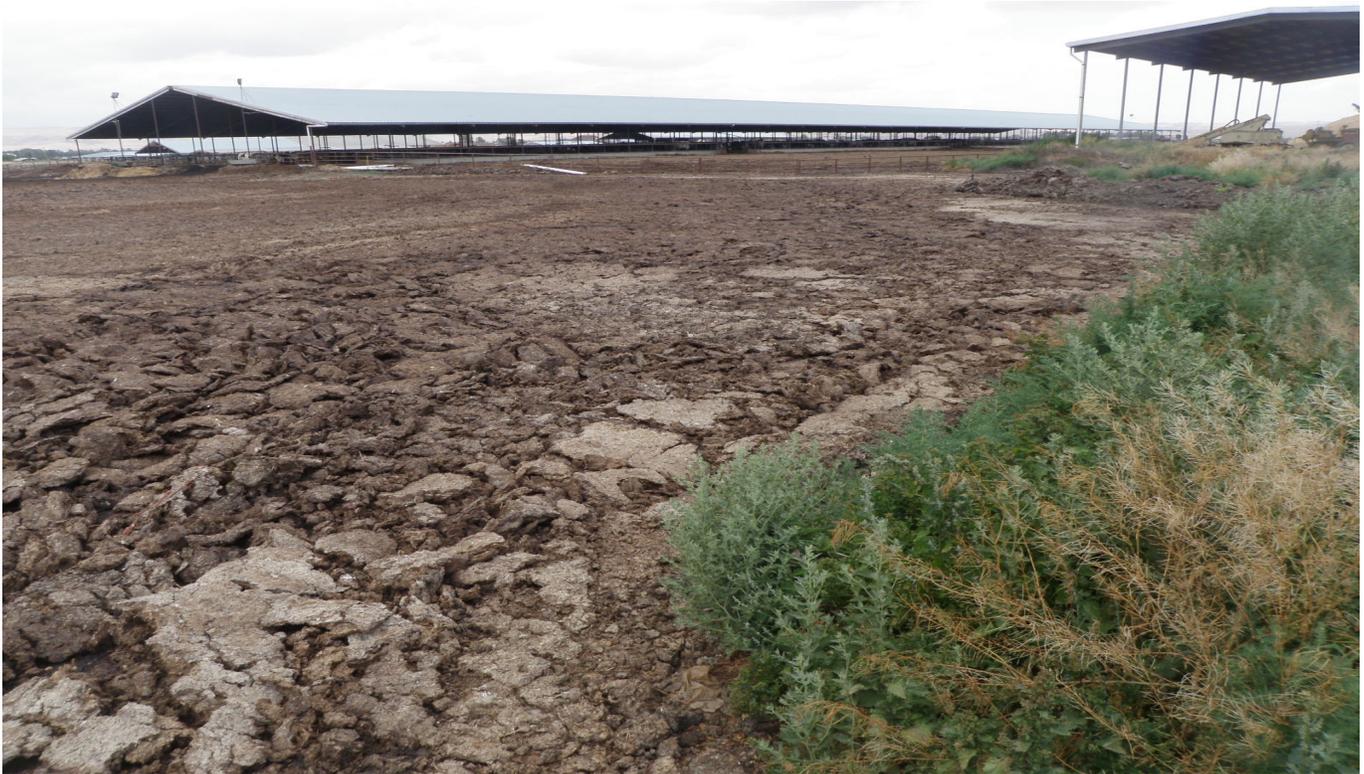
Photo 17: Looking southwest at the northern portion of the 3-4 acre slurry area; still significant amounts of slurry manure, solid manure, and wastewater present at the 3-4 acre slurry area.

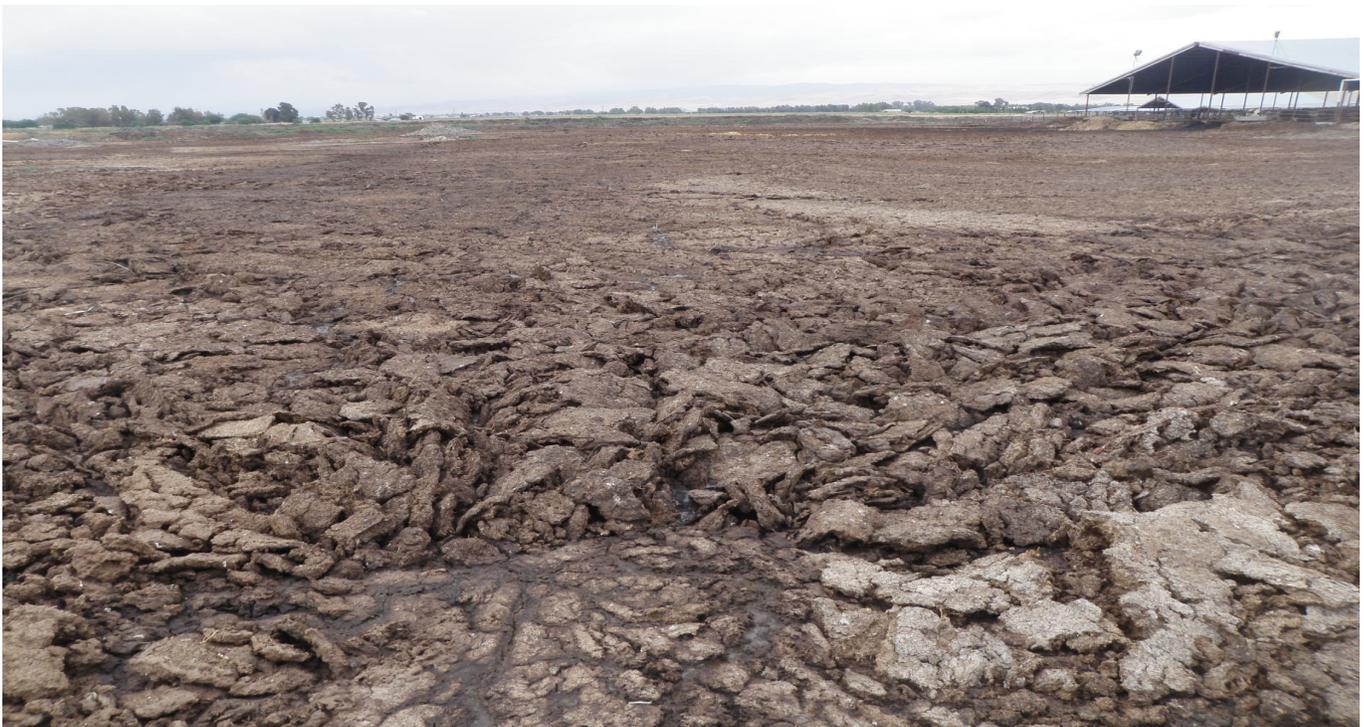
Photo 18: Looking southwest at the central portion of the 3-4 acre slurry area; still significant amounts of slurry manure, solid manure, and wastewater present at the 3-4 acre slurry area.

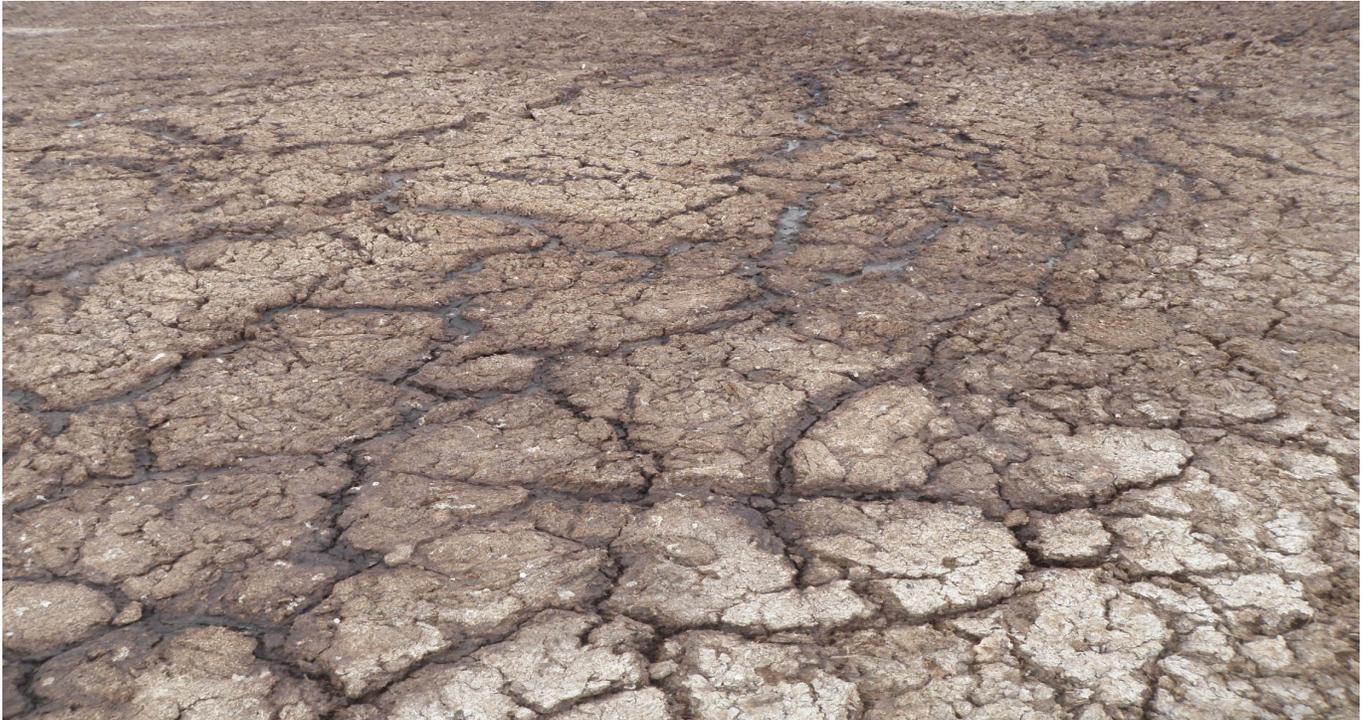
Photo 19: This photo displays the consistency of the manure in the 3-4 acre slurry area; a thin layer of crusted manure on top, with slurry and wastewater underneath. Because the manure has not been windrowed or spread – the manure underneath the crust is not drying.

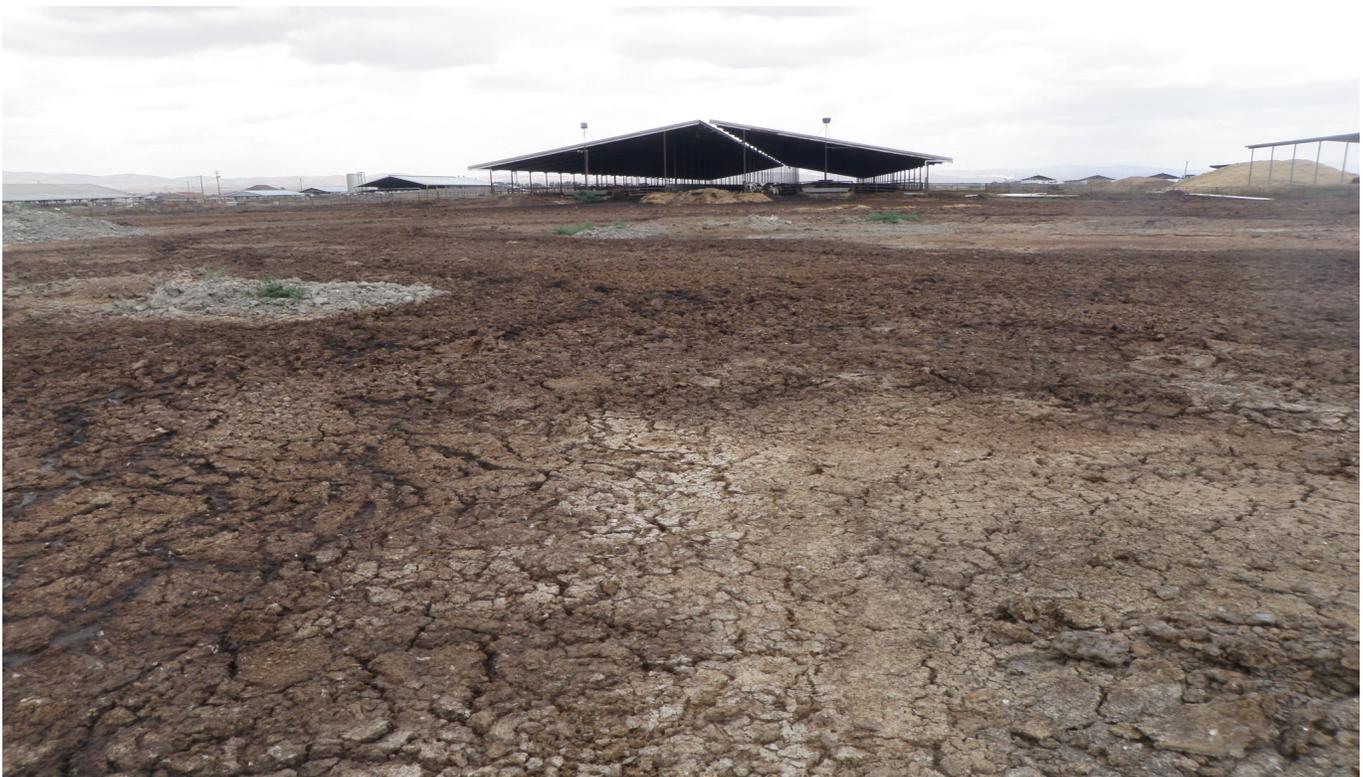
Photo 20: Looking west at the central portion of the 3-4 acre slurry area. Still significant amounts of slurry manure, solid manure, and wastewater present at the 3-4 acre slurry area.

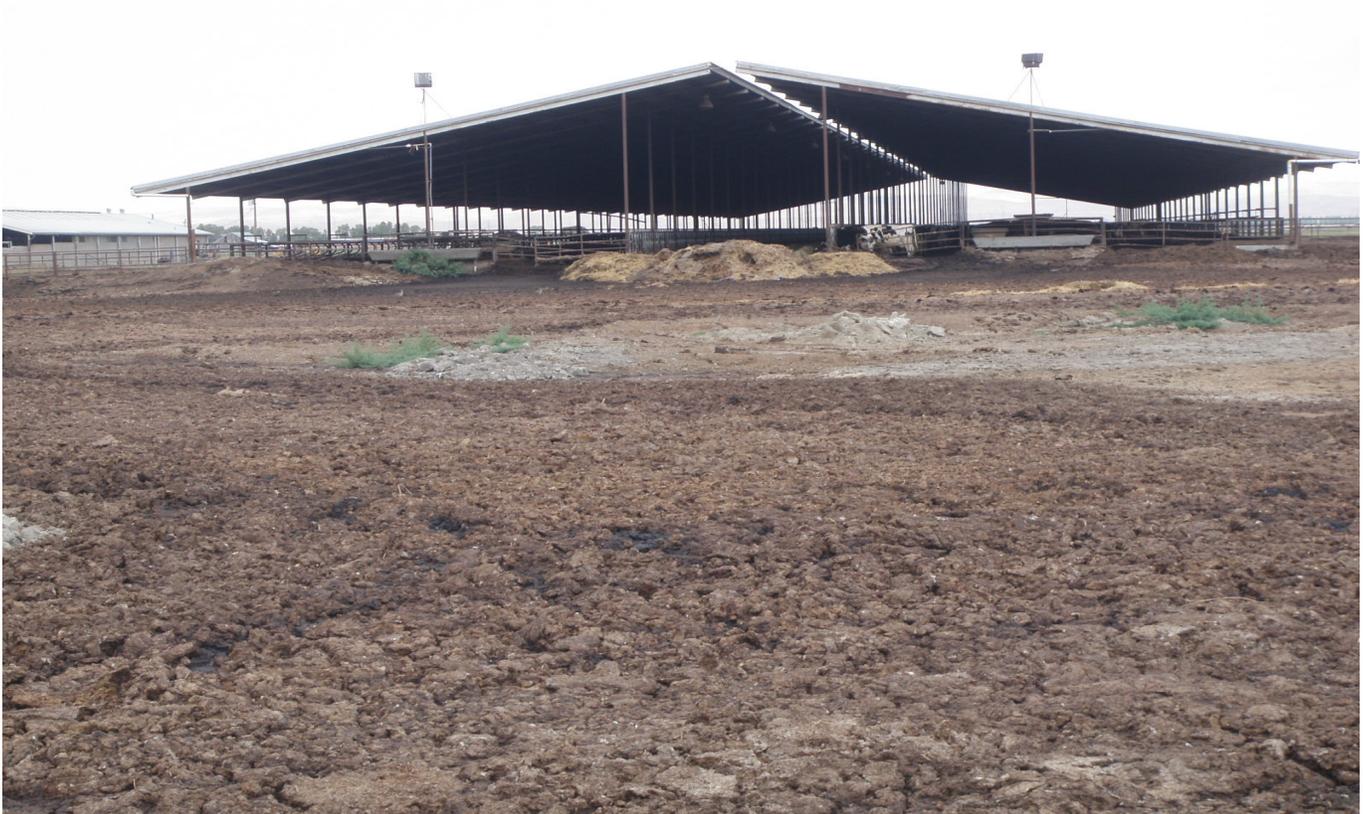
Photo 21: Looking west at the central portion of the 3-4 acre slurry area. Still significant amounts of slurry manure, solid manure, and wastewater present at the 3-4 acre slurry area.
