CENTRAL VALLEY REGIONAL WATER QUALITY CONTROL BOARD

INSPECTION REPORT

LOCATION & COUNTY: Henry Tosta Dairy
20662 San Jose Road, Tracy
San Joaquin County

INSPECTION DATE: 7 May 2013

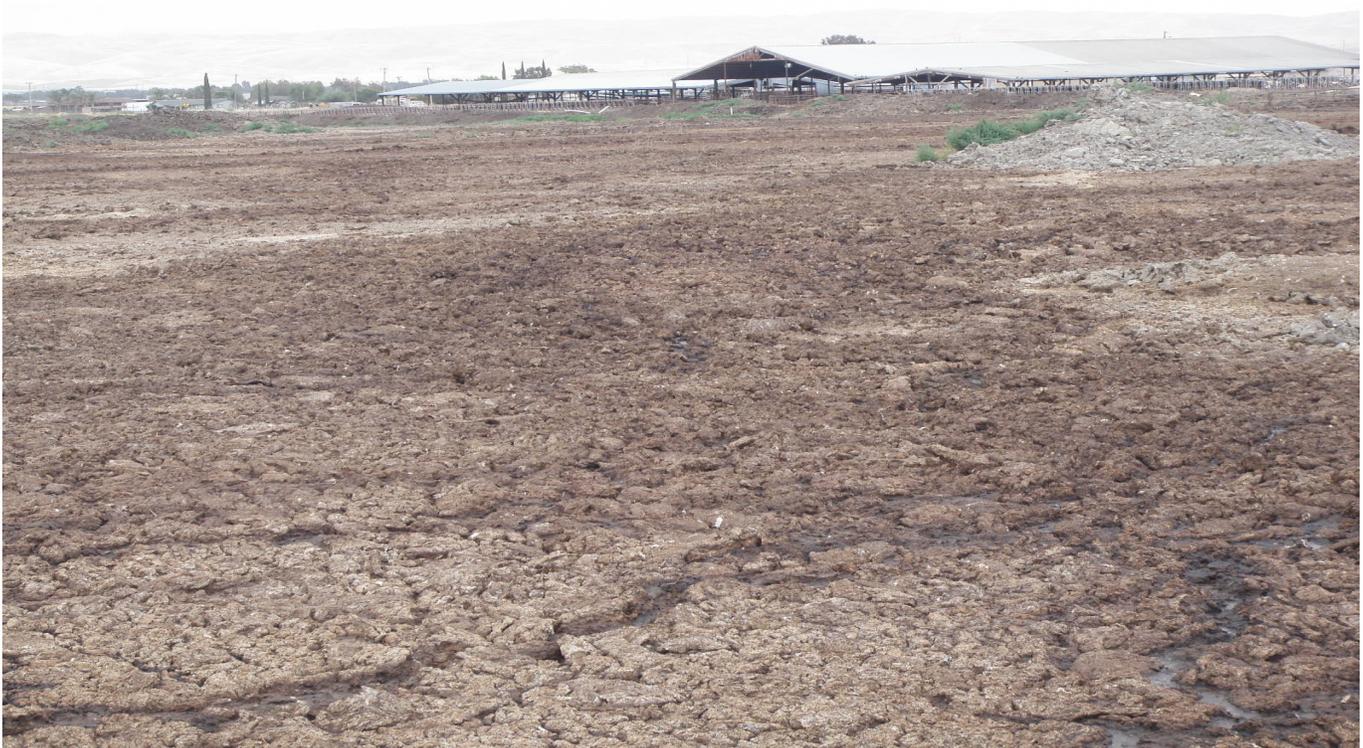
Photo 22: Looking southwest at the southern portion of the 3-4 acre slurry area. Still significant amounts of slurry manure, solid manure, and wastewater present at the 3-4 acre slurry area.

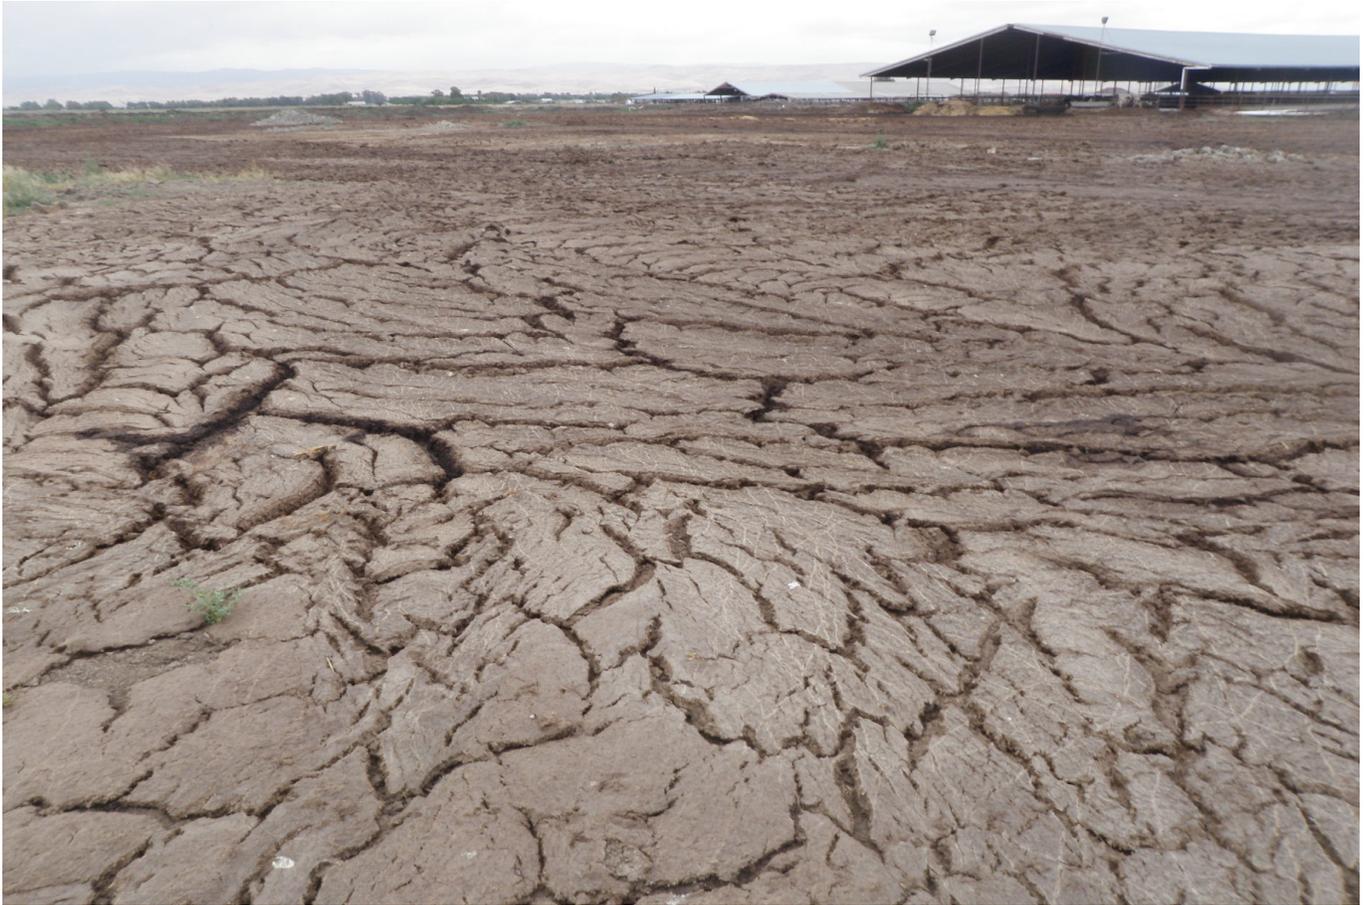
Photo 23: Looking southwest at the central portion of the 3-4 acre slurry area. Still significant amounts of slurry manure, solid manure, and wastewater present at the 3-4 acre slurry area.

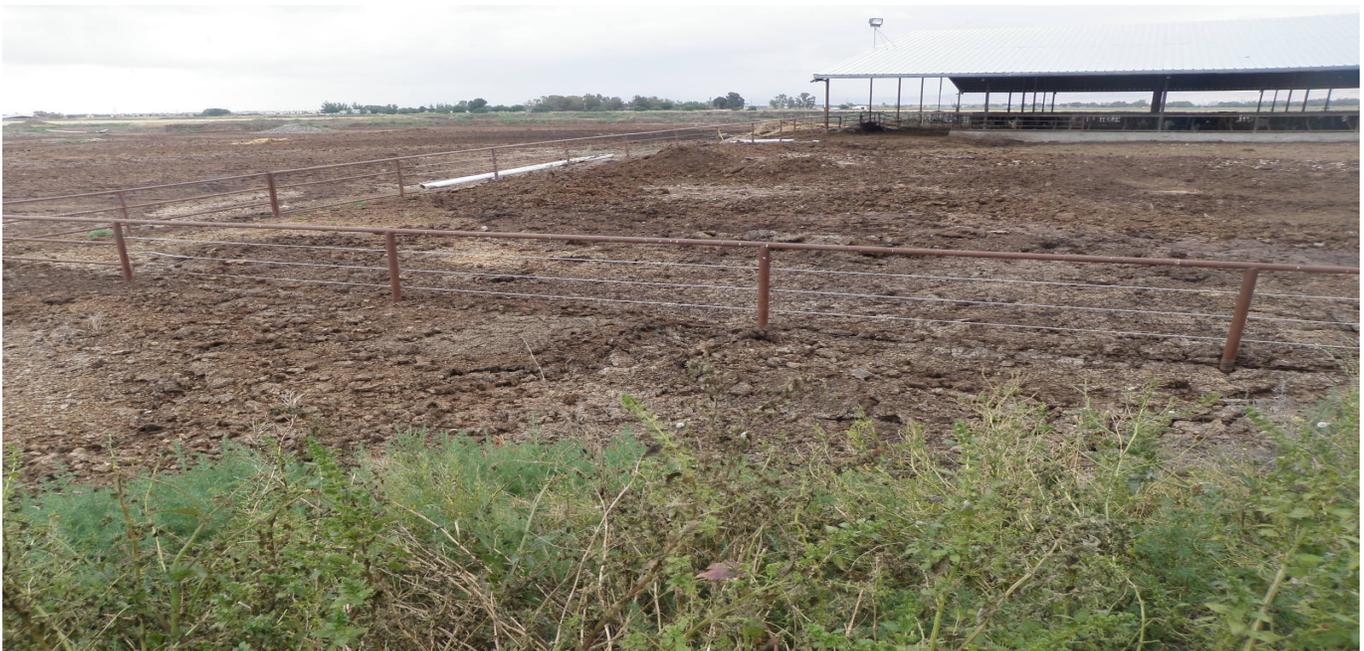
Photo 24: Looking southeast at the central portion of the 3-4 acre slurry area. Also note solid manure inside the fenced corral.

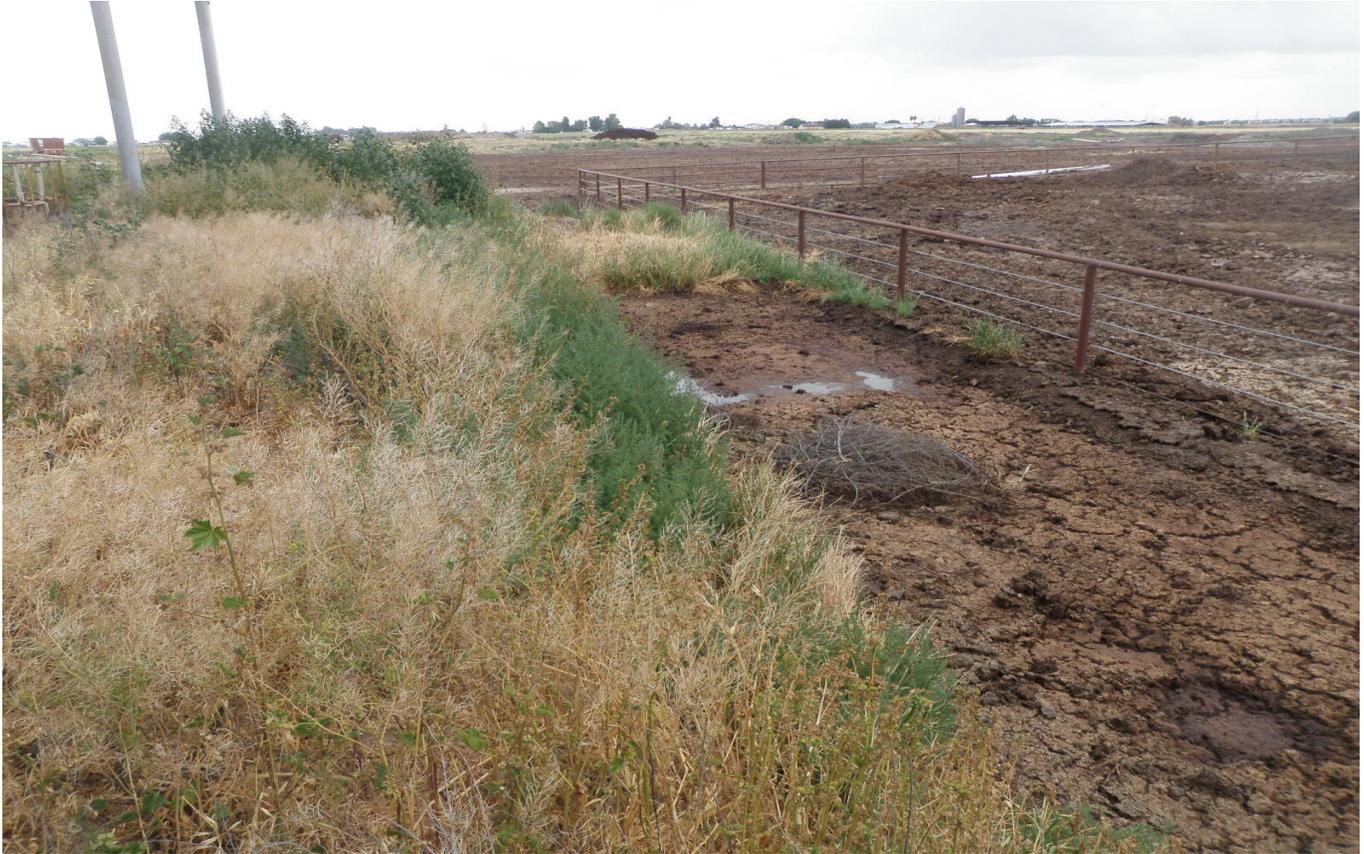
Photo 25: Looking east at a transfer lane full of solid manure and wastewater.
