Date: October 20, 2008

From: Steve Leach and Galen Peracca, URS

Subject: Evaluation of Wetlands Associated with Reservoir Operations  
Calaveras Dam Replacement Project (CUW 37401)

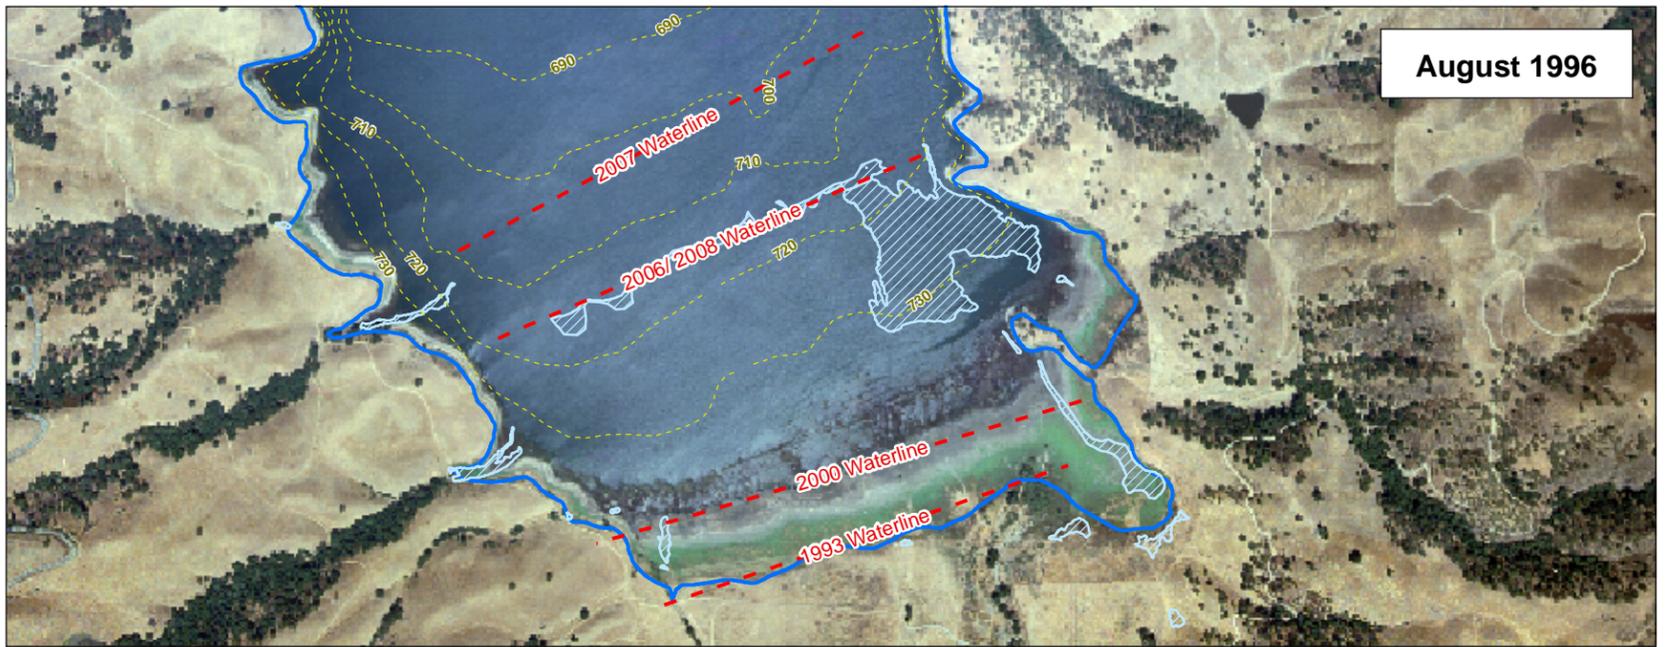
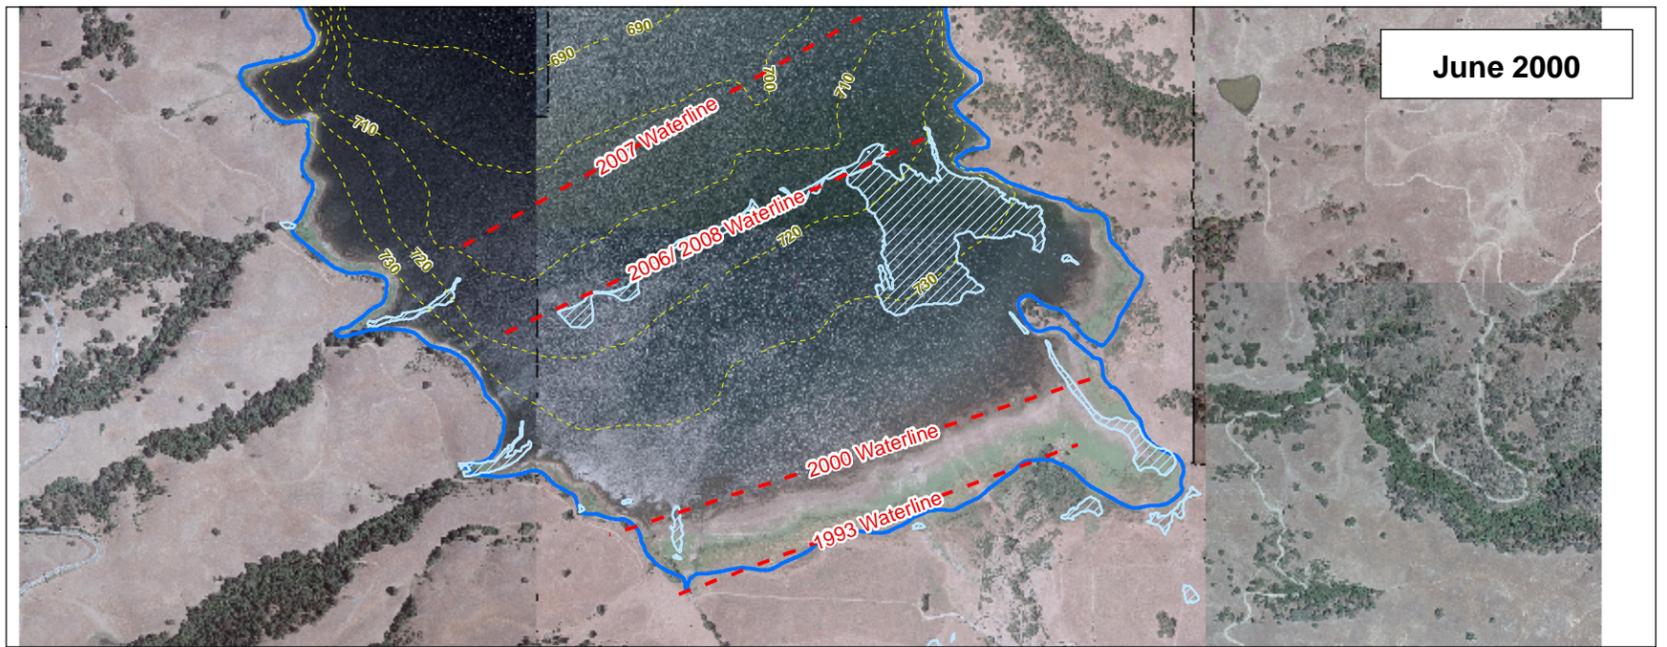
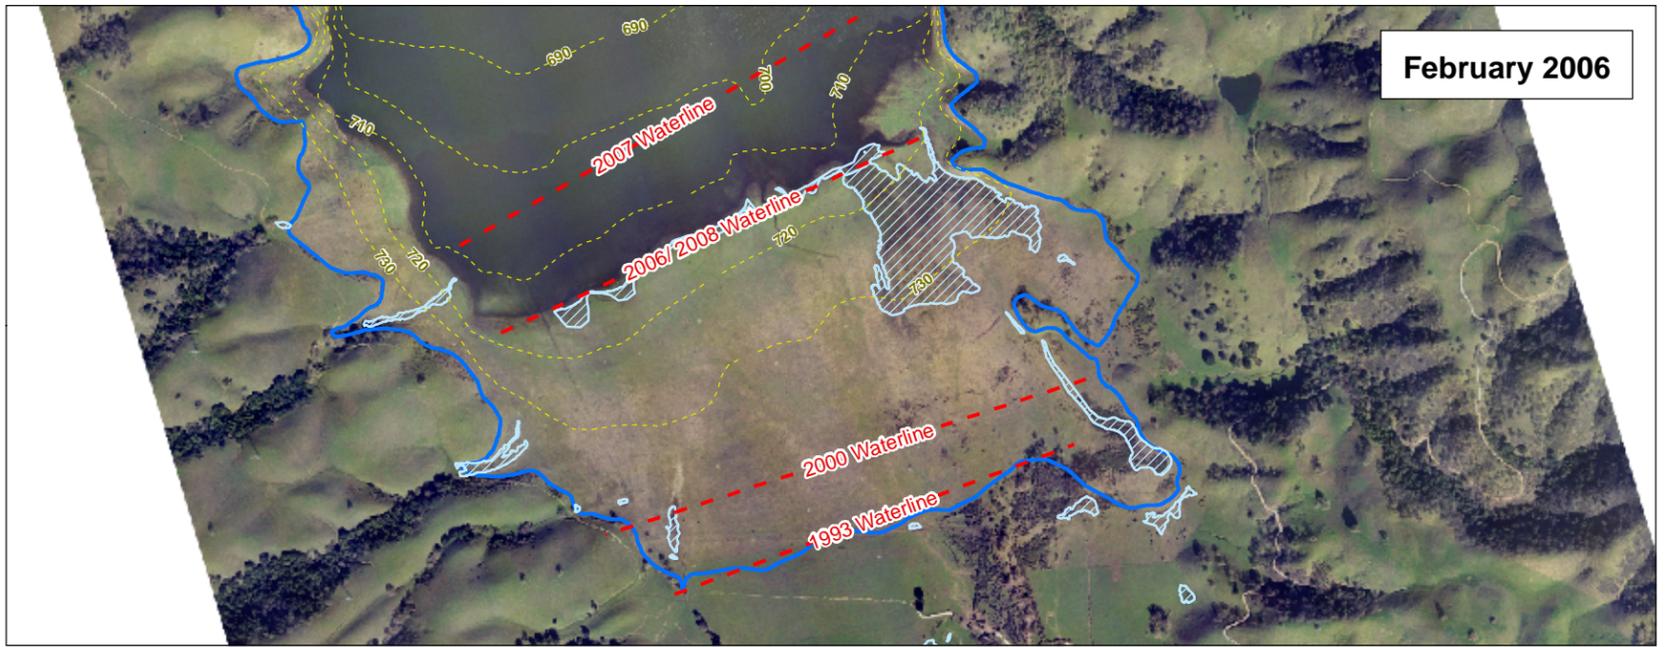
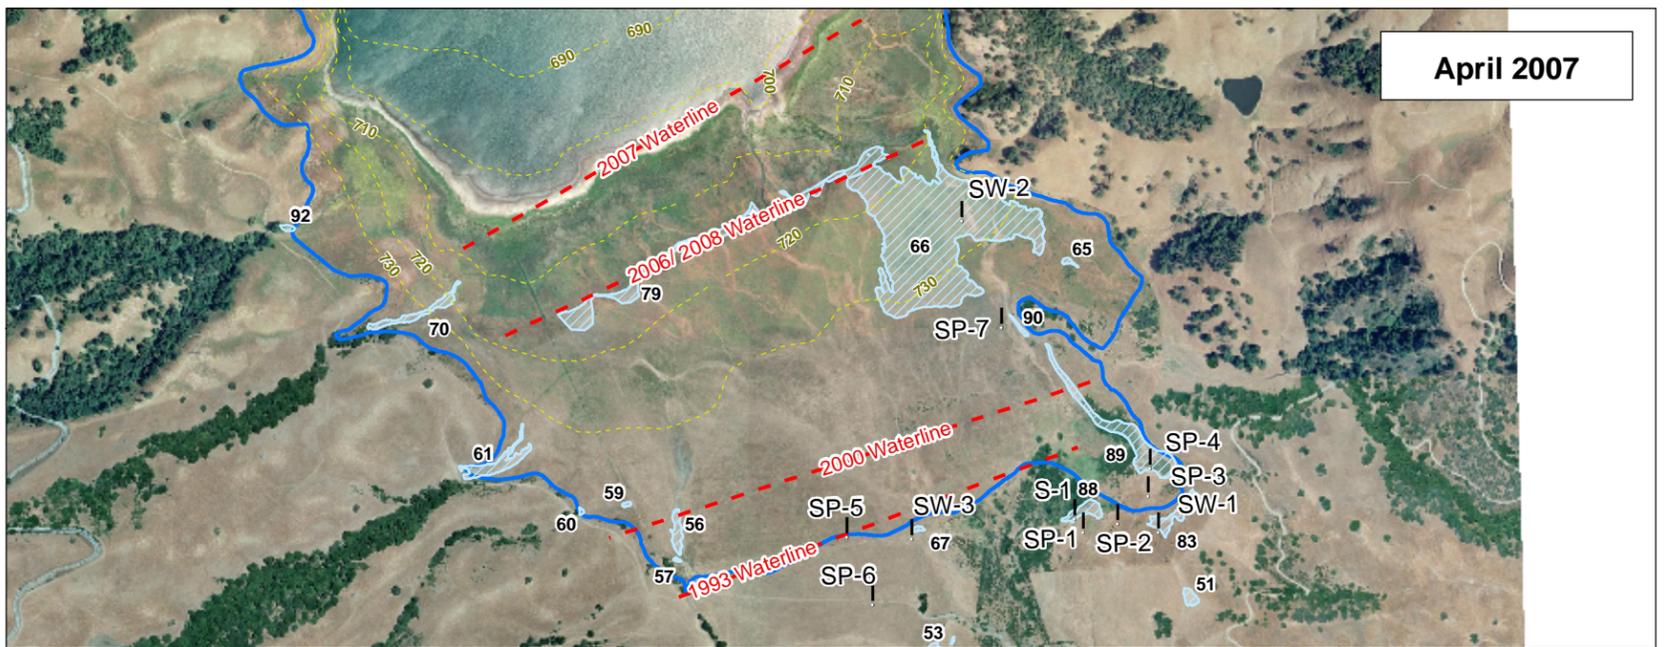
FIGURE 2

August 1996

June 2000

February 2006

April 2007

**WATERLINE COMPARISON FROM 1996-2007  
IN RELATION TO 2006 WETLANDS**

URS biologists reviewed a time-sequence of aerial imagery that illustrates fluctuations in the reservoir margins and associated saturated soils (Figure 2). Field work was conducted to compare the existing conditions with the locations of potential wetland features identified in aerial photos from 1993 to 2007. Existing conditions were then compared with the patterns of vegetation identified in the aerial imagery.

**Aerial Photo Review.** Five aerial images from 1993, 1996, 2000, 2006 and 2007 were compared. Four of these images (1996-2007) are shown in Figure 2<sup>4</sup>. Previous wetlands were identified and estimated based on a preliminary analysis of the aerial imagery. The southern margin of the reservoir was targeted as a location of interest in this study due to the preponderance of previous and current wetlands in the area. The preliminary analysis of the images clearly illustrates a distinct band of green vegetation that appears to follow the changing shoreline margins. These types of locations with a high probability of past wetland occurrence were selected for field verification.

The five aerial photos in Figure 2 illustrate variations in water surface elevation from approximately 756 feet in 1993 to 705 feet in April 2007. A light green band of vegetation along the margin of the reservoir is visible in all of the color aerial photos. This band appears to correspond to the zone of saturation and/or inundation. Surveys in February 2006 (May and Associates) and in April 2008 (Attachment A) documented that the saturated areas along the margins of the reservoir are dominated by a mix of wetland (hydrophytic) and non-wetland plants. Wetland plants observed in 2006 and 2008 surveys include curly dock (*Rumex crispus*) (FACW-), cudweed (*Gnaphalium luteoalbum*) (FACW-), spiny cocklebur (*Xanthium spinosum*) (FAC+), Canadian horseweed (*Conyza canadensis*) (FAC), clustered dock (*Rumex conglomeratus*) (FACW), and rabbitsfoot grass (*Polypogon monspeliensis*) (FACW+). Non-wetland plants in the saturated zone along the reservoir margin include black mustard (*Brassica nigra*) (NL), burclover (*Medicago polymorpha*) (NL), and milk thistle (*Silybum marianum*)(NL). In the 2008 survey, much of the vegetation along the reservoir margin was dead and appeared to have been recently inundated (the reservoir water level was decreasing) (See photo 8)

The sample point locations are shown on Figure 2 and observations at each sample point are briefly described below:

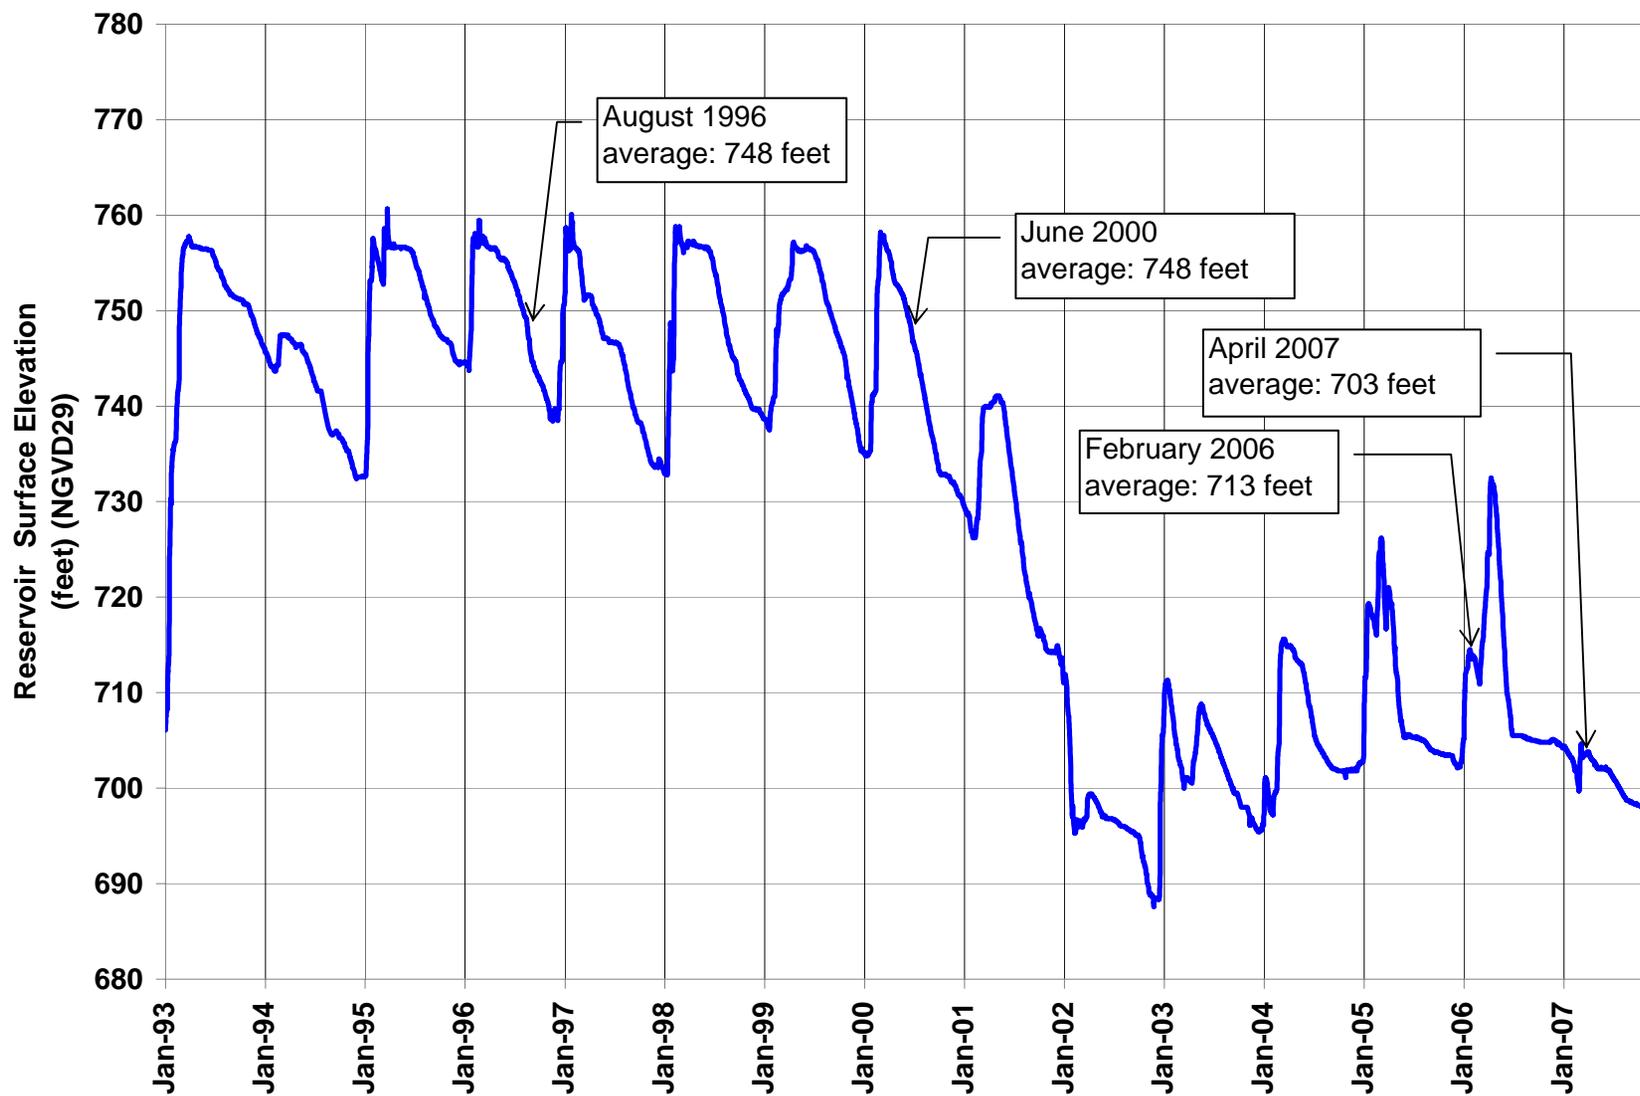
Figure 3. Daily Surface Elevation of Calaveras Reservoir

In addition to the reduction in water surface elevation after 2000, the water level of the reservoir also fluctuates seasonally. Figure 3 illustrates the seasonal variations of the water surface elevation. The amount of seasonal variation also varies between years. For example, the water surface elevation in April 2008 was higher than the water surface in April 2007 (Figure 2).

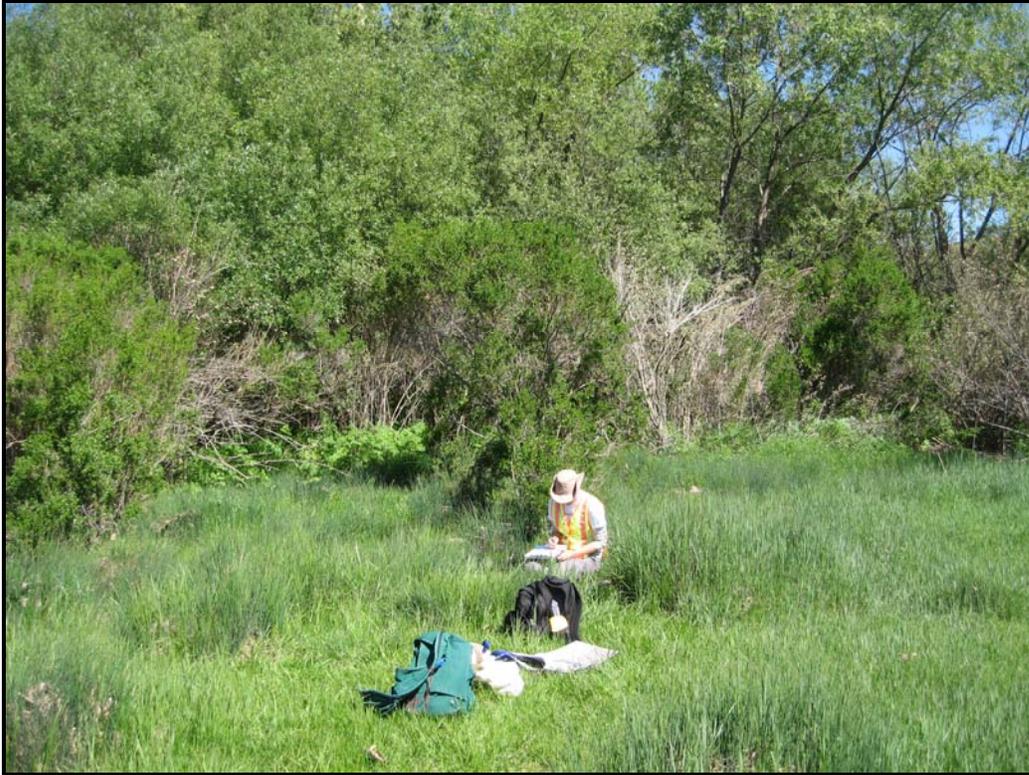
**Photo 1**– Looking north from Wetland #88 (SP-1). Riparian vegetation adjacent to the seep in the background is dominated by arroyo willow at the former confluence of Calaveras Creek and the reservoir inundation line.

- Clumps of spreading rush (*Juncus patens*) scattered among upland grasses near the former inundation limits (Photos 1, 3, and 4 );
- Stands of mulefat (*Baccharis viminea*) that parallel a rack line deposited during a previous high water period (Photo 5);
- The prevalence of ruderal, non-native herbaceous wetland plants along the current reservoir margins (Photo 6 and Photo 8). These species produce large numbers of seeds that are readily dispersed by water and air.
- Vegetation and soil information displayed on photos and field data taken around a former shoreline, near the 756 feet contour, document the presence of more persistent seasonal and riparian wetlands (Photos 1-9)

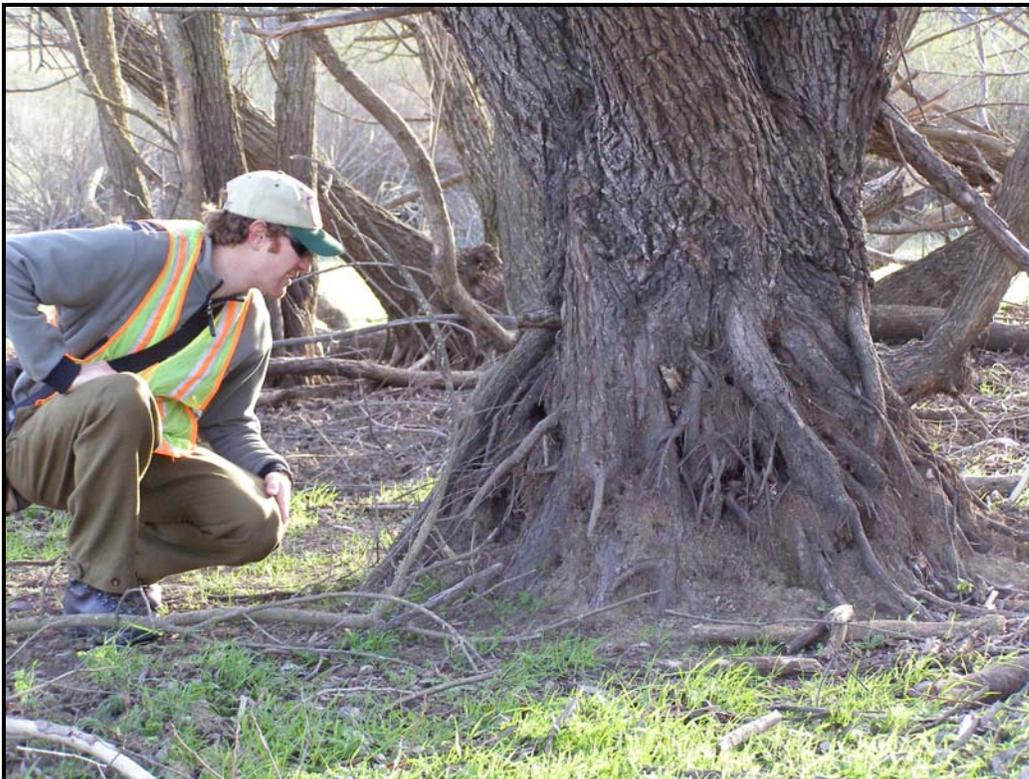
**Photo 2**– Close-up of arroyo willow trunk with adventitious roots at the former confluence of Calaveras Creek and Calaveras Reservoir (elevation approximately 756 feet). These roots occur in response to inundation or soil saturation. This site is not currently a wetland but appears to have been inundated or saturated in the past. Arroyo willows are a FACW species.

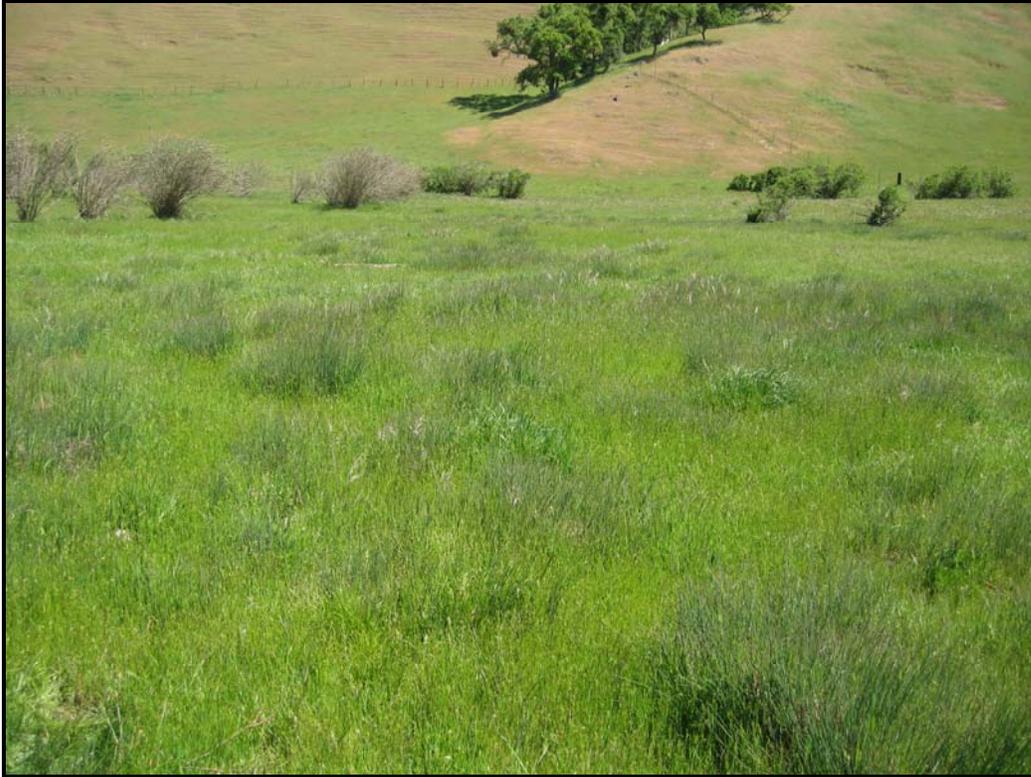
**Photo 3** –View of mule fat shrubs (FACW-) and clumps of spreading rush (FAC) near SP-3 at the former normal maximum water surface elevation (756 feet) illustrating historic wetland extent.

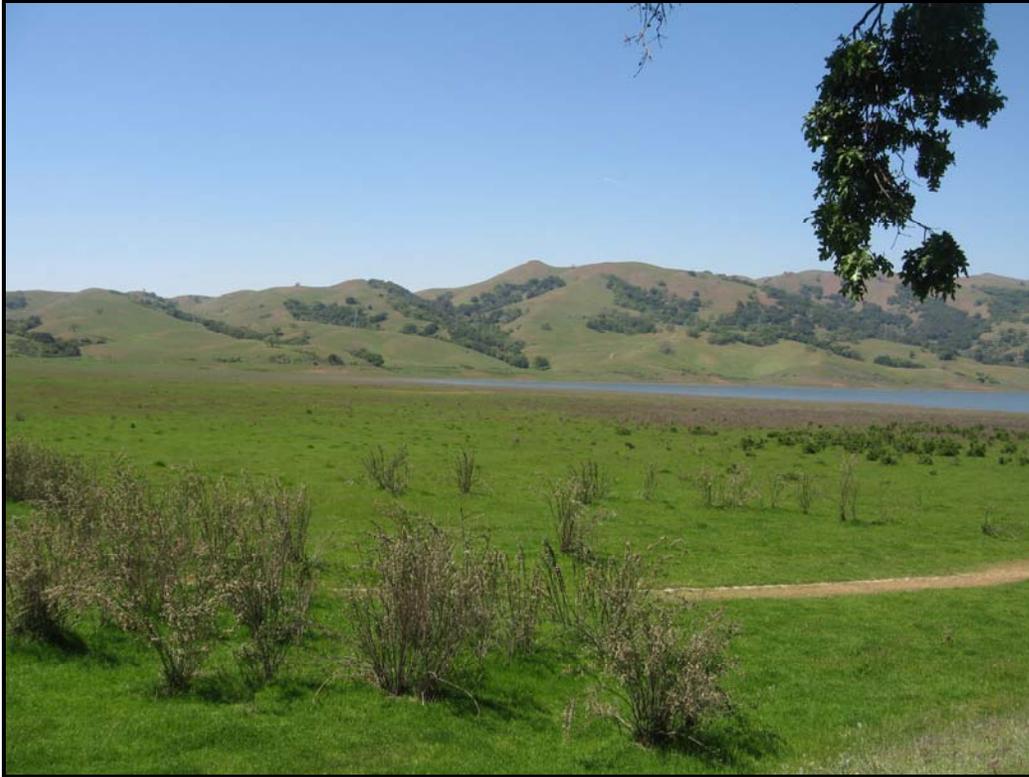
**Photo 6** - View toward the west from SP-7. Mule fat (FACW) grows in linear patterns that appear to correspond to former shorelines.

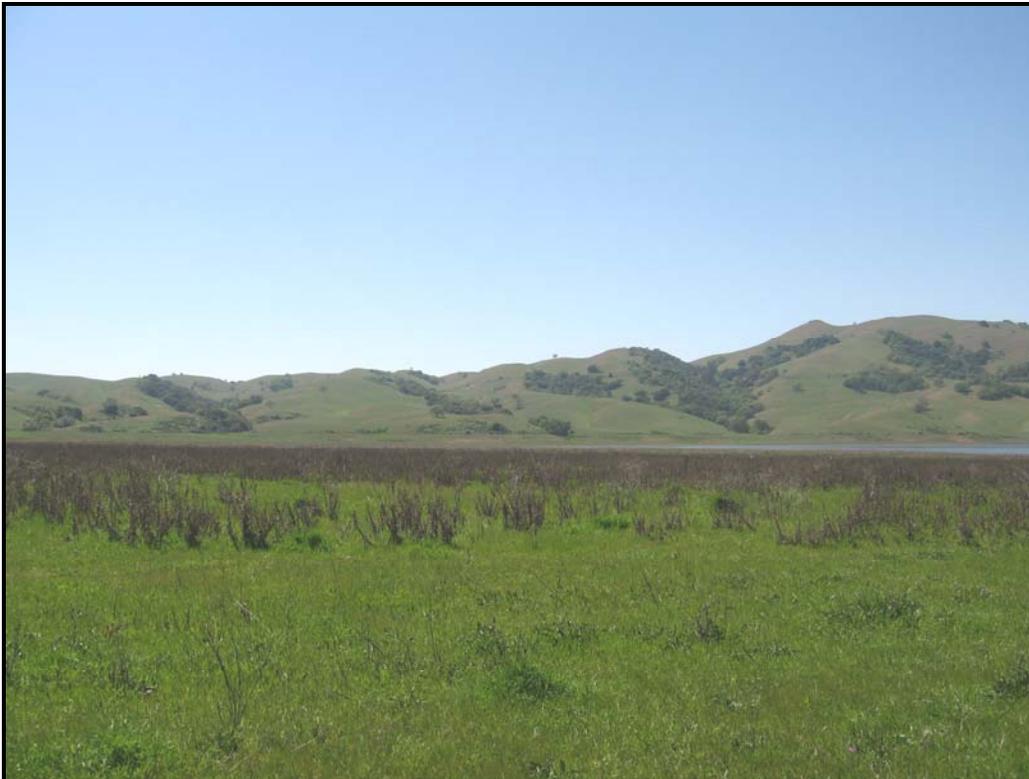
**Photo 7** –View northwest from SW-2 toward the current waterline. Foreground species included hydrophytic plants such as spiny cocklebur (FAC+) and toad rush (*Juncus bufonius*) (FACW+) that indicate the presence of seasonal wetlands adjacent to the current inundation level of the reservoir.

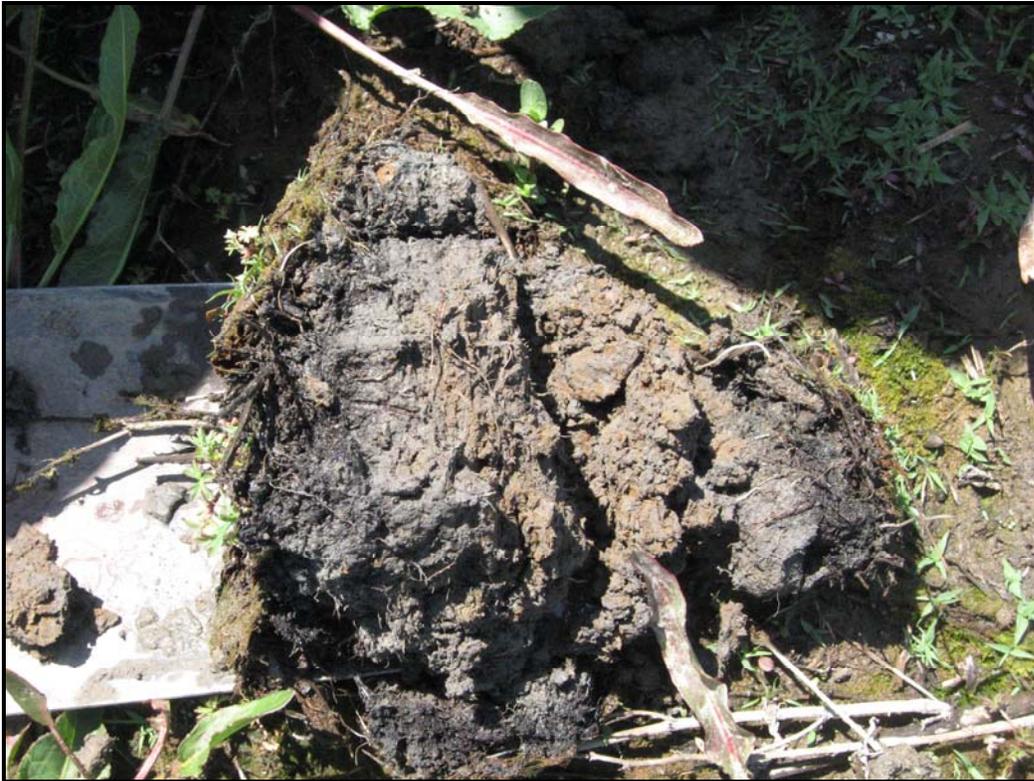
Photo 8 – Wetland #66. Redox depressions in soil sample at SW-2 demonstrate the presence of wetland soils in existing seasonal wetlands along the margins of the reservoir.

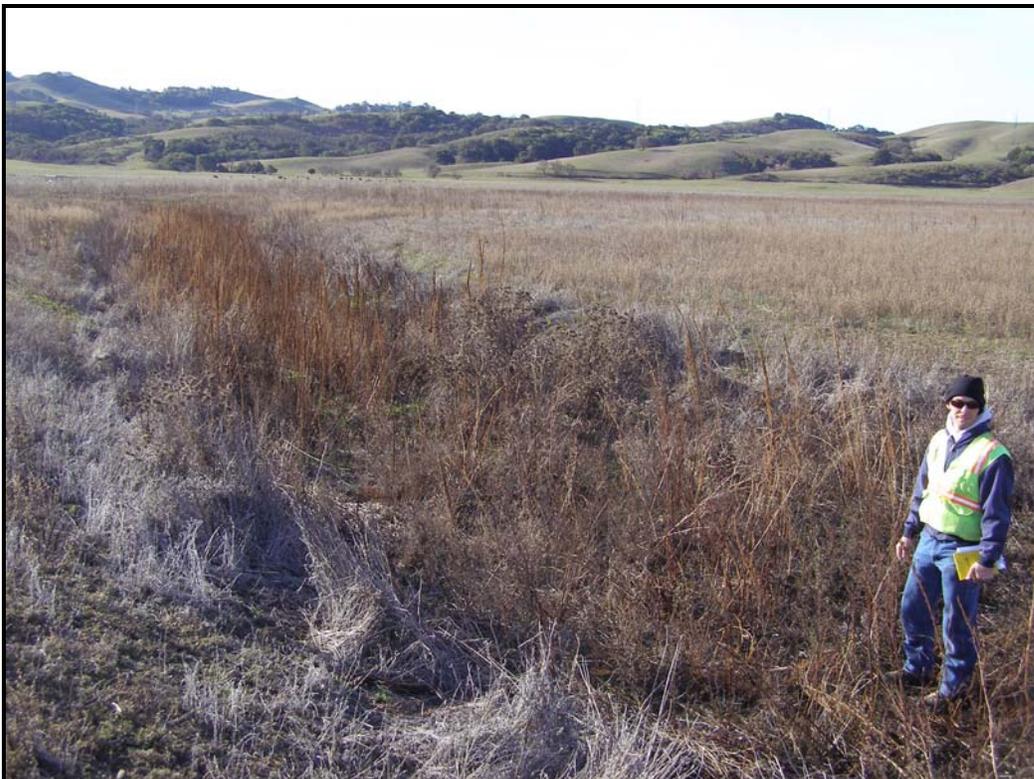
**Photo 9** – Canadian horseweed (FAC) and spiny cocklebur (FAC+) near the margin of the reservoir in January 2008 are wetland plant species that commonly occur along the margins of inundated areas. These warm season species are probably associated with the strong green color evident in the aerial photos taken in late summer.

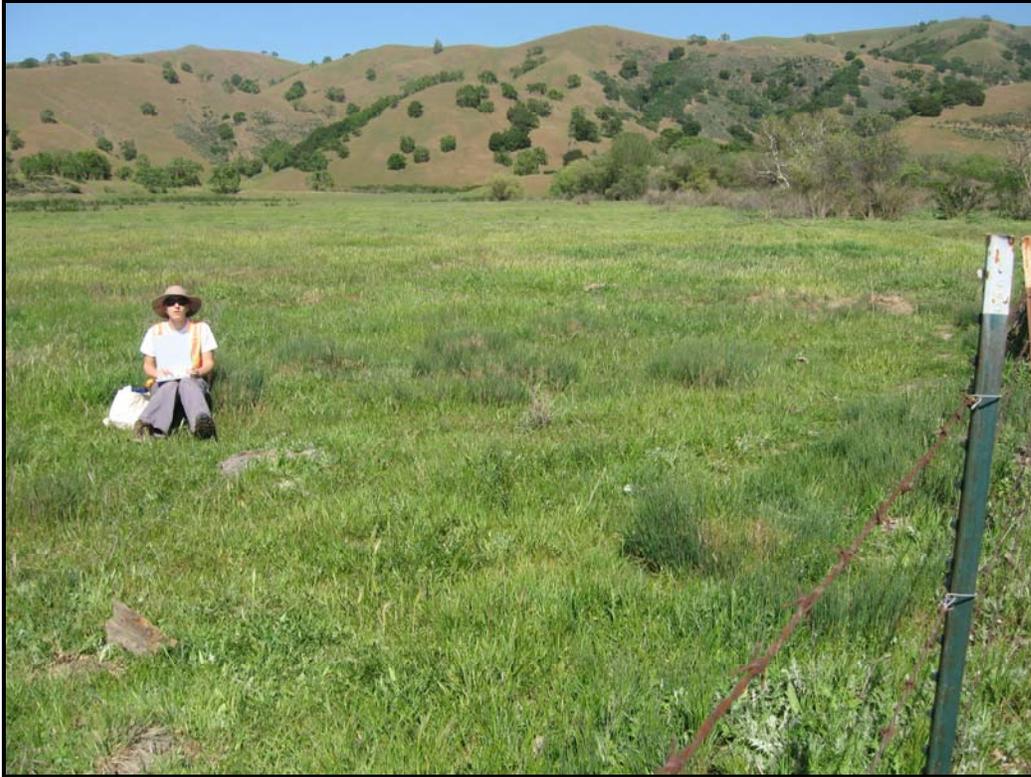
**Photo 9** –Wetland #67 looking northeast from SW-3. This seasonal wetland is located approximately along the former normal maximum water surface limit at the southern margin of the reservoir as demonstrated by the presence of wetland plants, soils and hydrology.
