December 1, 2014

Project No. 1301525

**RE: COMPOST AREA IMPROVEMENT REPORT FOR THE FEATHER RIVER ORGANICS
COMPOSTING OPERATION, RECOLOGY YUBA SUTTER FACILITY, MARYSVILLE,
CALIFORNIA**

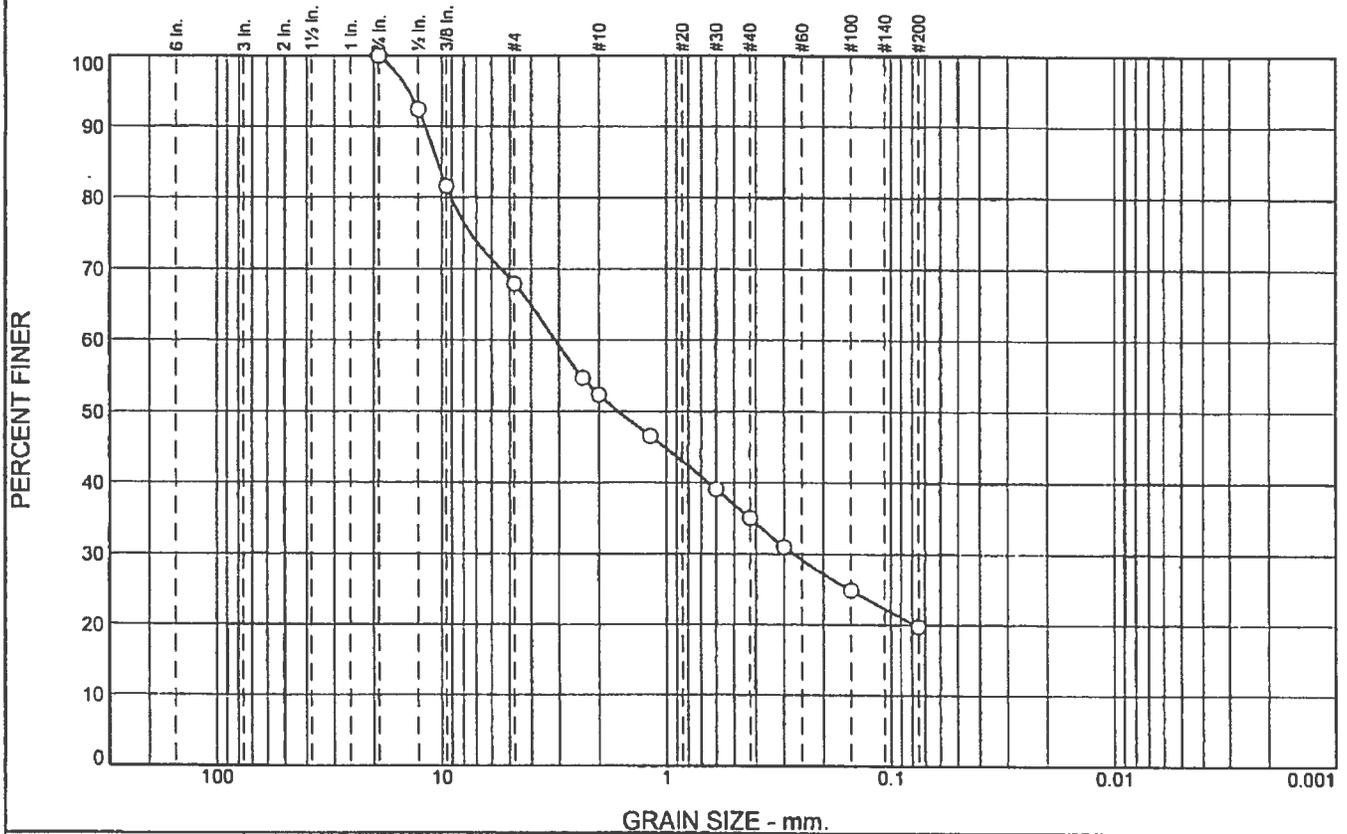
Particle Size Distribution Report

Test No.	Grain Size Analysis				Pass/ Fail
	> 1"	Gravel	Sand	Fines	
101	0%	32.1%	48.1%	19.8%	Pass
103	0%	34.0%	33.1%	32.9%	Pass
105	0%	29.6%	51.9%	18.5%	Pass
107	0%	29.0%	45.4%	25.6%	Pass
111	0%	46.4%	34.8%	18.8%	Pass

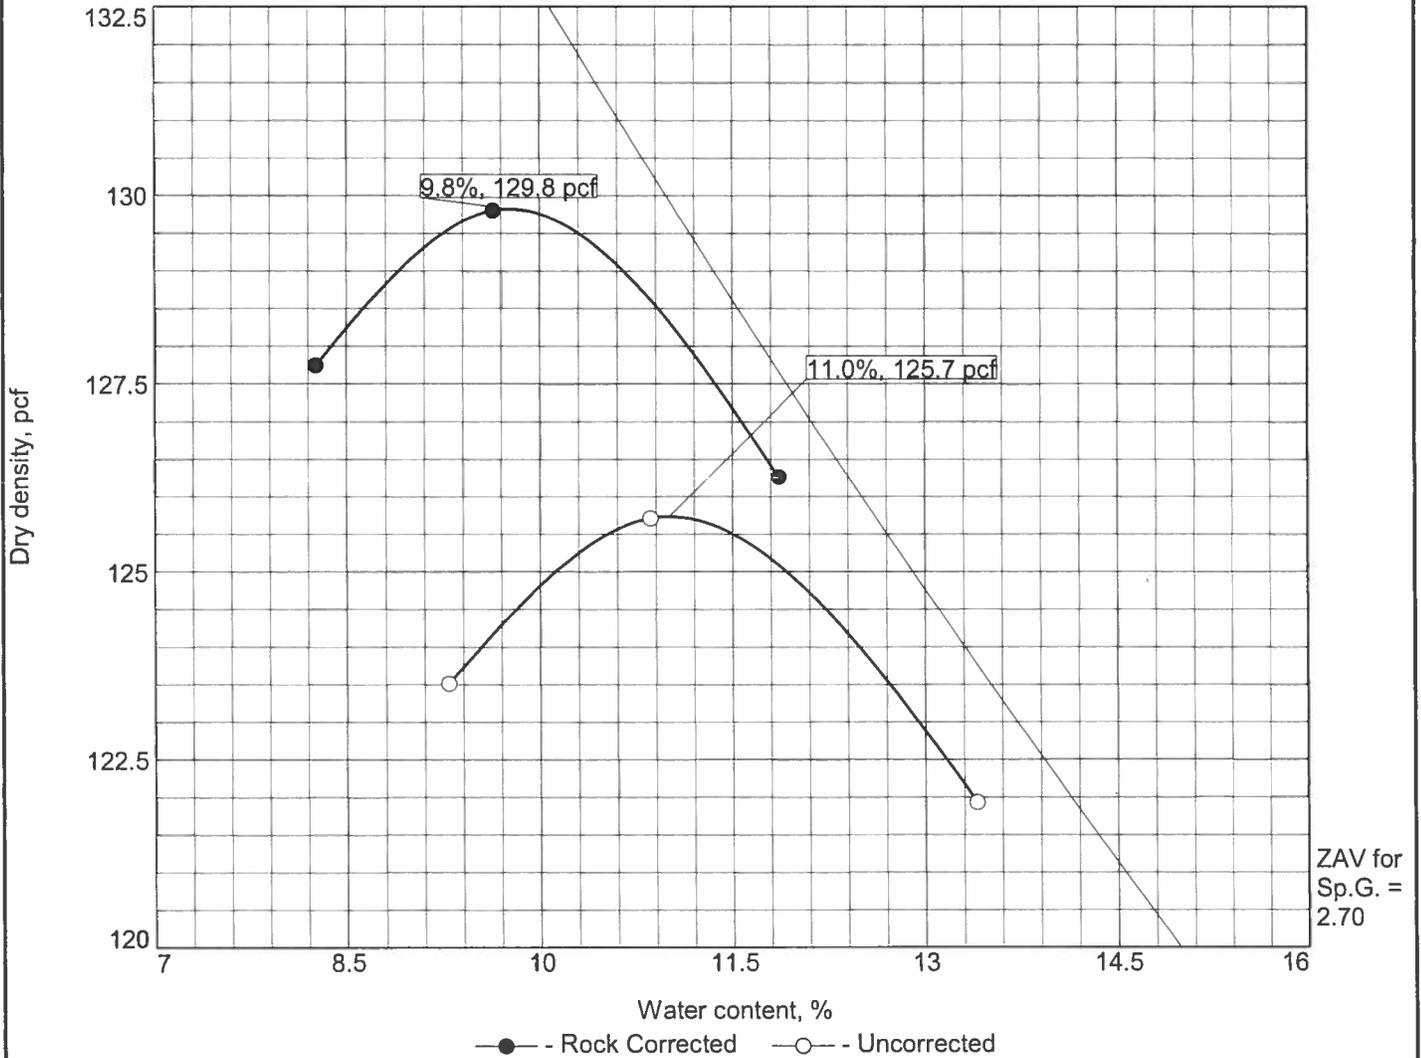
COMPACTION TEST REPORT

ROCK CORRECTED TEST RESULTS	UNCORRECTED	MATERIAL DESCRIPTION
Maximum dry density = 129.8 pcf	125.7 pcf	
Optimum moisture = 9.8 %	11.0 %

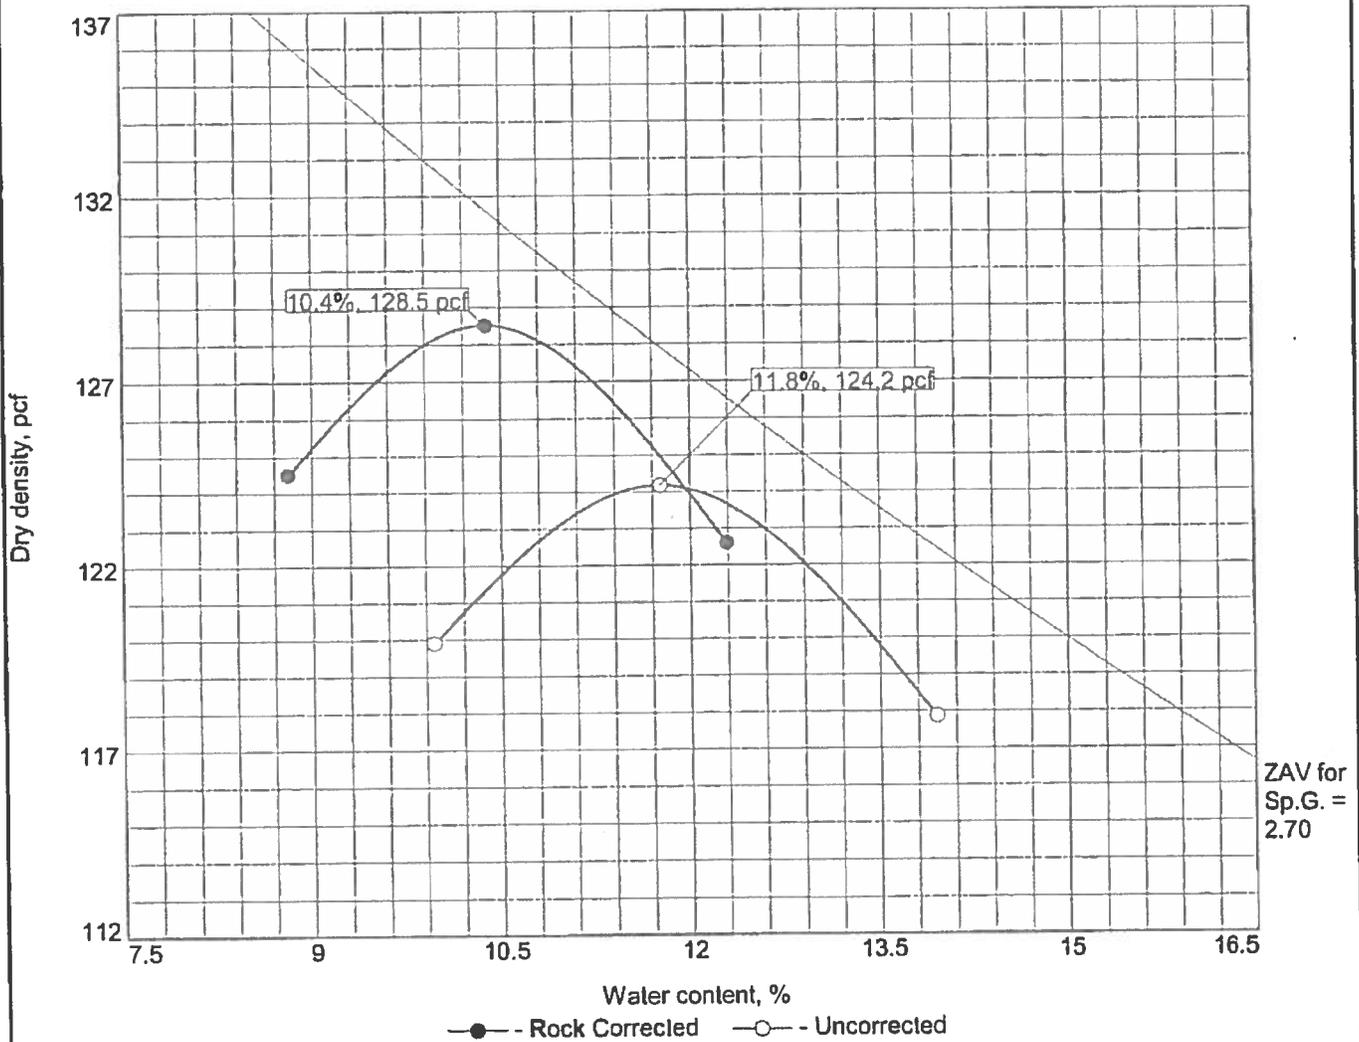
COMPACTION TEST REPORT

ROCK CORRECTED TEST RESULTS	UNCORRECTED	MATERIAL DESCRIPTION
Maximum dry density = 128.5 pcf	124.2 pcf	
Optimum moisture = 10.4 %	11.8 %
