**PARAGON GEOTECHNICAL, INC.**  
CONSULTING ENGINEERS

**RE:** **Preliminary Findings and Conclusions – Evaluation of Pond Seepage**  
Hidden Lakes Estates North Pond Dam  
Granite Bay, CA  
(Proj. No. 1383-01-07)

This memorandum presents the preliminary results of our seepage evaluation of a small earth dam located at the north end of the north lake in the Hidden Lakes Estates residential subdivision in Granite Bay, California. The scope of our work included: 1) reviewing selected geologic and project references; 2) drilling 4 exploratory borings in the area of the north dam; and 3) performing laboratory testing and engineering analyses. The purpose of this memorandum is to provide an update on the progress of our work. A final report summarizing our geotechnical findings, conclusions and recommendations will be produced upon completion of our work. Our scope of work was outlined in our Professional Services Agreement with the Hidden Lakes Estates Homeowners Association (HLEHA) dated February 16, 2007.

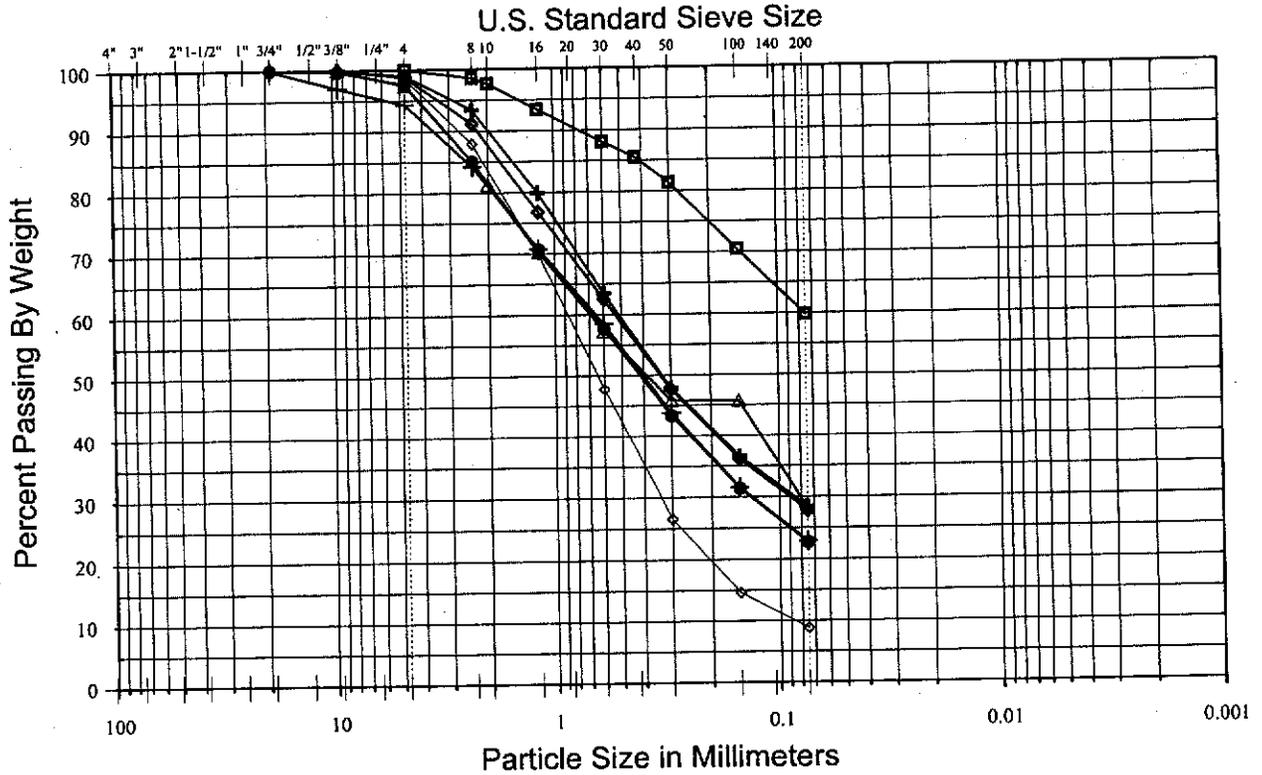
# Particle-Size Distribution

COBBLES	GRAVEL		SAND			SILT OR CLAY
	COARSE	FINE	COARSE	MEDIUM	FINE

- + — + Sample B1-2 2.5 - 4.0 ft
- △ — △ Sample B1-3-2 6.0 - 6.5 ft
- — ● Sample B2-2 2.5 - 4.0 ft
- + — + Sample B2-4 6.5 - 8.0 ft
- ◇ — ◇ Sample B3-1-1 1.5 - 2.0 ft
- — □ Sample B3-3-1 5.0 - 5.5 ft

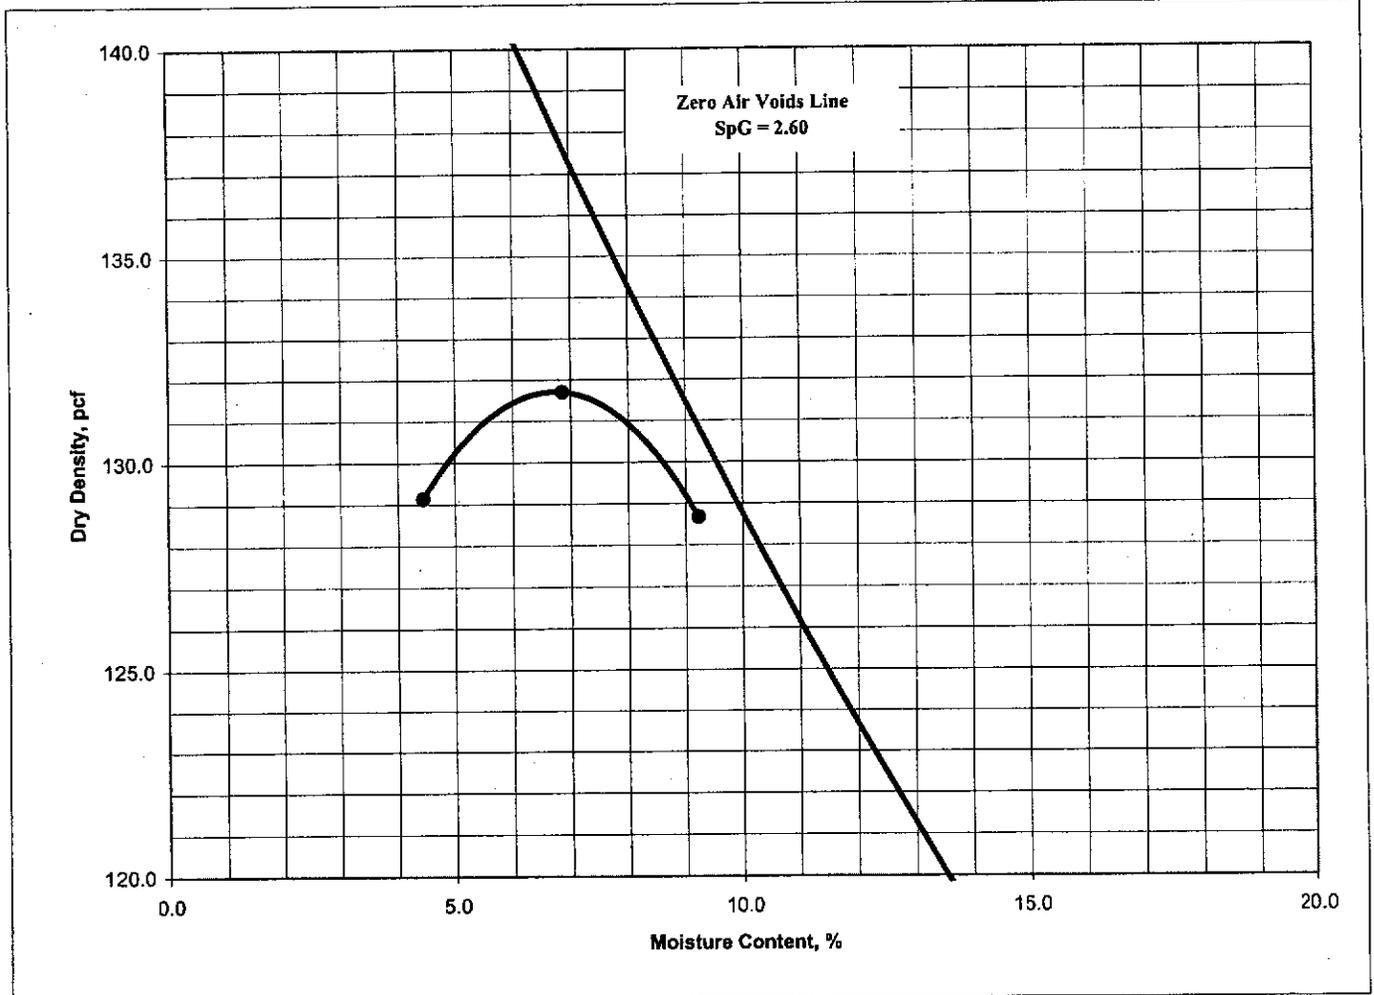
# MOISTURE DENSITY RELATIONSHIP CURVE

ASTM D 1557, Method A

1	2	3	4	5
Moisture (%)	4.4	6.9	9.2	0.0	0.0
Dry Density (pcf)	129.1	131.7	128.7	0.0	0.0

**Maximum Dry Density = 131.5 pcf**  
**Optimum Moisture Content = 6.5 %**

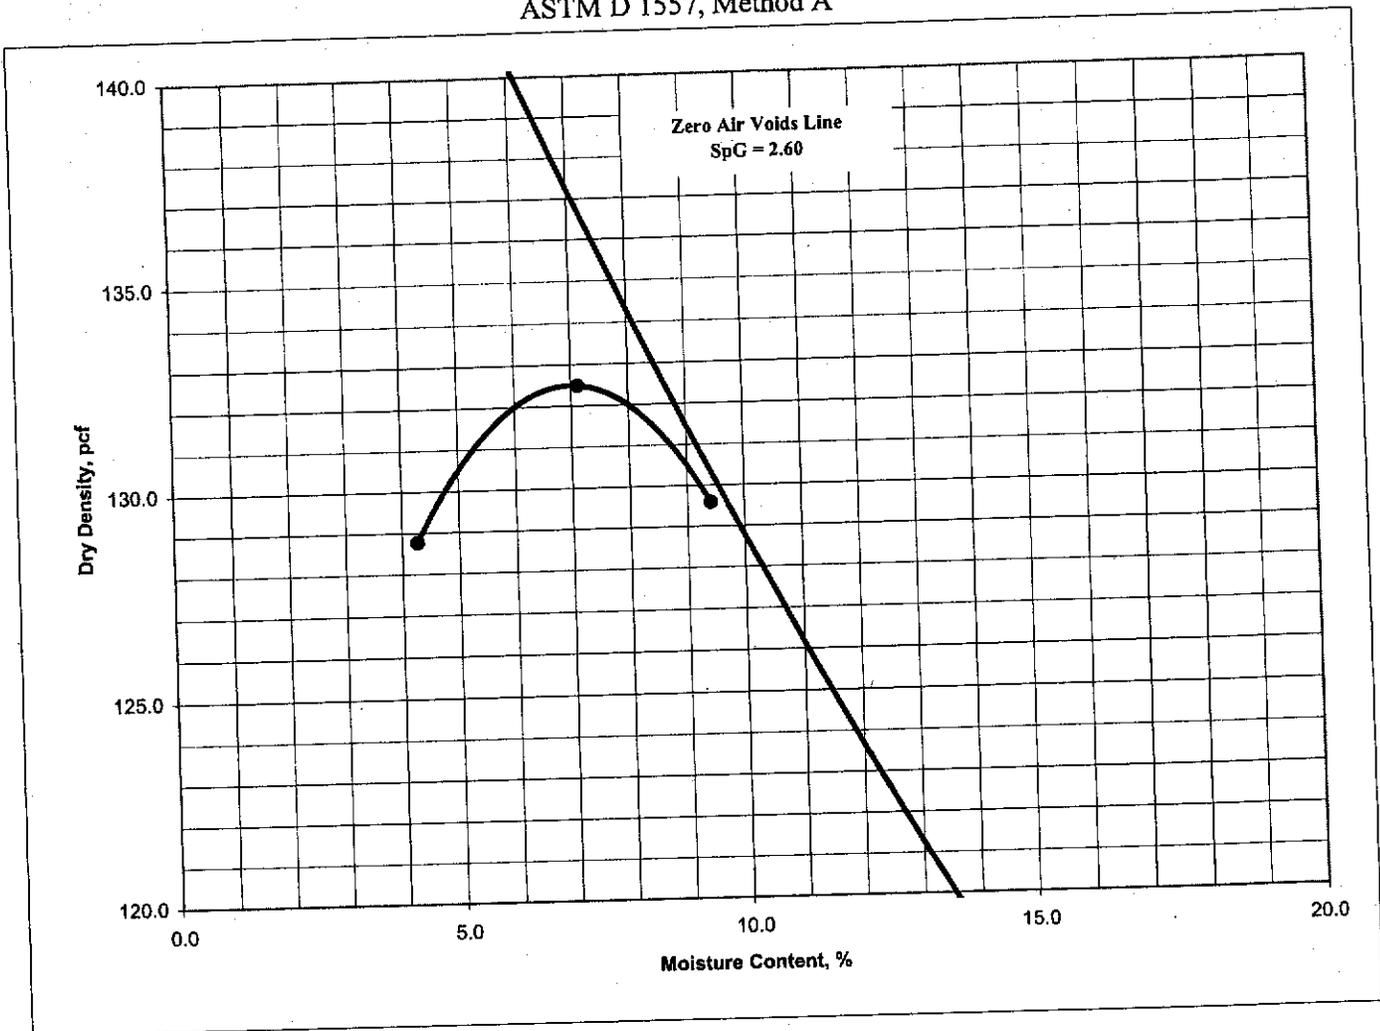
# MOISTURE DENSITY RELATIONSHIP CURVE

ASTM D 1557, Method A

1	2	3	4	5
Moisture (%)	4.3	7.1	9.4	0.0	0.0
Dry Density (pcf)	128.8	132.5	129.6	0.0	0.0

Maximum Dry Density = 132.5 pcf  
 Optimum Moisture Content = 7.0 %

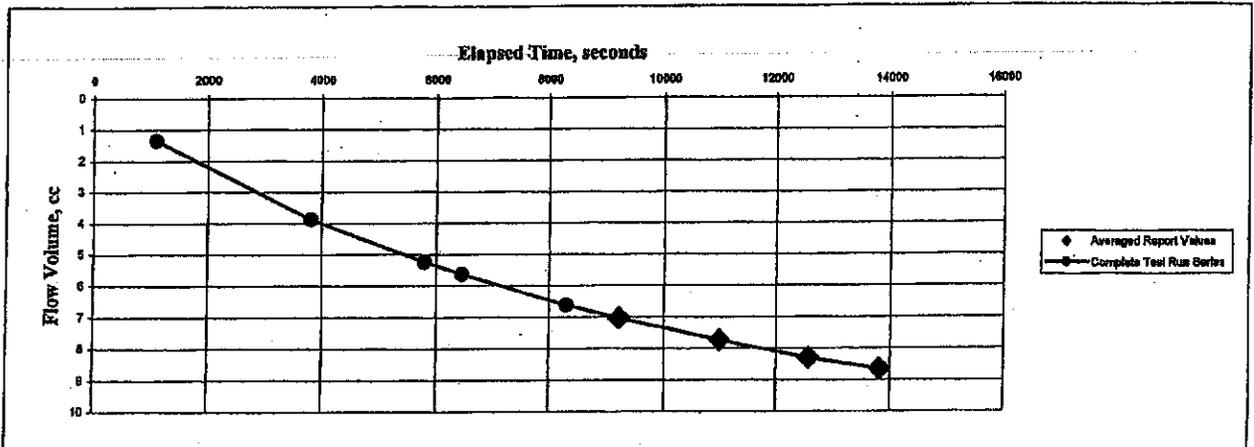
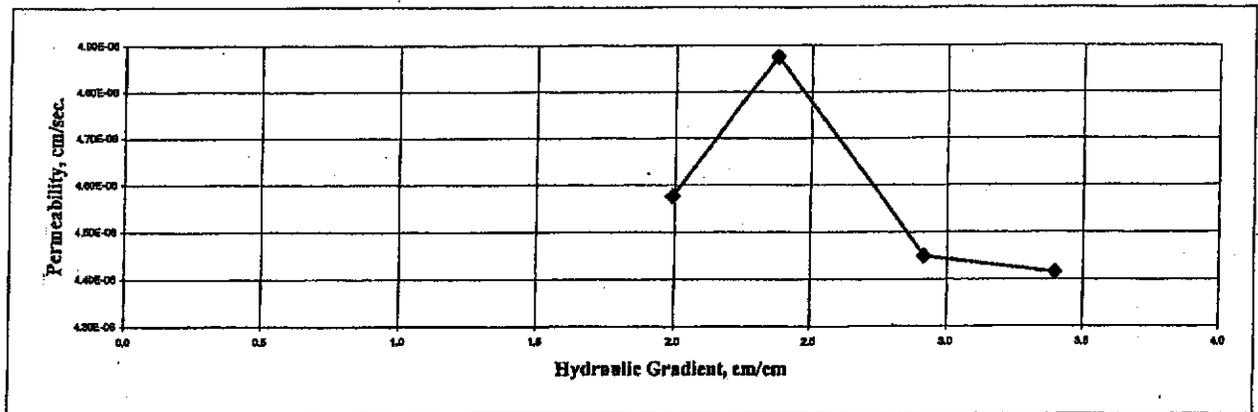
**TEST SAMPLE DATA**

<u>Before Test</u>	<u>After Test</u>
Specimen Height, cm: 7.62	Specimen Height, cm:
Specimen Diameter, cm: 6.17	Specimen Diameter, cm:
Dry Unit Weight, pcf: 119.9	Dry Unit Weight, pcf:
Moisture Content, % 8.0	Moisture Content, %
Specific Gravity, Assumed	
Percent Saturation:

Test Method: ASTM D 5856

The results of our laboratory and field permeability testing within the dam and dam foundation are summarized below:

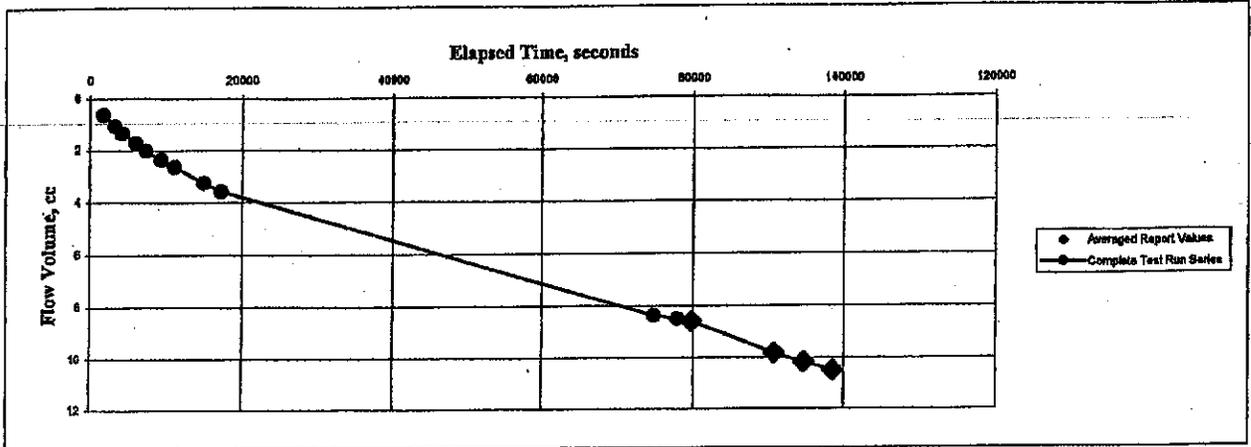
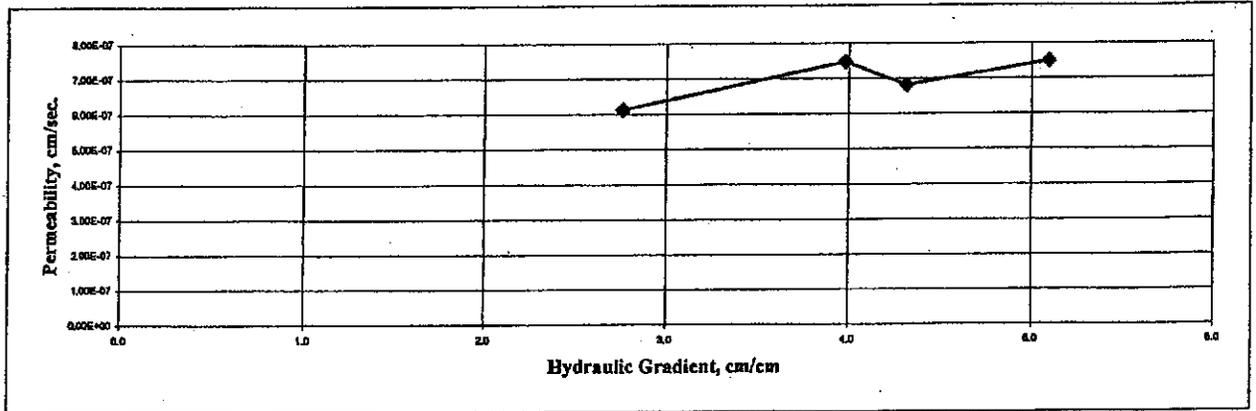
Specimen Height, cm: 6.91  
 Specimen Diameter, cm: 6.12  
 Dry Unit Weight, pcf: 120.2  
 Moisture Content, % 10.1  
 Specific Gravity, Assumed  
 Percent Saturation:

Specimen Height, cm: 6.73  
 Specimen Diameter, cm: 6.12  
 Dry Unit Weight, pcf: 128.7  
 Moisture Content, % 12.9

Test Method: ASTM D 5856

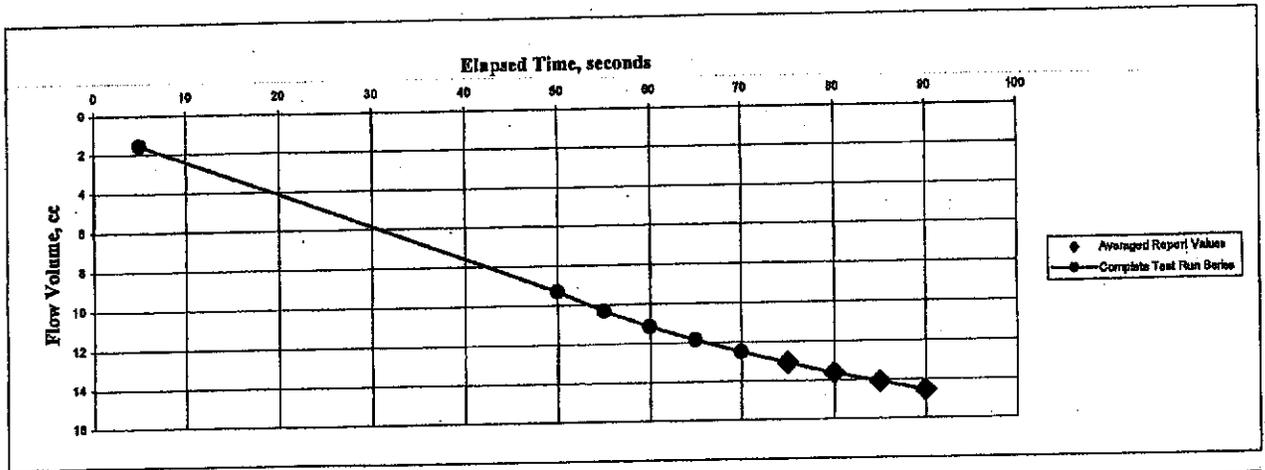
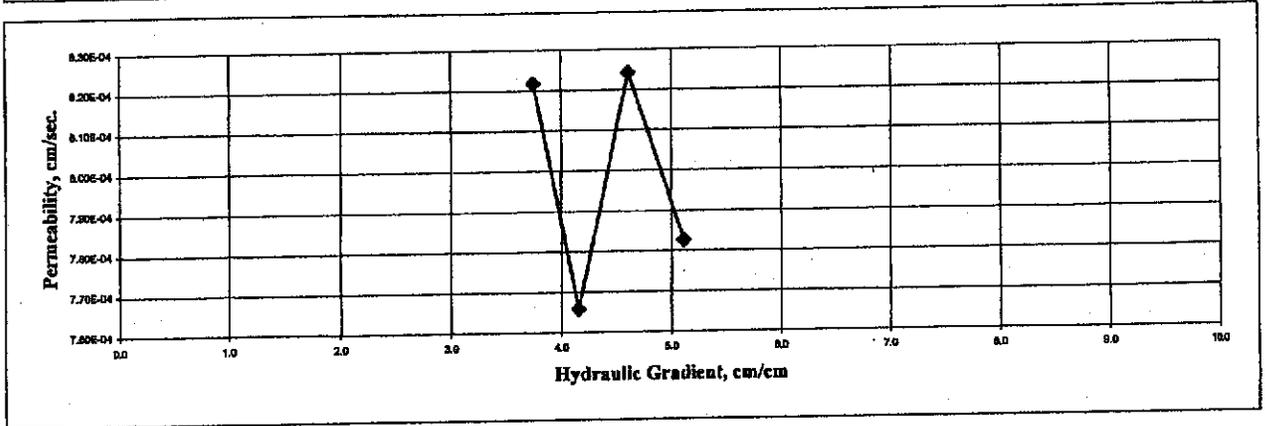
Specimen Height, cm: 8.13  
 Specimen Diameter, cm: 6.10  
 Dry Unit Weight, pcf: 115.4  
 Moisture Content, % 5.4  
 Specific Gravity, Assumed  
 Percent Saturation:

Specimen Height, cm: 7.49  
 Specimen Diameter, cm: 6.10  
 Dry Unit Weight, pcf: 105.7  
 Moisture Content, % 16.7

Test Method: ASTM D 5856
